TECH TIMES

The Professional Publication for Kia Dealership Technicians & Service Staff

Volume 15, Issue 5

Immobilizer System Identification Before Attempting Reflash

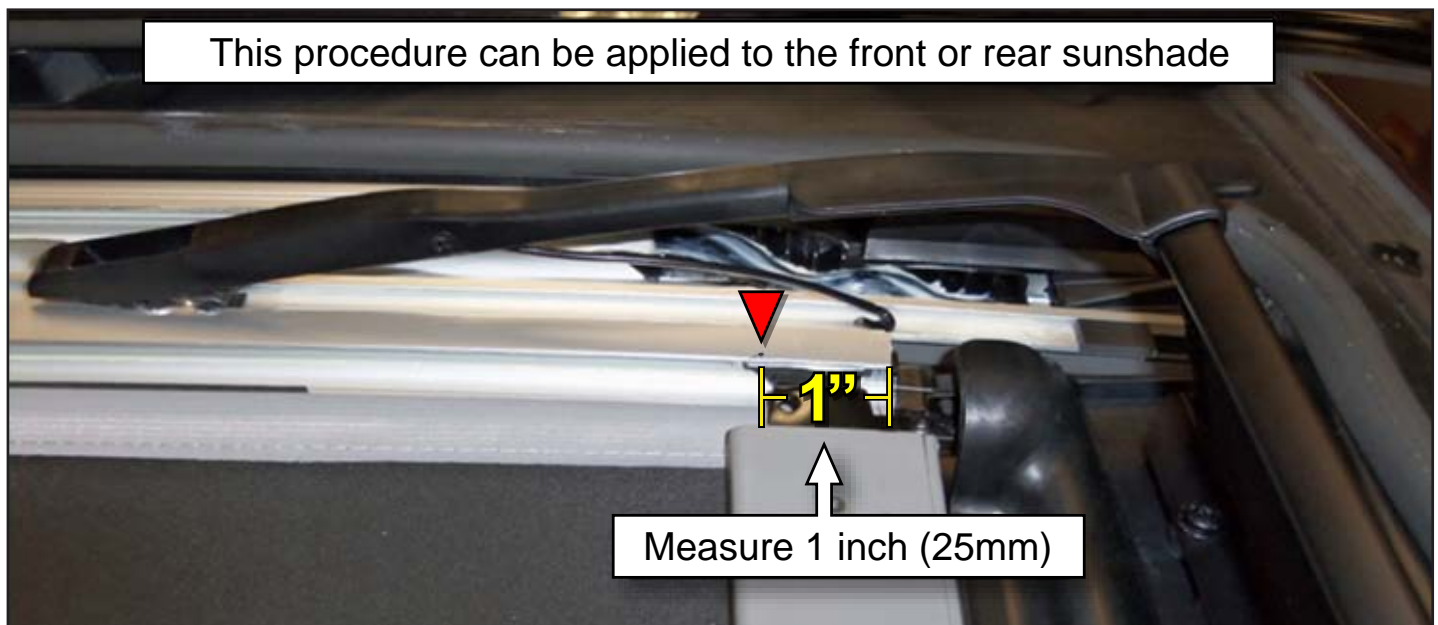
The current design intent for the sunshade has two positions, OPEN or CLOSED; if the sunshade is positioned in any other position, unintended movement remains possible during driving, especially over rough roads because there are no detent positions to hold it in place.

1. Open the front sunroof sliding glass.
2. Measure from the front edge of track 1" (25mm) and place mark.
3. Using a pair of pliers or a punch make a 0.020" (.5mm) depression in upper track where the measured mark was made to create resistance when closing the sunshade.
4. Repeat the same step on the opposite side, to adjust the rear sunshade detent, pull the headliner down slightly to disconnect the fasteners and make the same adjustment as described to the front track. When complete, snap headliner back into place, make sure your hands are clean when putting headliner back in place. Clean hand-prints as required.
5. If the adjustment you made is too tight, open the detent you created with a screwdriver and re-adjust the detent as required.

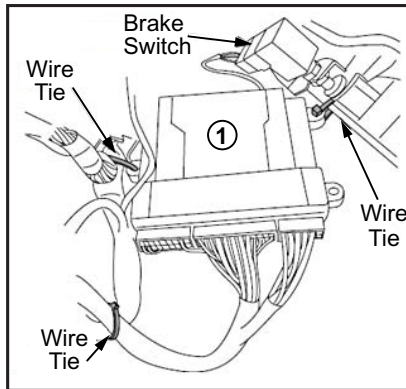
Some remote start equipped Forte's may not indicate that the doors have been locked. The customer may state that the vehicle will not flash the hazard lights or sound the horn when locking the doors with the transmitter. As designed, the vehicle should flash the hazard lights and sound the horn after pressing the lock button two times within five seconds.

2. Locate the Remote start control module (1) on the driver's side dash near brake switch as shown.

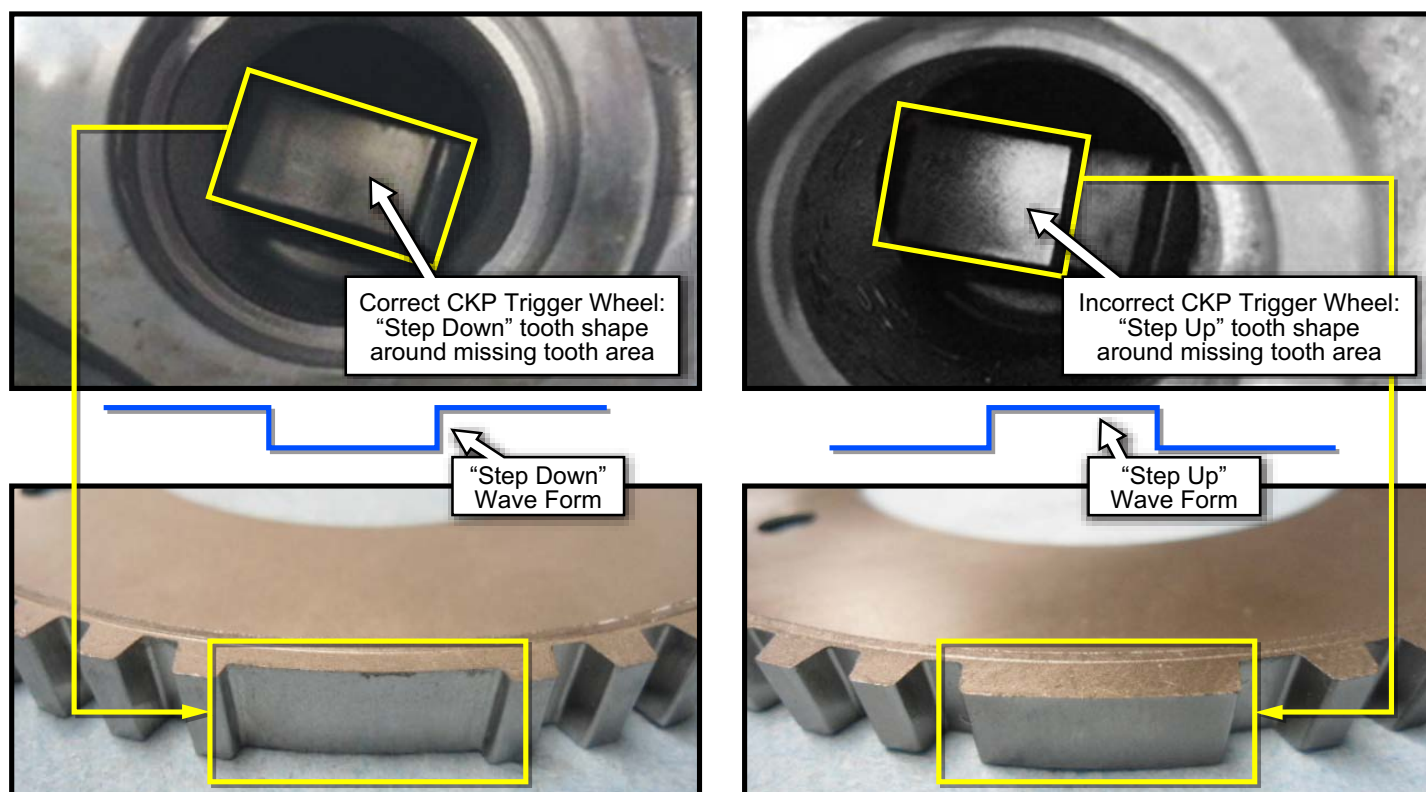
The purpose of this article is to assist in determining whether or not the CKP trigger wheel in 2.4L Theta I & II remanufactured engines is the correct trigger wheel prior to installing a new one on a vehicle. A very small number of remanufactured 2.4L Theta I&II engines may have had incorrect CKP trigger wheels installed, which may cause a hard start or hesitation concern.

To address this concern, remove the CKP sensor to gain access to the CKP trigger wheel. The image of the CKP trigger wheel on the left below illustrates a correct "step down" design, while the image on the right shows an incorrect "step up" design.

If a remanufactured engine has already been installed into a vehicle without prior inspection of the correct CKP trigger wheel verification, and a hesitation and/or hard start concern is experienced, use the following inspection and diagnostic procedure to identify the cause, since gaining access to CKP trigger wheel is difficult without removing the ladder support frame of the short block assembly.

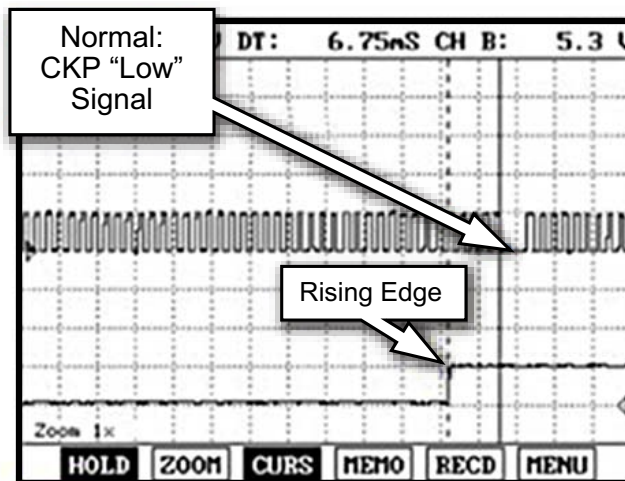
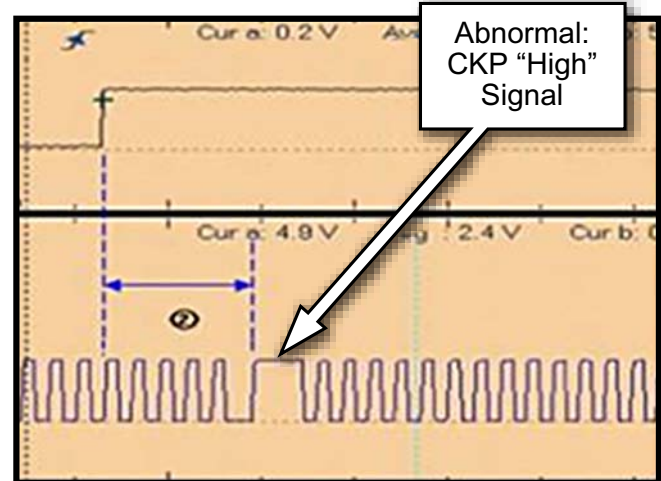
1. Connect the VMI and monitor CMP and CKP sensors, especially the CKP, to see if the scope pattern for "missing tooth" area is a "low" or "high" signal.
2. If you see a pattern similar to the image on the right, with "high" signal, please order either one of the part numbers below, and install it to correct this concern.

The part number for remanufactured 2.4L Theta I&II short block is **212Y2-25H00BR** or **212Y2-25H00CR**.
