Service Bulletin

PRELIMINARY INFORMATION

Subject: Blower Motor Inoperative and/or Water In Blower Motor Control Module Area DTC B0193

Models: 2013 Chevrolet Malibu eAssist

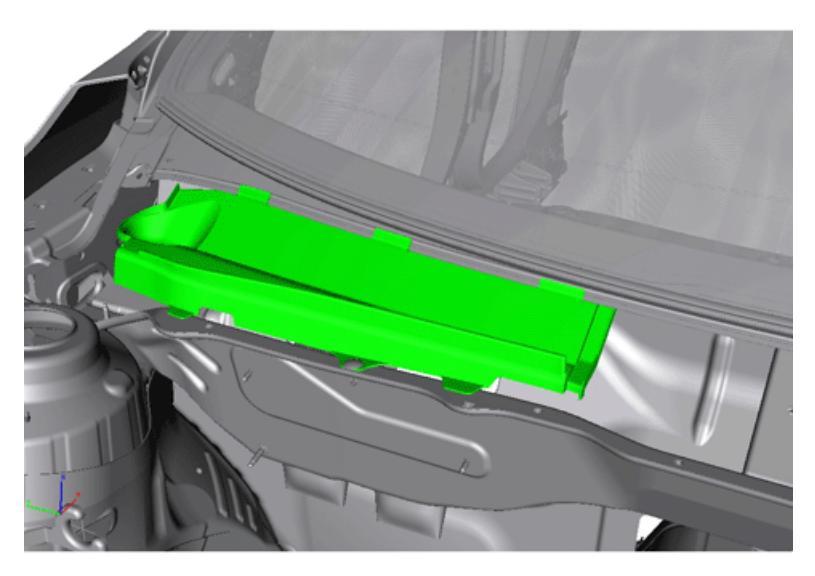
A customer or technician may indicate the blower motor is inoperative and/or there is water in the blower control module motor area. DTC B0193 may also be set.

If this concern is duplicated inspect the blower motor, blower motor control module and connectors for signs of water. If water is found it will be necessary to reseal the plenum deflector (see images below) and then replace parts and repair connectors as needed. Remove the air inlet grille to access the plenum water deflector.
