Service Bulletin

Bulletin No.: PI0695

Subject: Diagnosis and Repair HVAC Blower Function

Models: 2008-2012 Cadillac Escalade, Escalade ESV, Escalade EXT 2007-2012 Chevrolet Silverado 2008-2012 Chevrolet Suburban, Tahoe 2007-2012 GMC Sierra 2008-2012 GMC Yukon, Yukon XL, Yukon Denali, Yukon Denali XL

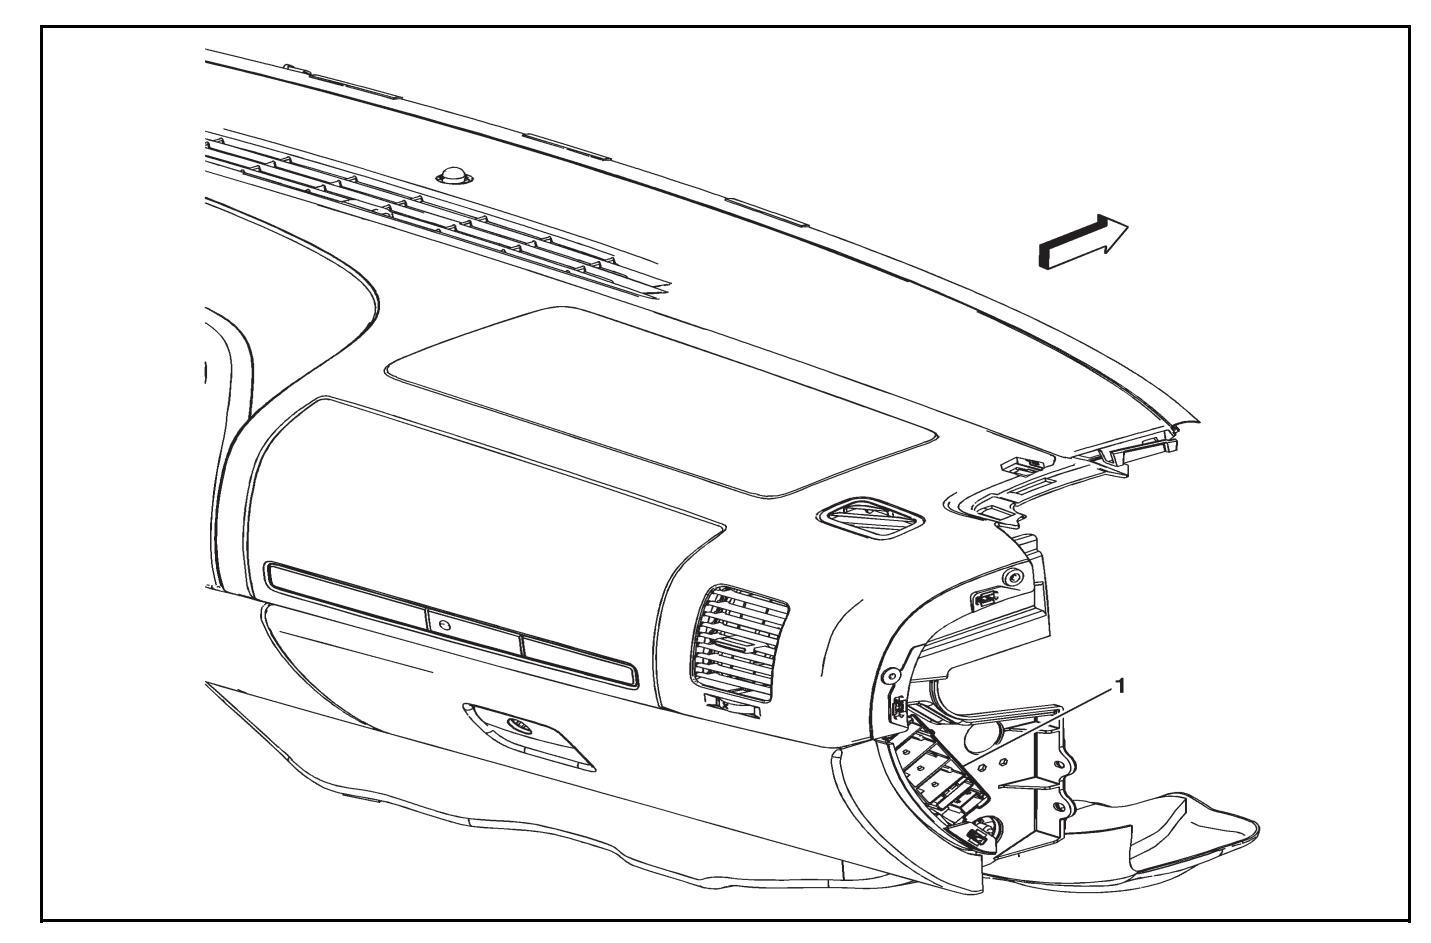
2062300

One possible cause of this condition may be the contacts in the HVAC junction block(s) located at the right side of the instrument panel.

1. Remove the cover on the right side of the instrument panel, exposing the junction blocks.
