PARTS MANAGER	IMPORTANT - All Service Personnel Should Read and Initial in the boxes provided, right.	QUALITY DRIVEN® SERVICE
and the set	SERVICE BULLET	
APPLICABILITY:	2013MY BRZ	NUMBER: 06-44-12
SUBJECT:	Diagnosis of DTC C1249 Brake Light Switch Malfunction	DATE: 10/22/12

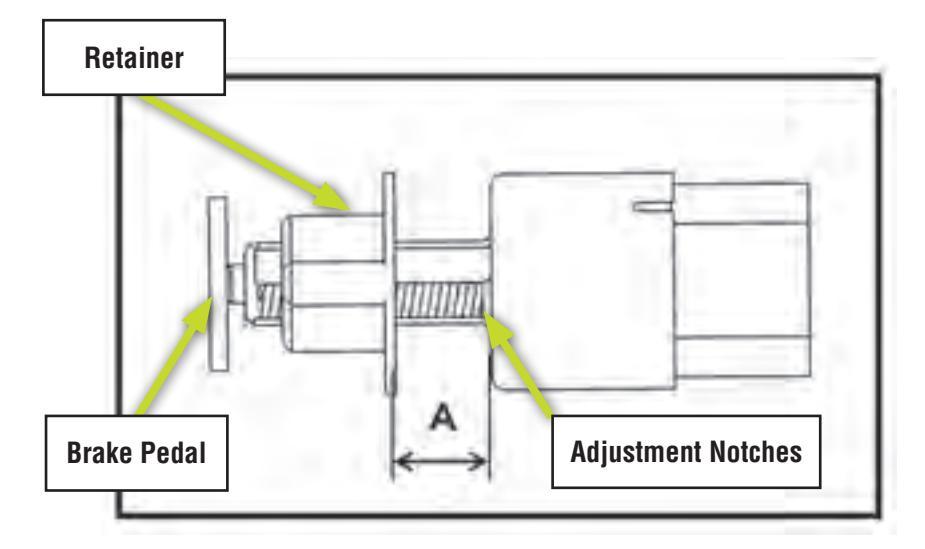
Other possible causes are a faulty or improperly adjusted brake light switch.

• Illustration shows the brake light switch and "Gap A" dimension which is explained below.

When the brake light switch status turns from "off" to "on", master cylinder pressure should be between **0.08 to 0.27 MPa (11.6 to 39.2 psi)**.

- If the pressure measured is exceeds .3MPa (43.5psi) as indicated on the SSMIII, increase the "Gap A" dimension by 1 mm. Before adjusting the brake light switch, add a mark to reference it to the retainer as shown in the photos on page 3. This will help make the adjustment process easier. **CAREFULLY** rotate the brake light switch **SLOWLY**, counter-clockwise approximately 1/4 turn until you feel it begin to release from the retainer. Before it releases completely, move it one "notch" outward toward the steering wheel. Turn it back to the right (clockwise) until you feel it snap back into the "locked" position. You will need to develop a "feel" for the adjustment notches along with how the brake light switch releases and locks back into place. This may involve some trial and error. One notch is equivalent to 1mm of adjustment. If the brake light switch releases completely, insert it back into the retainer until your reference mark is in the original position then try again.

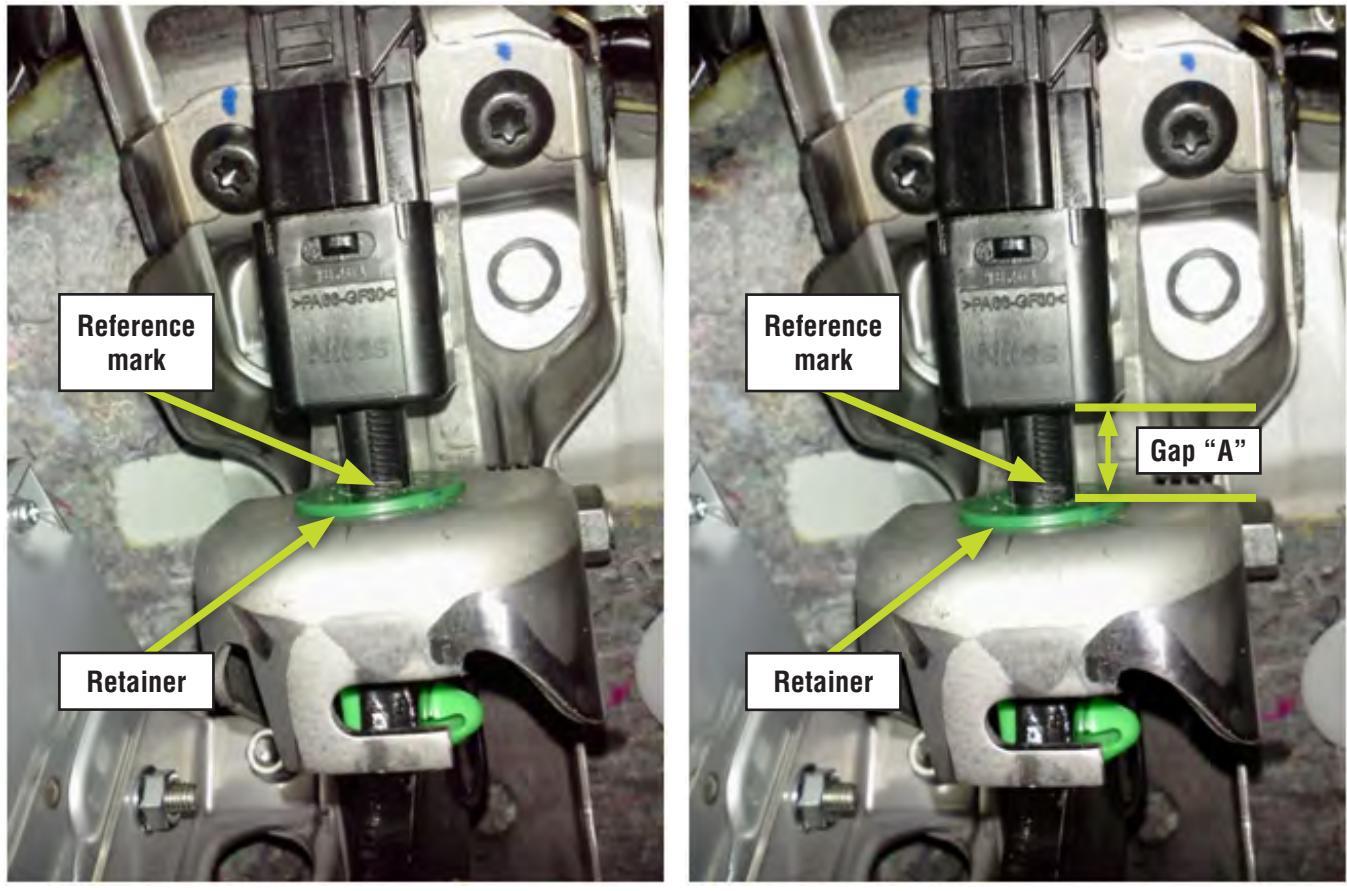
"BEFORE" AND "AFTER" REFERENCE PHOTOS

Before adjustment

After adjustment, "Gap A" increased by 1mm

- Once you have increased "Gap A" 1mm as shown in the reference photos on page 3, repeat the pressure measurement.
- If the brake pressure is still out of the specified range and C1249 resets, continue diagnosis following the procedures found in the applicable Service Manual.
