Service Bulletin

ubject:		Bulletin No:	01-016/12	
	UNUSUAL NOISE FROM EXHAUST FIPE SEAL RING	Last Issued:	10/19/2012	
_				-

2009-2012 Mazda6 2.5L with automatic transmission

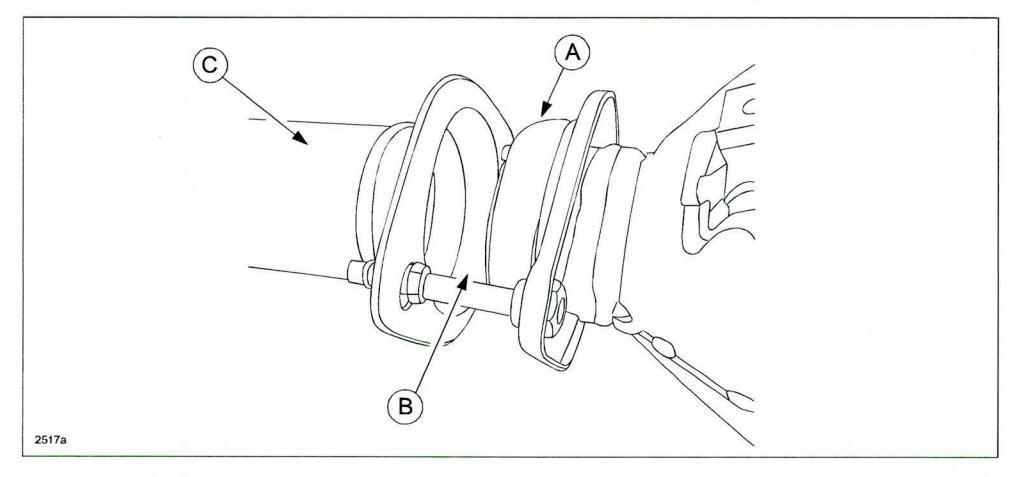
Some vehicles may exhibit an unusual squeak noise when the engine is idling, or just at the moment when the engine is shut off. The noise may be audible from inside the vehicle if one or more windows are open, or if any passenger is opening a door to exit the vehicle.

Due to engine vibration and a lack of seal ring lubrication, the mesh in the seal ring (A) rides in the flared portion (B) of the catalytic converter (C) resulting in a slight noise from the exhaust system while the engine is running. The friction between the exhaust system parts and the resulting slight noise are normal. This friction does not cause breakage, gas leakage, or other functional problems with the vehicle's exhaust system.

During normal vehicle aging, the noise level may change as the surface of the metal flange deteriorates. Usually this noise cannot be heard when the engine is running, however the noise may be heard in a quiet environment when the customer is outside the vehicle or when a door or window is open.

Customers having this concern should have their vehicle repaired using the following repair procedure.

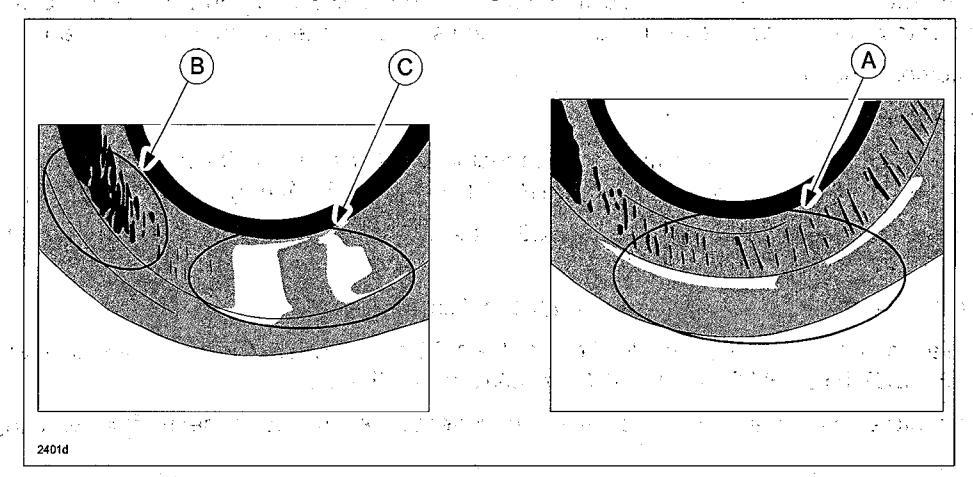
12. If severe damage appears on round surface of catalytic converter-side flared flange (A), replace catalytic converter.

NOTE: If the catalytic converter is replaced and a black coating (B) remains on the round surface of the flared flange, the white coating of the seal ring will stick to the black coating, which may cause noise. Be sure to sufficiently polish the flange (C).

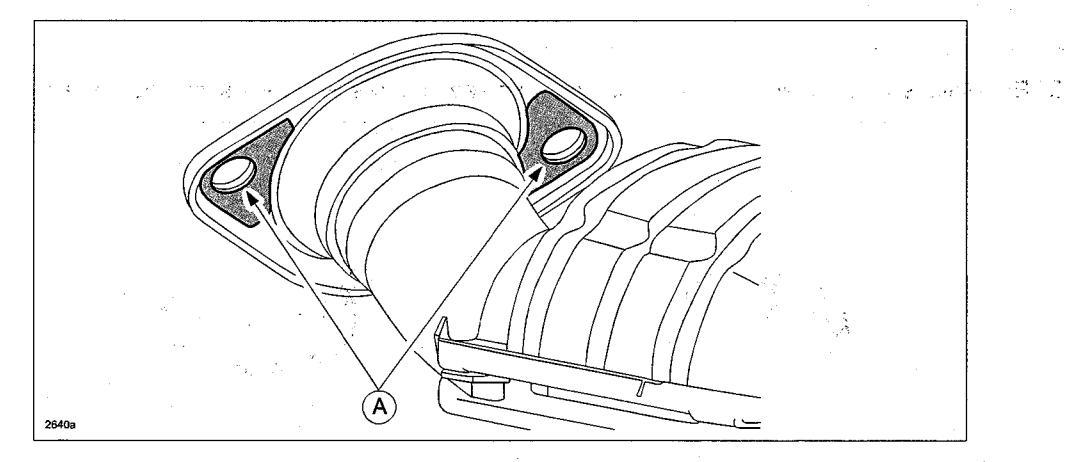
- In case where catalytic converter is NOT replaced:
 - a. Install a new exhaust stud.
 - b. Confirm if patch (A) exists behind the catalytic converter flange.

If YES (patch exists) - Install washer listed in the Part(s) Information to reduce spring tension. NEVER use an originally equipped washer.

- If NO (patch does not exist) Washer installation is NOT necessary.
- In case where catalytic converter is replaced:

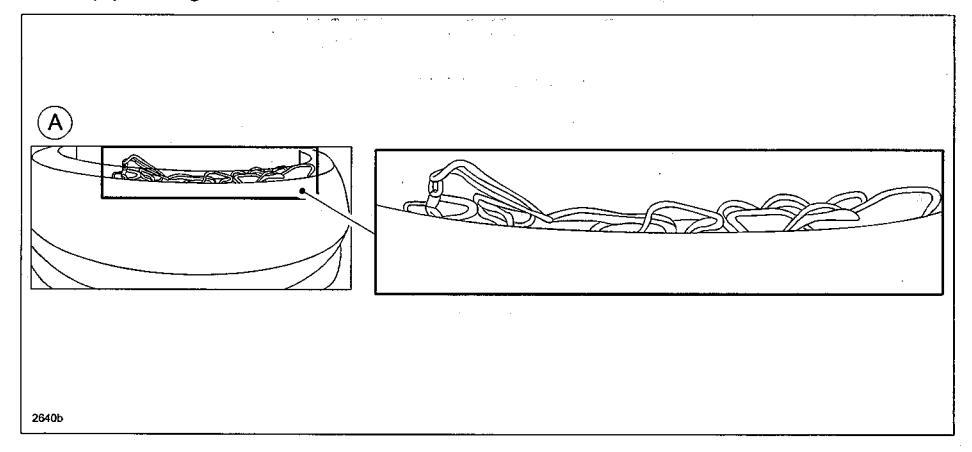
19. If the seal ring is NOT installed straight, mesh wire (A) will come out from the seal ring which will then contact the exhaust pipe flange.
