The Professional Publication for Kia Dealership Technicians & Service Staff

Forte Lock Confirmation Inoperative on Remote Start Equipped Vehicles

10 • TECH TIMES - Volume 15, Issue 5 - 2012

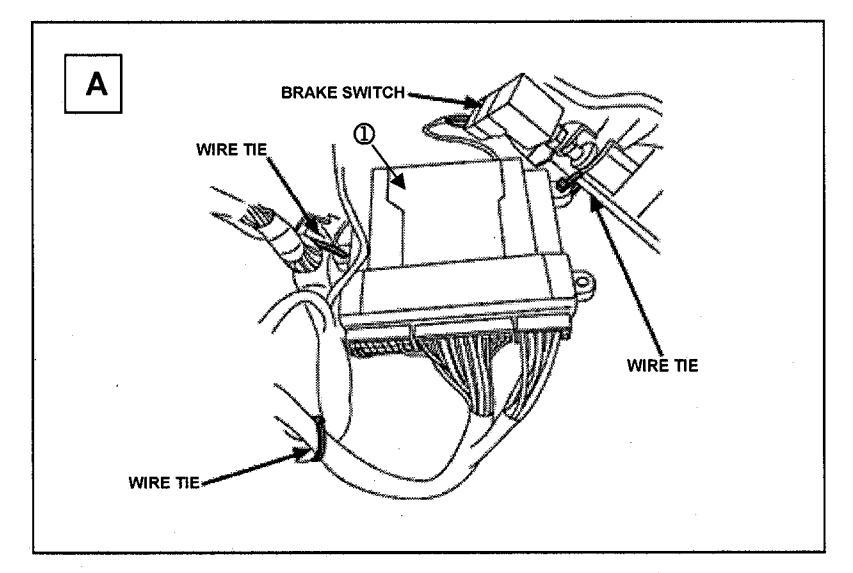
Some remote start equipped Forte's may not indicate that the doors have been locked. The customer may state that the vehicle will not flash the hazard lights or sound the horn when locking the doors with the transmitter. As designed, the vehicle should flash the hazard lights and sound the horn after pressing the lock button two (2) times within five (5) seconds.

- 1. Remove and isolate the negative battery terminal from the battery. NOTE: Record customer's radio presets before disconnecting the negative terminal from the battery.
- 2. Locate remote start control module ① under the driver's side dash near brake switch as shown in Figure A.

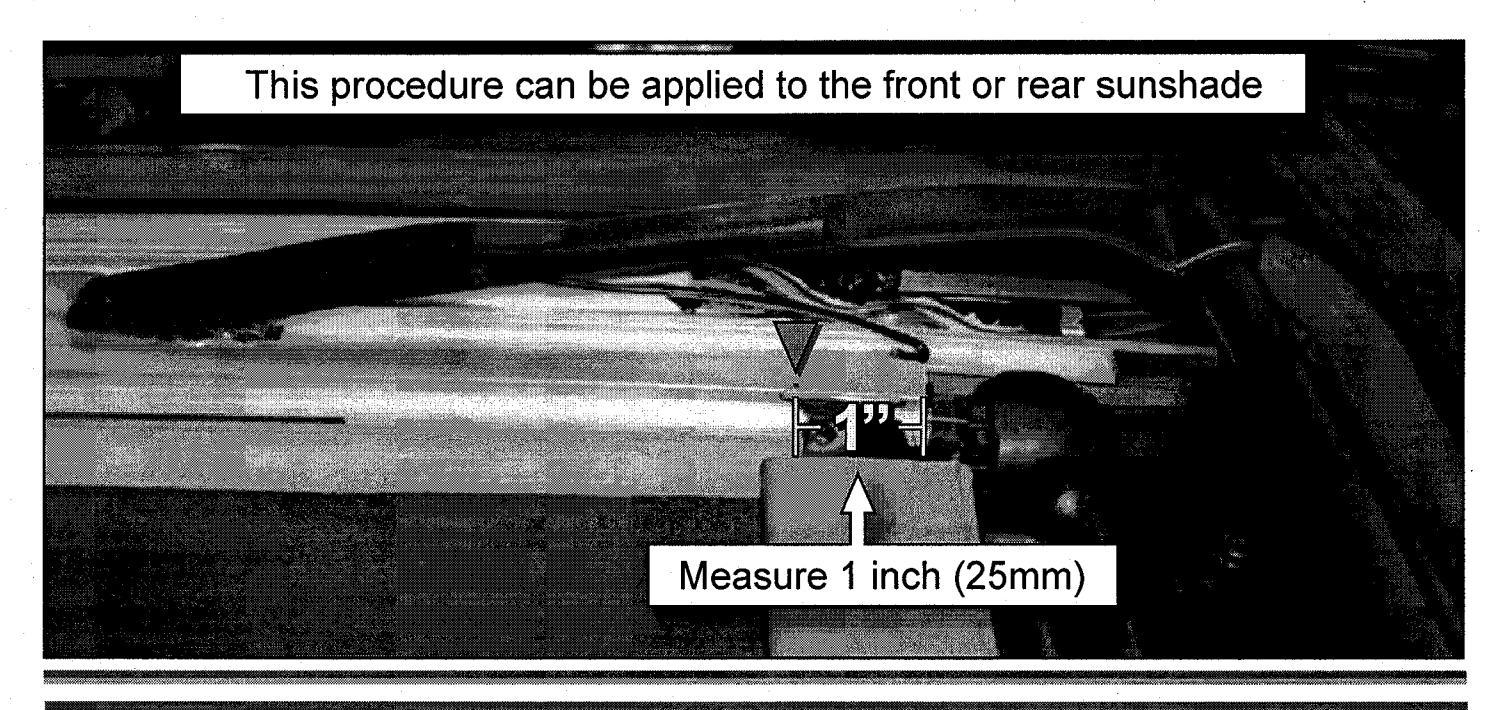
The current design intent for the sunshade has two positions, OPEN or CLOSED; if the sunshade is positioned in any other position, unintended movement remains possible during driving, especially over rough roads because there are no detent positions to hold it in place.

- 1. Open the front sunroof sliding glass.
- Measure from the front edge of track 1" (25mm) and place mark.

- Using a pair of pliers or a punch make a 0.020" (.5mm) depression in upper track where the measured mark was made to create resistance when closing the sunshade.
- 4. Repeat the same step on the opposite side, to adjust the rear sunshade detent, pull the headliner down slightly to disconnect the fasteners and make the same adjustment as described to the front track. When complete, snap headliner back into place, make sure your hands are clean when putting headliner back in place. Clean hand-prints as required.
- 5. If the adjustment you made is too tight, open the detent you created with a screwdriver and re-adjust the detent as required.

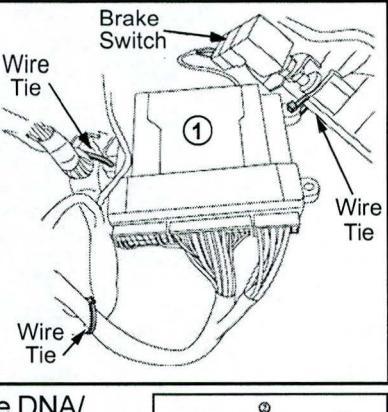
Some remote start equipped Forte's may not indicate that the doors have been locked. The customer may state that the vehicle will not flash the hazard lights or sound the horn when locking the doors with the transmitter. As designed, the vehicle should flash the hazard lights and sound the horn after pressing the lock button two times within five seconds.

Locate the Remote start control module (1) on the driver's side dash near brake switch as shown.

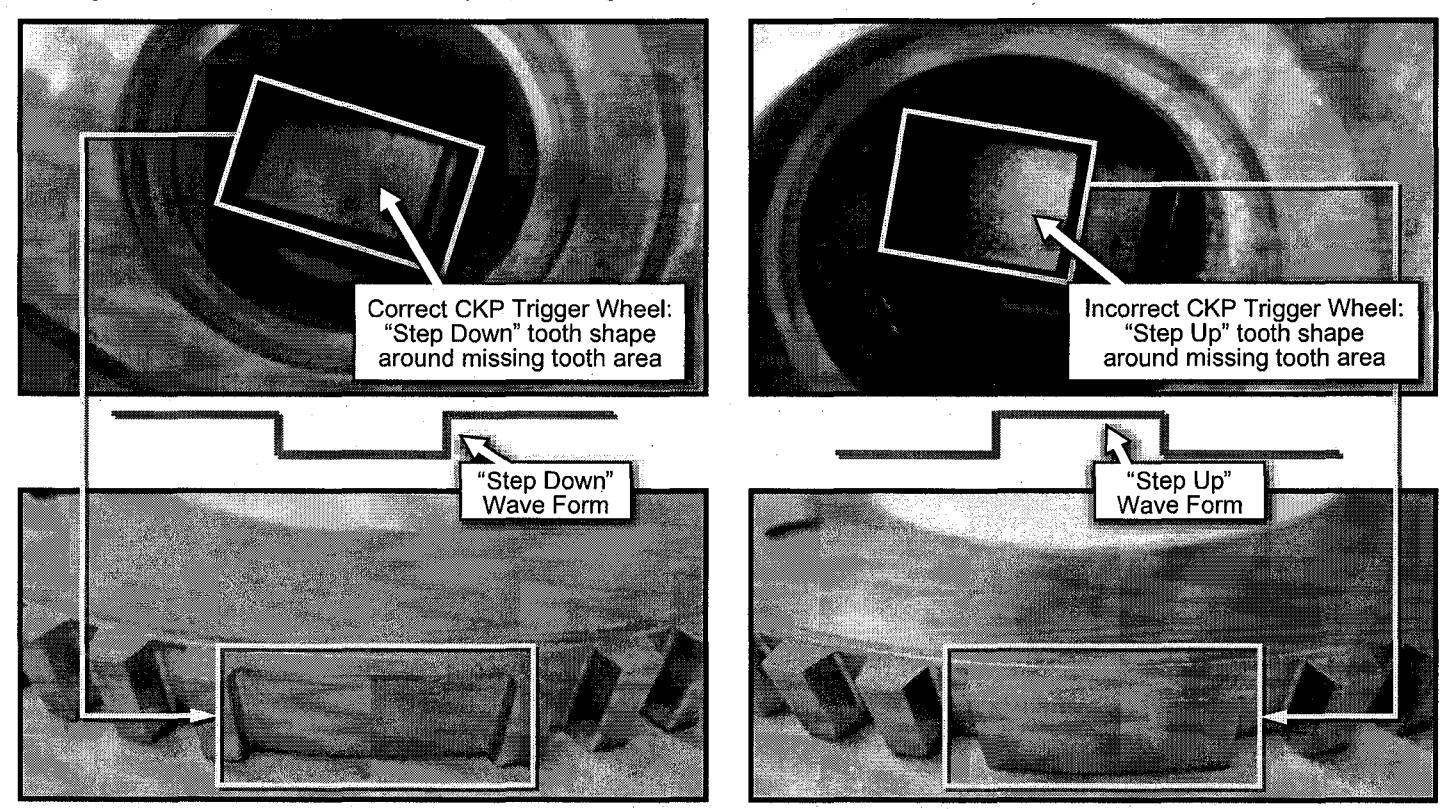
The purpose of this article is to assist in determining whether or not the CKP trigger wheel in 2.4L Theta I & II remanufactured engines is the correct trigger wheel prior to installing a new one on a vehicle. A very small number of remanufactured 2.4L Theta I&II engines may have had incorrect CKP trigger wheels installed, which may cause a hard start or hesitation concern.

To address this concern, remove the CKP sensor to gain access to the CKP trigger wheel. The image of the CKP trigger wheel on the left below illustrators a correct "step down" design, while the image on the right shows an incorrect "step up" design.

If a remanufactured engine has already been installed into a vehicle without prior inspection of the correct CKP trigger wheel verification, and a hesitation and/or hard start concern is experienced, use the following inspection and diagnostic procedure to identify the cause, since gaining access to CKP trigger wheel is difficult without removing the ladder support frame of the short block assembly.

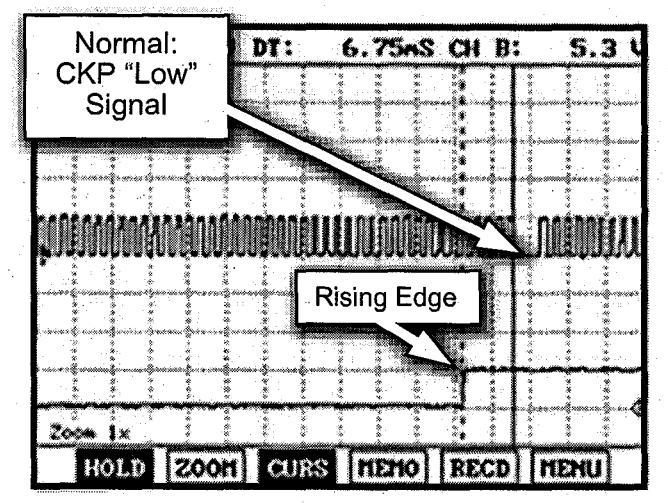
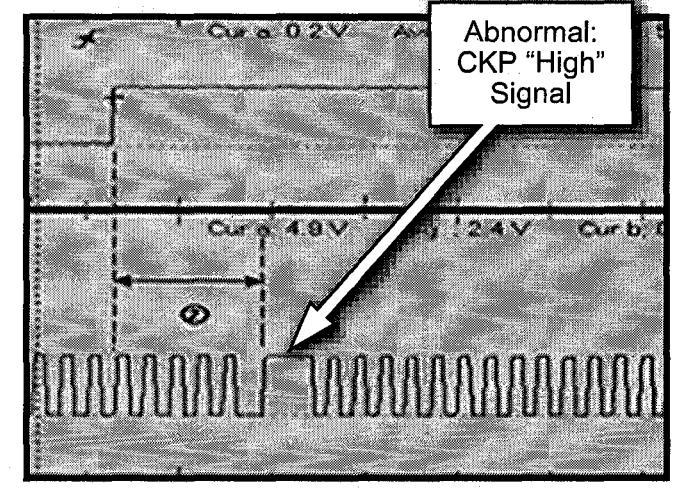
- 1. Connect the VMI and monitor CMP and CKP sensors, especially the CKP, to see if the scope pattern for "missing tooth" area is a "low" or "high" signal.
- 2. If you see a pattern similar to the image on the right, with "high' signal, please order either one of the part numbers below, and install it to correct this concern.

The part number for remanufactured 2.4L Theta I&II short block is **212Y2-25H00BR** or **212Y2-25H00CR**.
