SUBJECT: CVT Secondary Pressure Sensor Diagnostics

REVISED: 12/12/12

CLAIMS PERSONNEL	Initial in the boxes provided, right.		UALITY DRIVEN	[®] SERVICE
	SERVI	CE BULLETIN		
APPLICABILITY:	2010-2012MY Legacy with CVT	and Outback Models	NUMBER: DATE:	<mark>16-85-12R</mark> 11/26/12

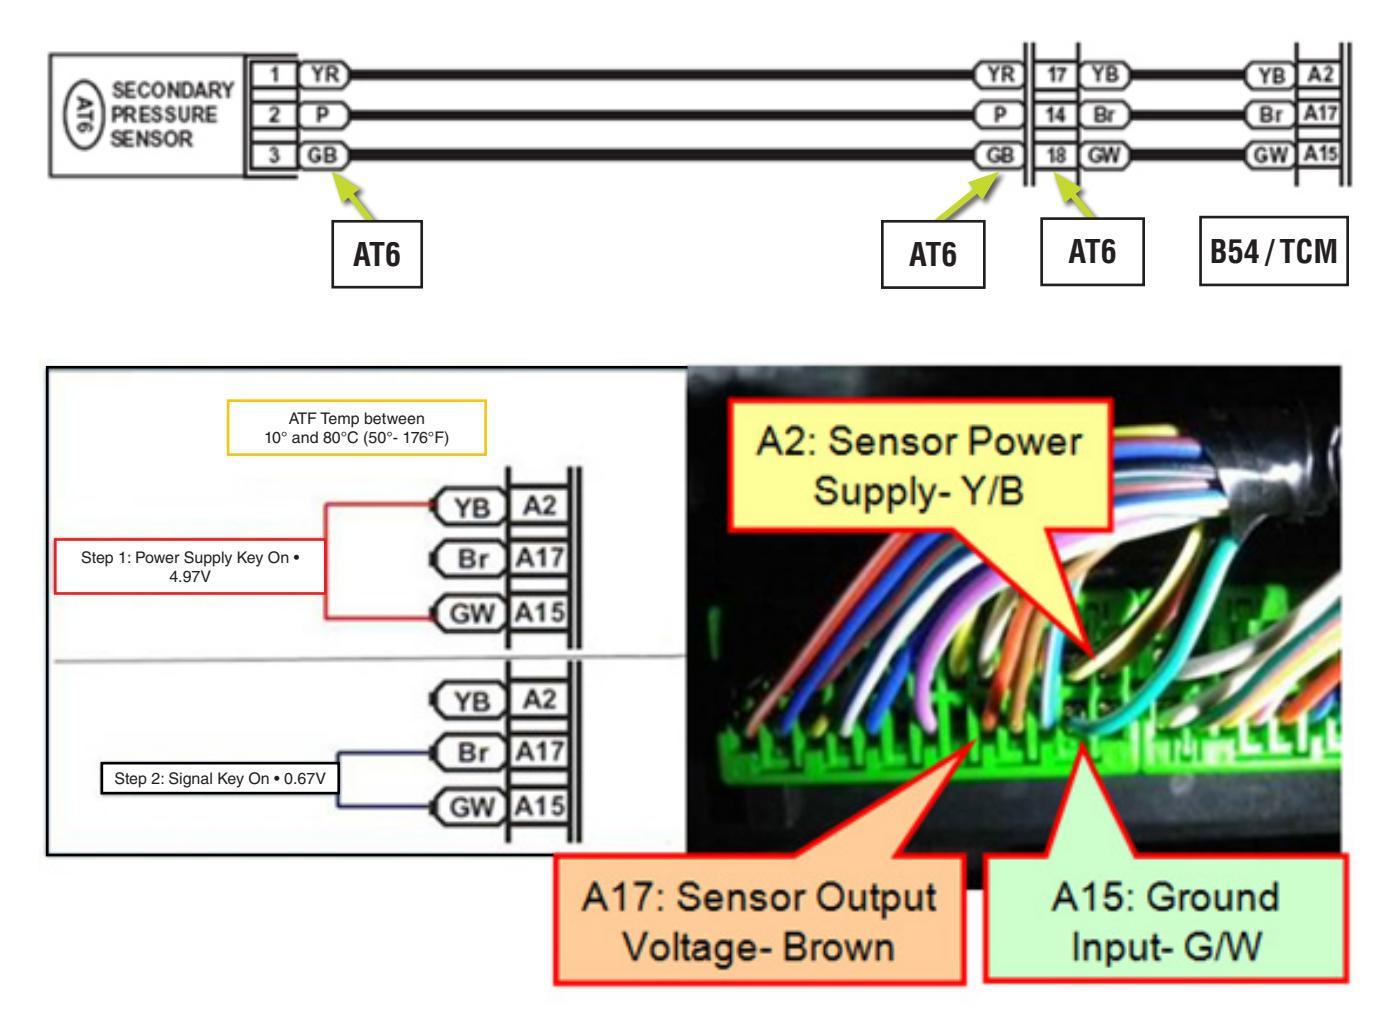
and #15 (ground). Specified value is 4.8v to 5.2v. If the voltages are outside of the specified range, the TCM is damaged along with the pulley surfaces of the CVT due to chain slippage. Replace both the TCM and the CVT assembly. **IMPORTANT:** Although both the TCM and CVT assembly may need to be replaced, the testing

1. With the ignition switch on and engine off, check the voltage between pin #2 (power supply)

voltage checks. Perform the following voltage checks on the TCM connector, B54:

- 2. With the ignition switch on and engine off, check the voltage between pin #17 (pressure sensor output voltage) and #15 (ground). Specified value is 0.45v to 0.55v. If the voltages are outside of the specified range, the secondary pressure sensor is damaged along with the pulley surfaces of the CVT due to chain slippage. Replace the CVT assembly.
- 3. **IMPORTANT:** Before ordering a new TCM and / or CVT, perform these same voltage checks at the secondary pressure sensor connector (AT6) and (if necessary), the main transmission harness connectors (T4 and B11). Ruling out wiring issues will prevent repeat or unnecessary component replacements.
