TECHNET TIMES

VOL. 23, ISSUE 05

page06
Fix-It-Right:
Automatic
Transaxle (6-Speed)
Oil Temperature
Sensor

AUTOMATIC TRANSAXLE (6-SPEED) OIL TEMPERATURE SENSOR DTC P0711, P0712 & P0713

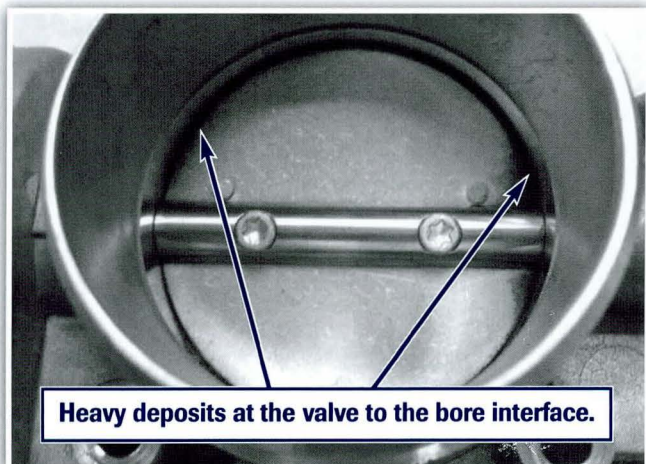
This throttle body cleaning procedure should be performed when diagnosing the conditions listed below. Do not replace the ETC throttle body assembly prior to performing this procedure. If a vehicle exhibits any of the listed condition and deposits are found at the valve-to-bore interface inside the ETC throttle body, clean the throttle body using the procedure described in this article.

Any of the following conditions may be caused by throttle body deposits:

- No start (due to throttle valve stuck closed or air flow significantly restricted)
- Rough idle or fluctuating engine speed at idle (due to air flow restricted)
- MIL "On" with DTC P2118 or P2119 occurring along with P2110:
- P2118: Throttle Actuator Control Motor Current Range/Performance
- P2119: Throttle Actuator Control Throttle Motor Current Range/Performance
- P2110: Throttle Actuator Control System-Forced Limited Power

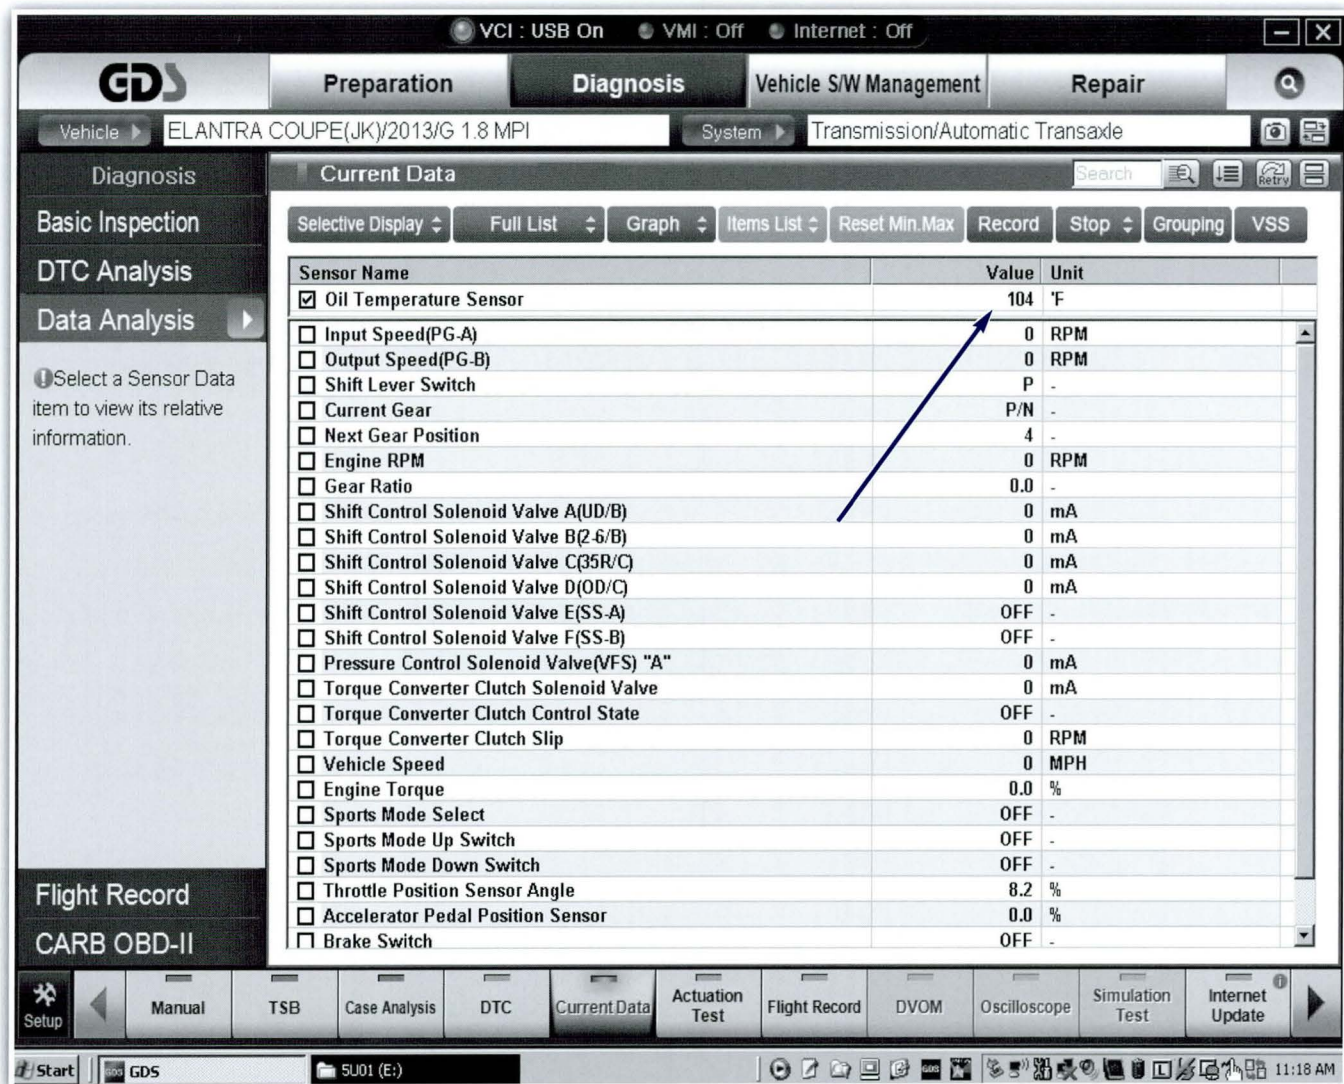
1. Using a GDS, check for DTC in the “Automatic Transaxle” menu. Record the DTC and description. Delete the DTC.
2. From the GDS, select the following parameters.
Drive the vehicle and monitor the sensors.
 - Vehicle and A/T menu.
 - “Current Data”
 - Oil temperature sensor.
3. If the sensors show:
 - Continuous and changing output while driving, the wiring currently has no open/short circuits. Go to Step 6.
 - No output or unchanging output, go to Step 4.
4. Visually check the wiring harness between the PCM and transmission for a damaged wire or short circuit to ground. Check for a damaged pin or pin not fully inserted into the connector.
 - If damage exists, repair or replace the ECM control harness and drive the vehicle to confirm the repair.
 - If not, go to Step 5.
