Service Bulletin

Subject: SES Lamp P0300 P0351 - P0358

Models: 2014 Chevrolet Silverado 1500 2014 GMC Sierra 1500 Built with RPOs 4.3L 5.3L L83 LV3

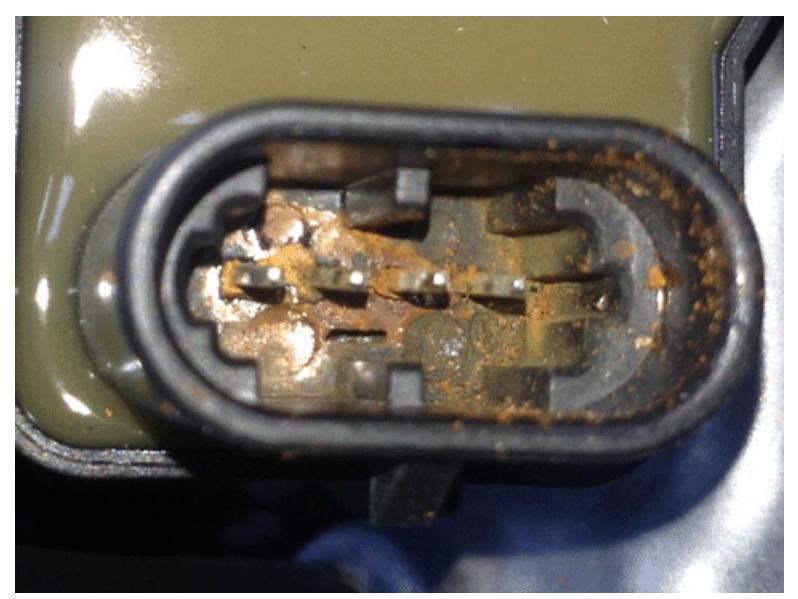
If the vehicle has a misfire with any of the following codes:

P0351-P0358, P2300, P2301, P2303, P2304, P2306, P2307, P2309, P2310, P2312, P2313, P2315, P2316, P2318, P2319, P2321, or P2322

Inspect the coil connectors for a clear water and/or a discolored connector.

Picture of a coil with the concern:

If this is found inspect the pigtail for pin drag or loose terminals (repair as needed).

Swap the coil to a known good location.

If the concern follows the coil replace the coil or coils with the concern and add dielectric grease to the connection.
