Service Bulletin

Subject: Updated Left and Right I/P Fuse Block Labeling

Models: 2014 Chevrolet Silverado 1500

2014 GMC Sierra 1500

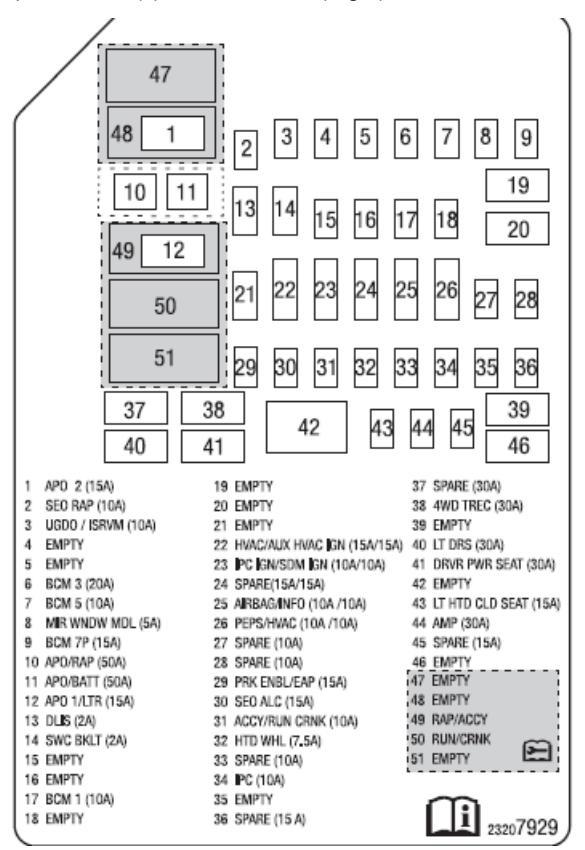
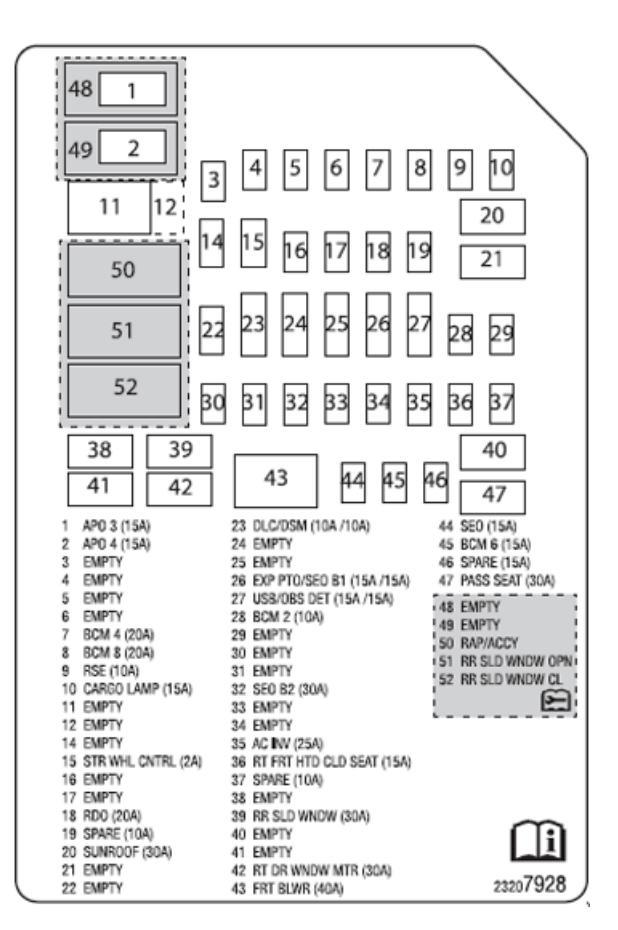
After inspecting the Left and/or Right I/P Fuse Block Labels, it may be noted the numbering is incorrect.

Inspect the lower right corner of each label for P/N 23114670 (Left) and/or P/N 23114671 (Right). If these part numbers are found, replace the label(s) with updated label(s): P/N 23207928 (Right) and P/N 23207929 (Left). See photos below of the updated labels:
