Service Action: Real Time Traffic Information Activation

F30

With option 609 (NAVIGATION SYSTEM PROFESSIONAL, CIC)

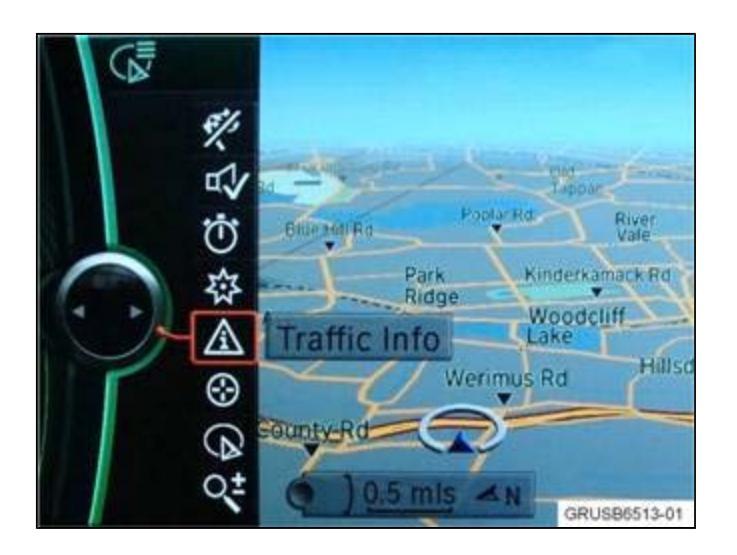
The Real Time Traffic Information (RTTI) is inoperative.

• The traffic information icon is missing from the menu in the navigation map screen.

Option 6UH (RTTI) is missing from the Vehicle Order (VO).

- 1. If the "Traffic Info" selection is available in the Navigation Map display on the left side, no further action is required. If the "Traffic Info" selection is missing, proceed to the next step.
- 2. Submit a PuMA case to Technical Service requesting a modified Vehicle Order with option code 6UH added. An IBAC code is no longer needed if ISTA/P 2.48.2 or later is used.
- 3. Once the Vehicle Order is obtained via PuMA, download it onto a USB device for import into ISTA/P 2.48.2 or later.
- 4. Import the VO into ISTA/P and select complete car coding.
