Service Bulletin

PRELIMINARY INFORMATION

Subject: Front Seat Cage Nut Spins - Unable To Remove Bolt

Models: 2010 - 2014 Chevrolet Camaro

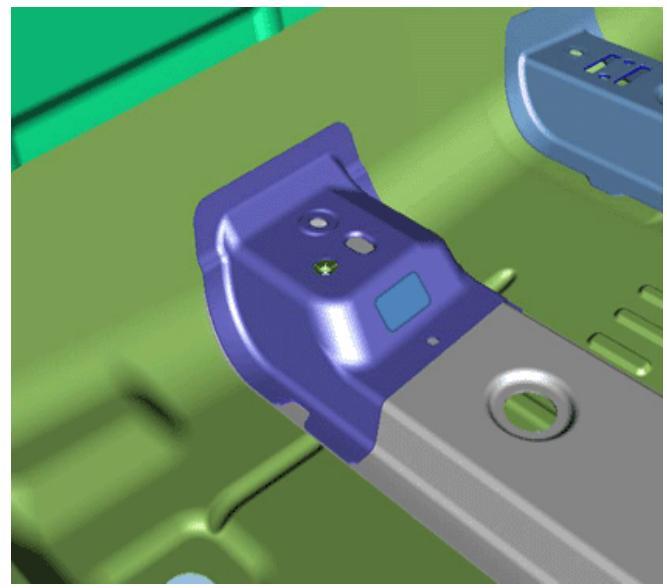
2696605

A technician may experience difficulty removing a seat and state the bolt is spinning but not coming out of the floor pan. This could be caused by a cage nut that broke loose from the weld in the floor pan during removal of the bolt.

- 1. To remove the seat you will need to cut or drill the head of the bolt off.
- 2. Remove the seat following published procedures and re-position the carpet as needed to allow the remainder of the steps to be completed.
- 3. Cut a square hole 45 mm (W) X 35 mm (H) in the Seat Anchor Bracket containing the loose cage nut, as illustrated below.

- 4. Remove the cage nut from the Seat Anchor Bracket and, using a vise and pliers, remove the remainder of the bolt from the nut. Clean the threads of the nut as necessary.
- 5. Drill two 5mm holes next to the bolt hole in the Seat Anchor Bracket. These holes should be 180 degrees opposite of each other. This will allow the nut to be tack welded back in place.
