Service Bulletin

File in Section: -Bulletin No.: PIP5161 Date: November, 2013

Subject: Oil Consumption Possible PCV Pull Over

Models: 2012-2013 Cadillac Escalade, Escalade ESV, Escalade EXT 2012-2013 Chevrolet Avalanche, Express, Silverado 1500, Suburban, Tahoe 2012-2013 GMC Savana, Sierra 1500, Sierra Denali, Yukon, Yukon XL, Yukon Denali,Yukon Denali XL Equipped With engines: L20, LC9, LH9, LMF, LMG, L96, LC8, LZ1, L94, L9H

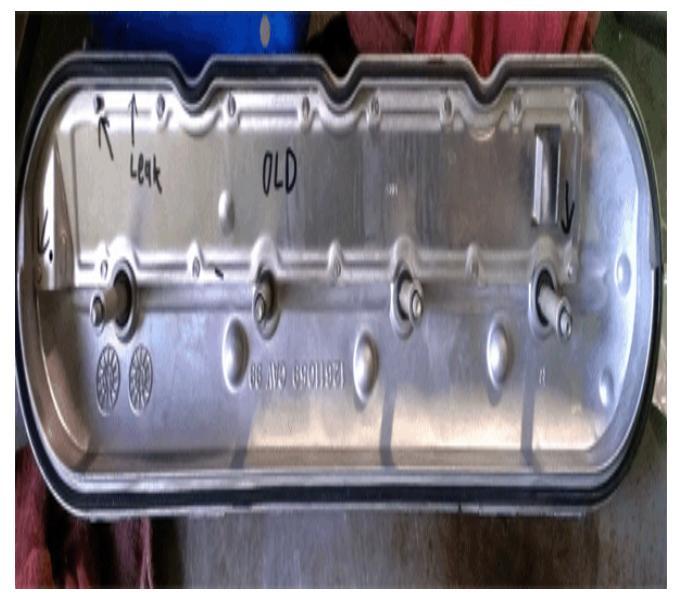
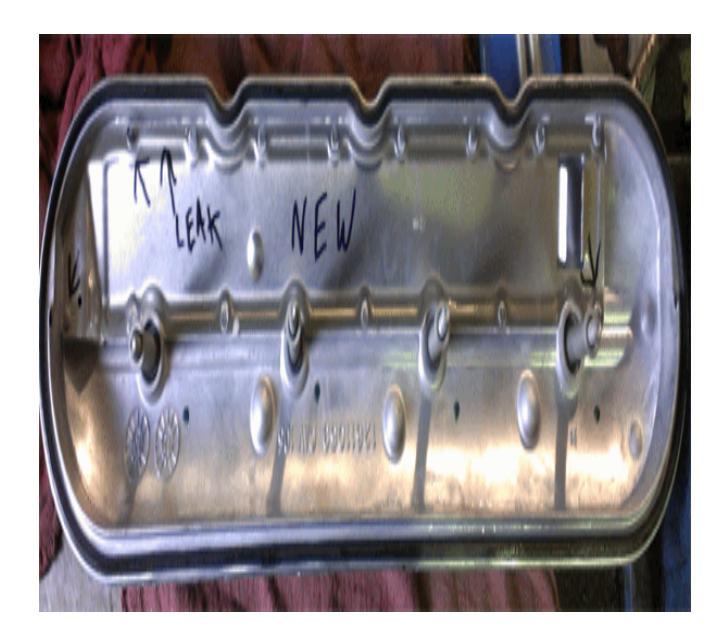
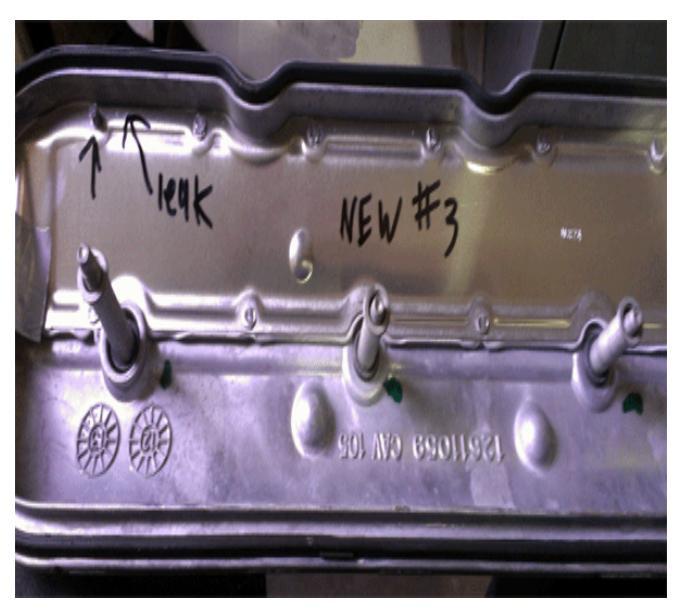
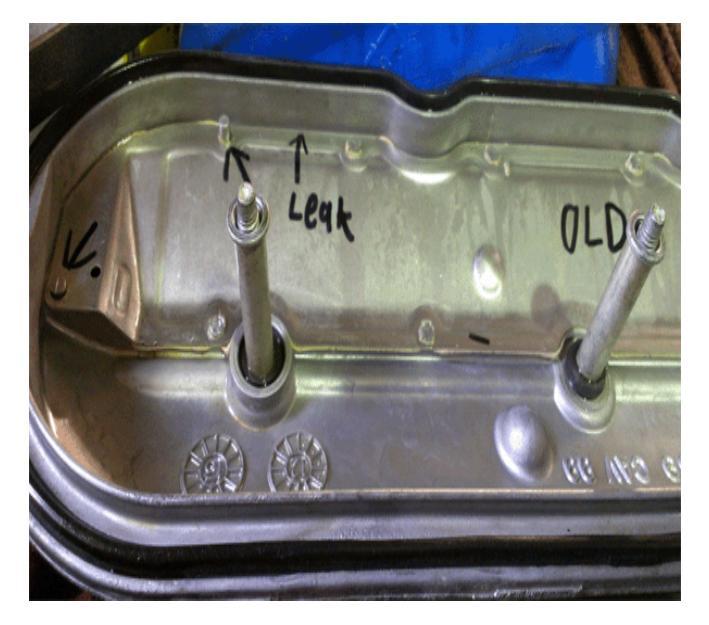
Check for possible PCV baffle leaks with the left valve cover removed, (see the attached pictures.)

Below you will find pictures showing areas of a possible PCV baffle leak.

The pins that are shown as not staked; that is normal.

Check for possible PCV baffle leaks by plugging both the baffles' small hole and square vent, then apply regulated air pressure through the PCV pipe and spray soapy water where the PCV baffle and valve cover meet with soapy water to inspect for possible signs of a leak.

If a leak is found, the valve cover should be replaced.

The new valve cover should also be tested before it is installed.
