## **Service Bulletin**

Subject: Water Leak Into Rear Floor

### Models: 2010 - 2014 Chevrolet Camaro

#### Both Coupe and Convertible Models

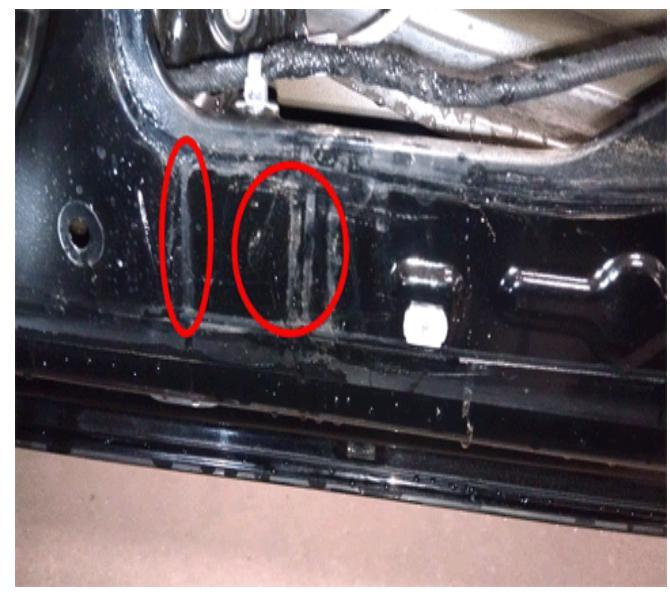
3605546

Water may pool into the rear floor pan on either the driver or passenger side. This condition could occur on either the Coupe or Convertible body style and should be inspected for prior to performing other repairs.

Water test the vehicle to duplicate the condition. Remove the door trim panel of the effected side of the vehicle to inspect for water pooling in or leaking from the door water deflector. If water is pooling between the door and water deflector or is leaking past the water deflector then carefully remove the water deflector. Reseal it to the door using a butyl rope such as 3M Strip-Calk\*, or equivalent, to eliminate the possibility for pooling or leaking.
