T-SB-0050-13

ECU Software Update: Charging System Improvement

YEAR(S)	MODEL(S)	ADDITIONAL INFORMATION	
2012	RAV4 EV

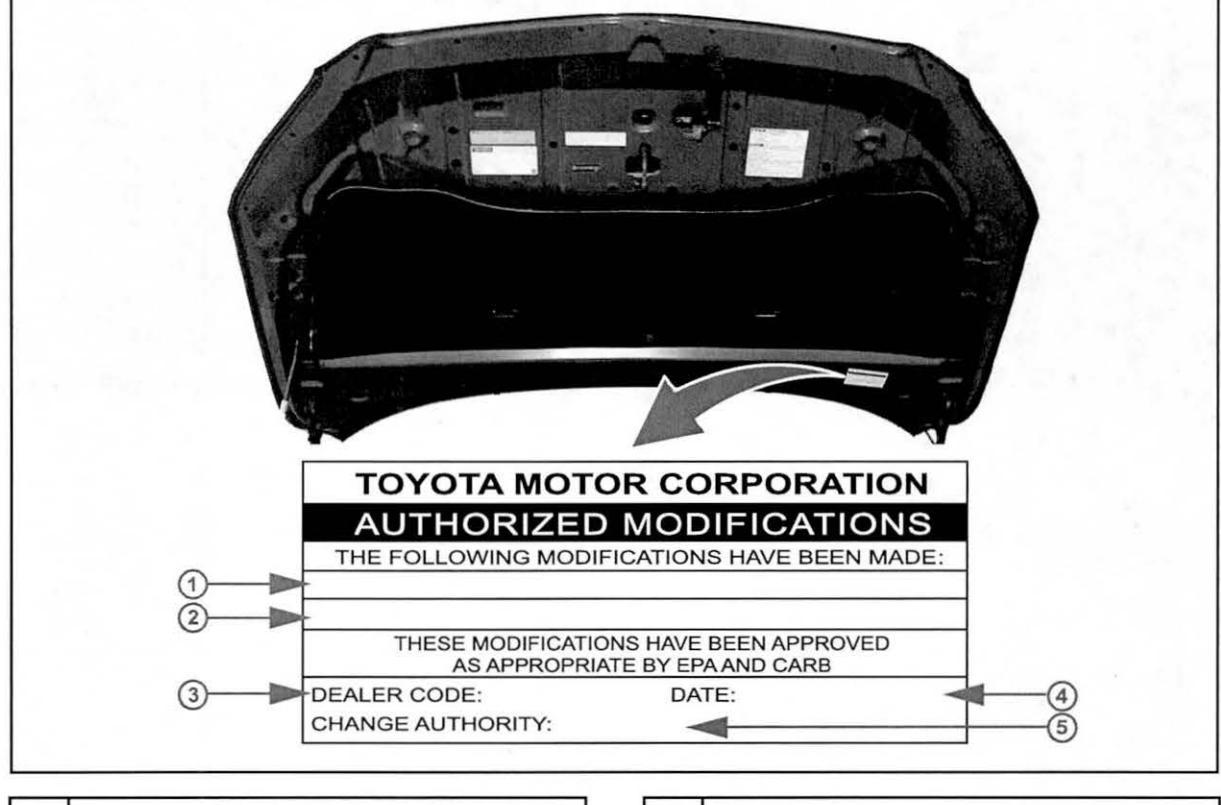
Figure 1. Location of Authorized Modifications Label on 2012 RAV4 EV

Check for the Authorized Modifications Label affixed to the vehicle in the location shown in Figure 1. Confirm if the ECU calibration has been updated. If the calibration ID listed is NOT the latest ECU calibration — go to step 2.

- 3. Install the Authorized Modifications Label.
 - A. Using a permanent marker, enter the following information on the label:
 - ECU part number [Refer to the Parts Information section for the CURRENT PART NUMBER]
 - Calibration ID(s) [Refer to the Calibration Information chart for the NEW CALIBRATION ID]
 - Dealer Code
 - Repair Date
 - Change Authority [This SB number]
 - B. Affix the Authorized Modifications Label to the vehicle at the location shown in Figure 1. The Authorized Modifications Label is available through the MDC, P/N 00451-00001-LBL.
- 4. Test drive the vehicle to confirm proper vehicle operation.
