## Service Bulletin

#### Subject: Ventilated Seat Fan Clicking or Ticking Noise When Operating

### Models: 2013 Cadillac XTS with RPO KU1, KU3 Condition/Concern

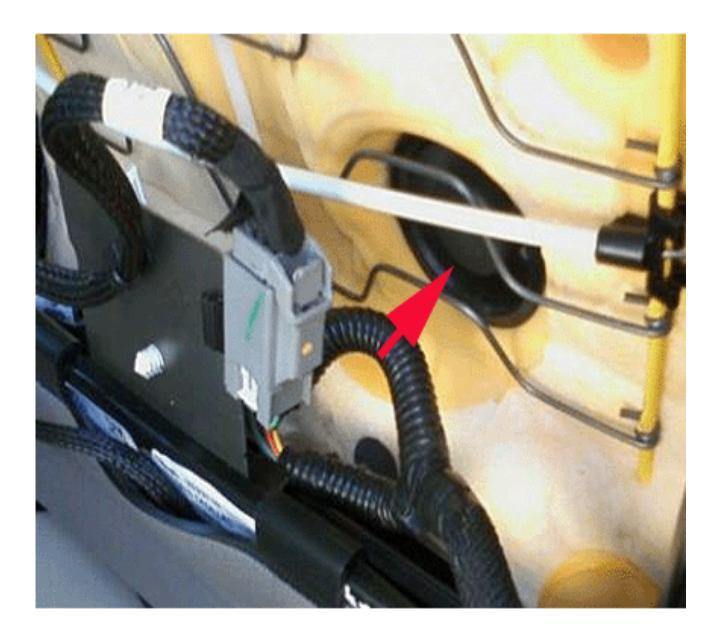
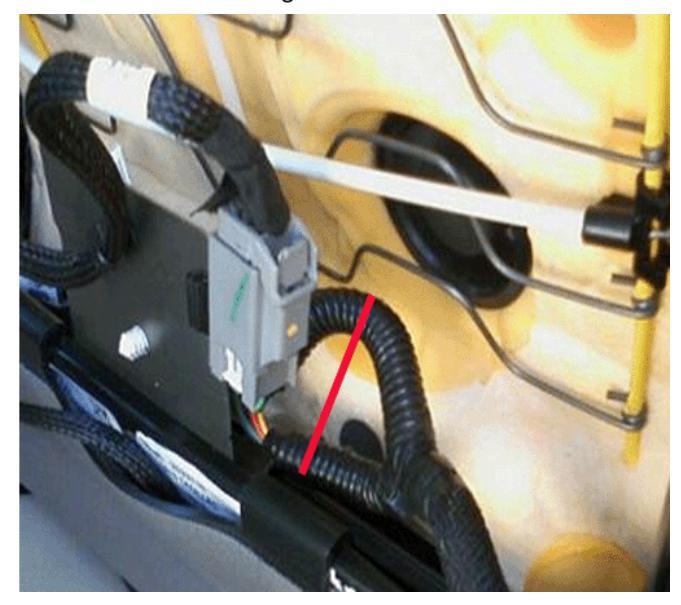
3304704

9. Inspect the under seat harness for excessive length and interference with the fan blade.

• If the harness is contacting the fan blade, secure the harness with a wire tie as shown.

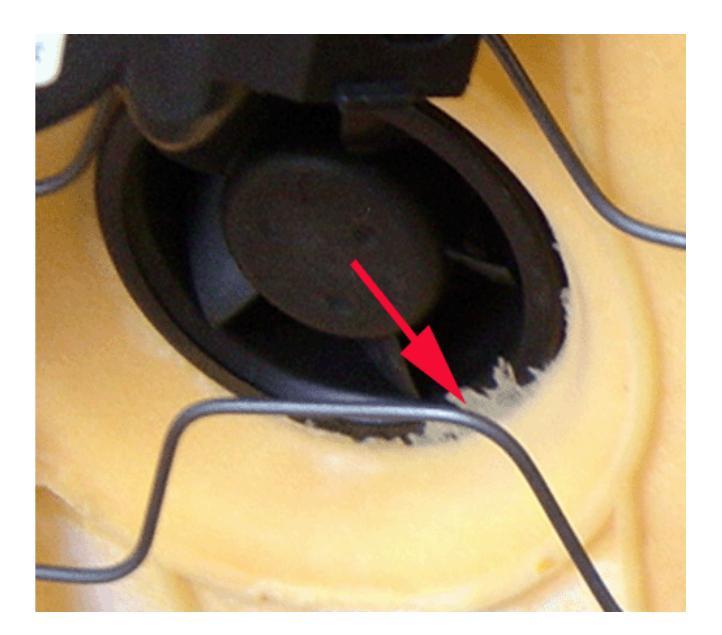
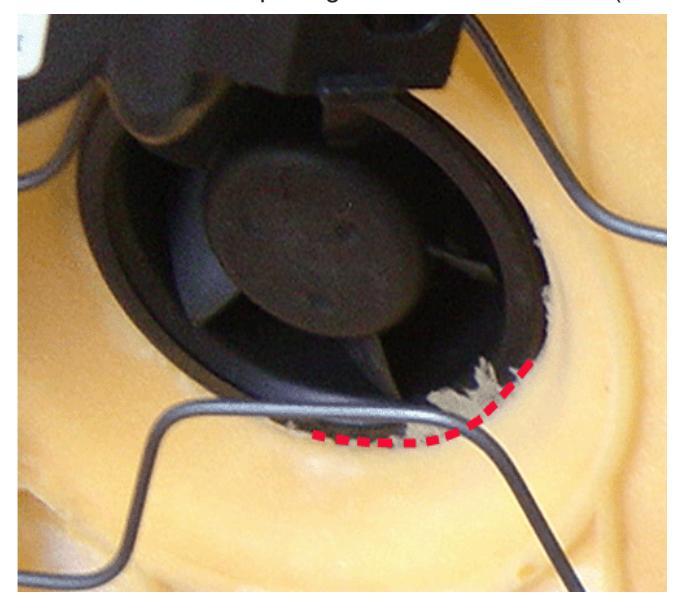
3305178

10. Inspect the foam seat cushion around the fan opening for excessive material (flashing).

• If flashing is present, use a appropriate tool to trim the foam as shown.

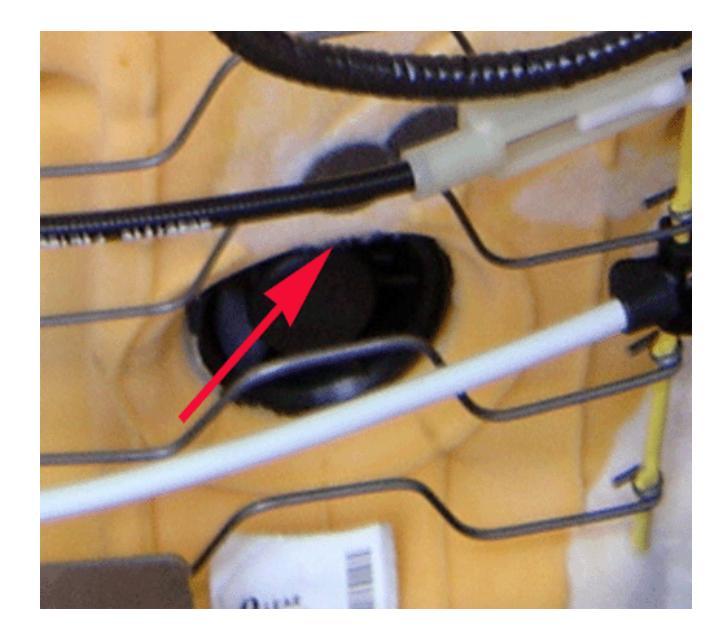
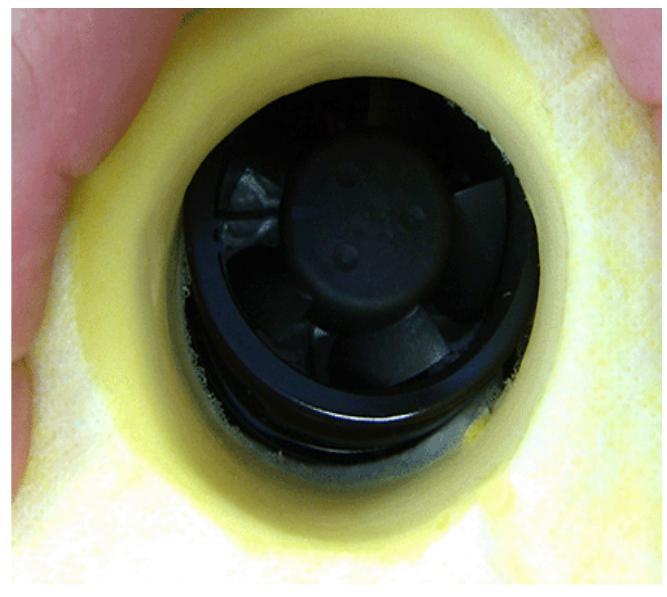
3305186

11. Inspect the felt attached to the foam seat cushion for excessive material that may contact the fan blades, trim as required.

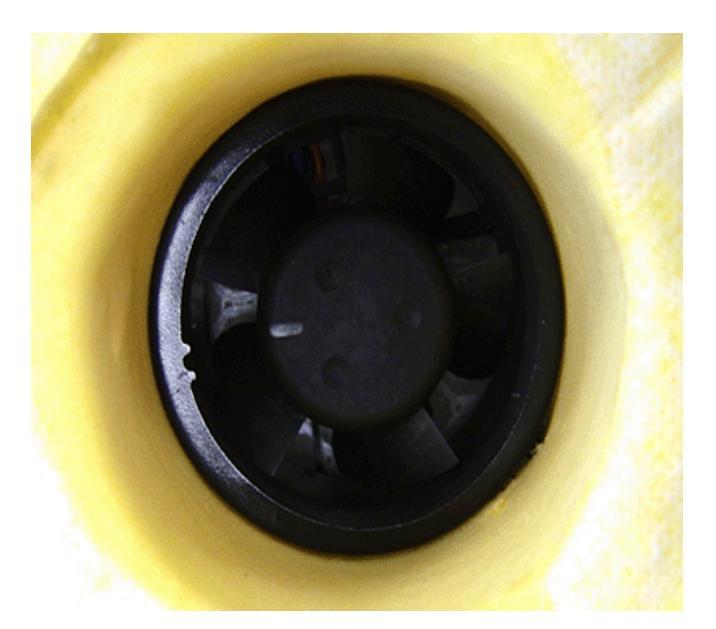
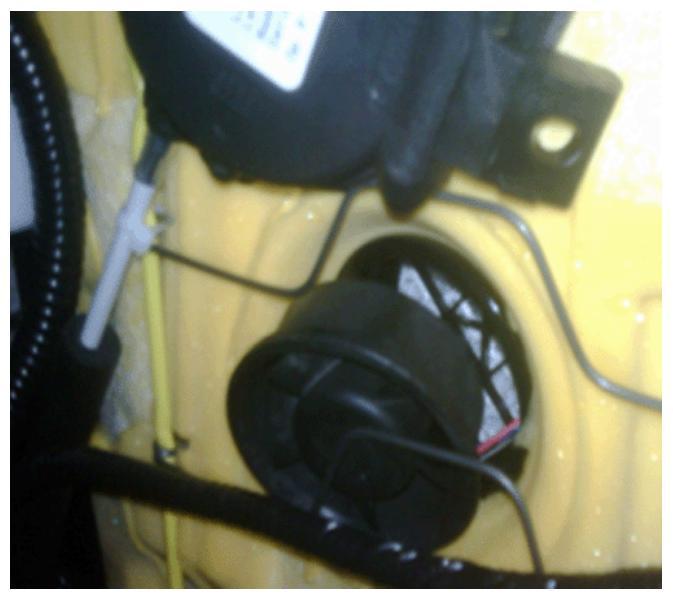
3305191

12. Inspect the fan assembly and ensure it is seated squarely in the housing.

Reposition the fan to achieve the proper seating as shown. DO NOT PULL EXCESSIVELY ON THE FAN – IT MAY BECOME UNSEATED.

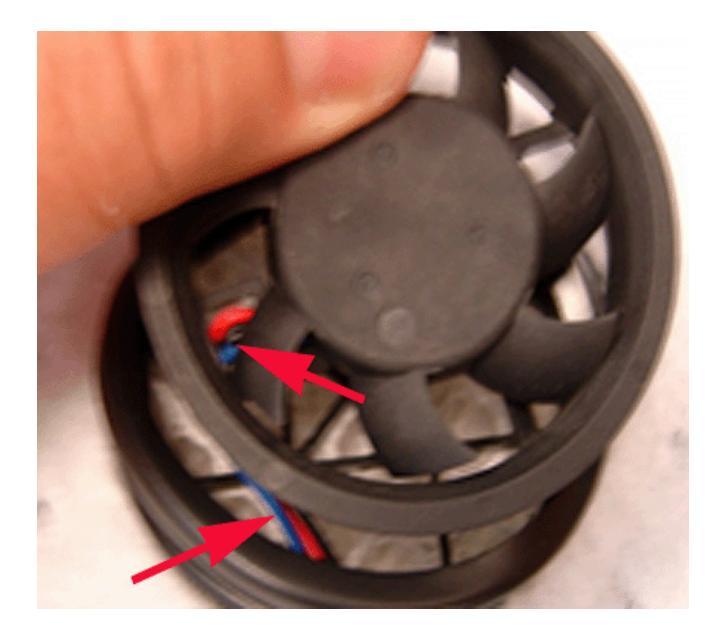
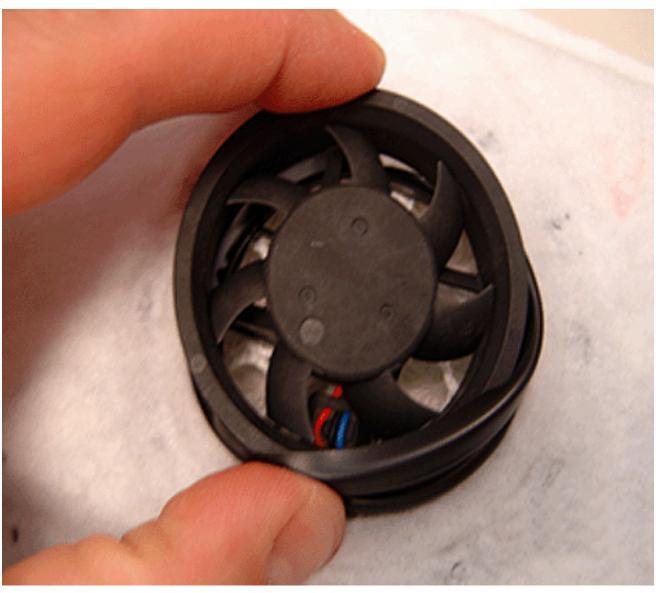
3305200

13. If the fan can not be reseated into the housing, the motor housing has dislodged from the vent mat assembly. Use the following steps to remove the seat vent mat assembly and reinstall the fan motor housing:
13.1. Remove the front seat vent fan mat. Refer to Front Seat Vent Fan Mat Replacement (with Heat) in SI.

13.2. While returning the fan housing to its sheathing, rotate the motor to a position that minimizes the slack in the wires. Tuck the wires along the outside of the housing, eliminating the potential for them to interfere with the fan blades.
