Audi TAC Technical Newsletter

November 2013

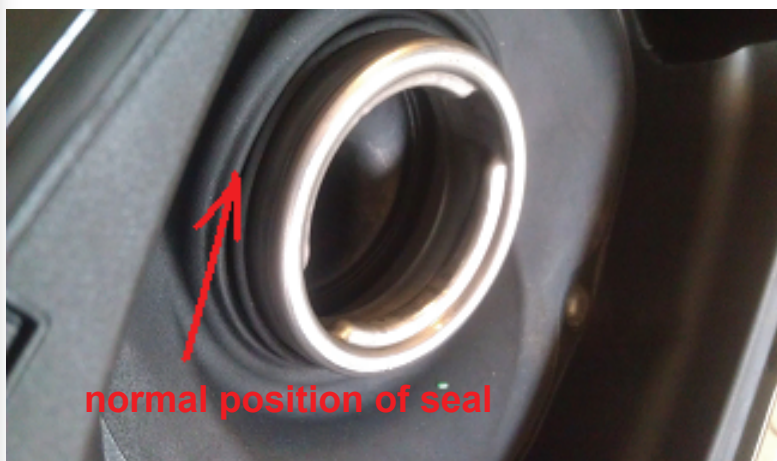
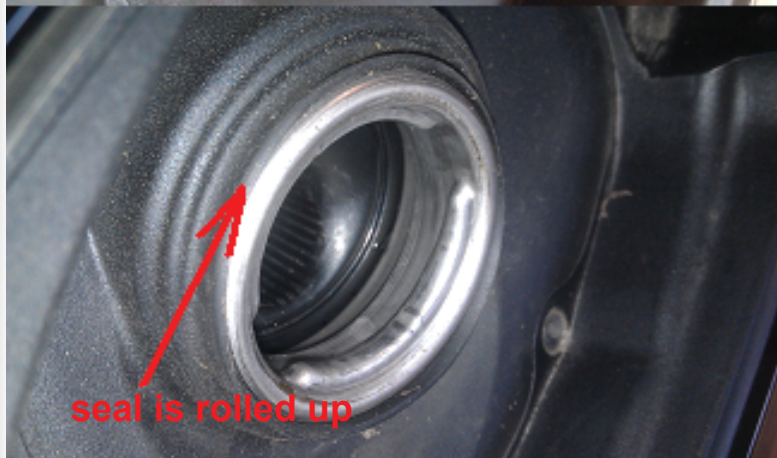
## EVAP fault P0456 P0455 P0442

Besides running the test plan, you may want to inspect the fuel filler neck seal. If the seal is rolled up around the gas cap sealing surface, a leak may occur because the cap cannot seal properly. See pictures below.
