SERVICE BULLETIN

APPLICABILITY: 2012-13MY Impreza and WRX STI

NUMBER: 15-164-13R DATE: 06/07/13 **REVISED:** 08/26/13

SUBJECT: Fujitsu Ten (F10) SD Card Audio/Navigation System **Operation Tips**

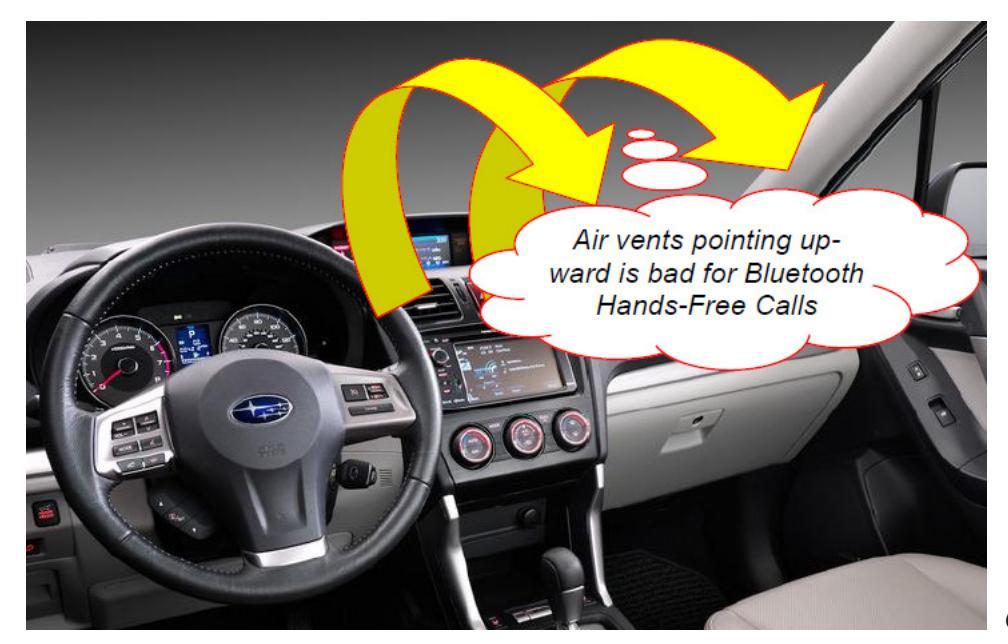
CONDITION: Static or Echo is heard when making a Bluetooth hands-Free call.

The HVAC blower speed is set on high and the dash vents are pointed upward toward the Bluetooth microphone which is picking up "wind noise".

- Position the HVAC vents to not blow air upward toward the Bluetooth microphone when • attempting to make a hands-free call.
- Lowering the blower speed setting can also reduce the static and/or echo.

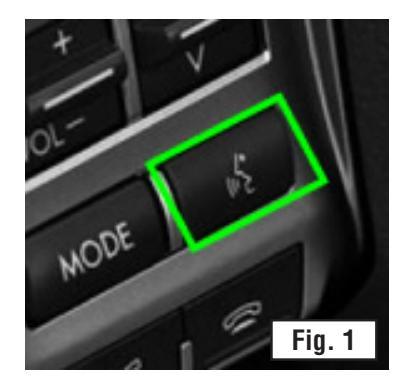
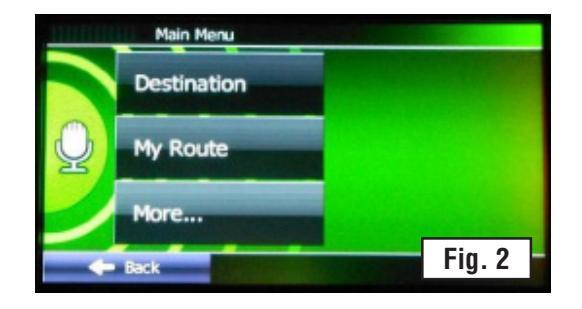
Handsfree		s Back
1.	₀§ Call <name></name>	
(m ²	√ Call <name><location></location></name>	
	S History	and the second se
	🖋 Dial <number></number>	
	💦 Redial	
Repeat		Fig. 0
Cancel		Fig. 3

CONDITION: Voice Recognition function does not recognize Navigation and/or Bluetooth hands-free commands.

For Navigation and Bluetooth hands-free voice commands, there is a hierarchy of commands which must be followed for proper operation.

- 1. First, press the "I Agree" button on the display screen or the voice recognition feature will not work properly
- 2. Press the Push to Talk button Fig. 1
- 3. After the Beep, say "Navigation"
- 4. A list of available navigation commands will appear on the screen. Fig.2

- 1. Press the Push to Talk button Fig. 1
- 2. After the beep, say "Hands free"
- 3. A list of Bluetooth Handsfree commands will appear on screen Fig.3

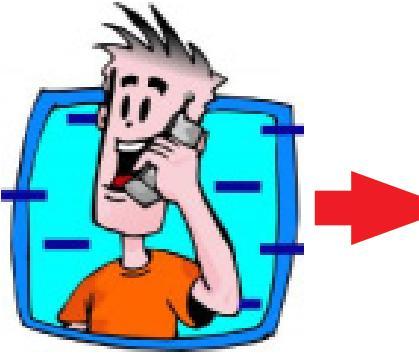
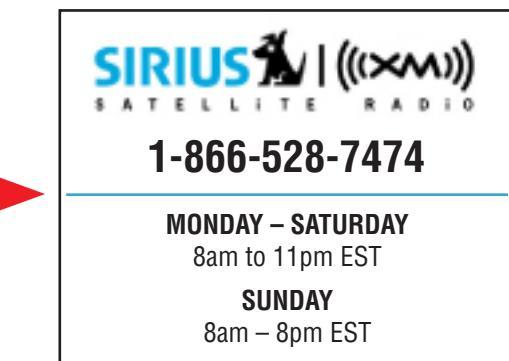
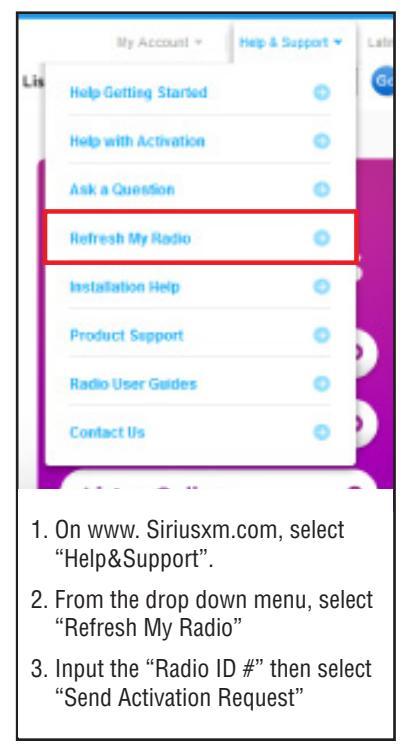
CONDITION: XM Traffic stopped working but XM Radio operates normally.

The user may have not paid for the Sirius XM traffic service after the Free Trial period expired.

- 1. Check with Sirius XM to verify the customer is subscribed to both Sirius XM Radio and Traffic.
- 2. After verifying an active subscription, with the vehicle outside, go to www.SiriusXm.com. Click on "Help and Support" then select "Refresh My Radio" to have another activation signal sent to the vehicle. Tune to channel 0 (zero) and the Radio ID number will display.
- 3. If the Traffic does not start working within about 15 minutes after sending the "Refresh" request, exchange the audio unit.

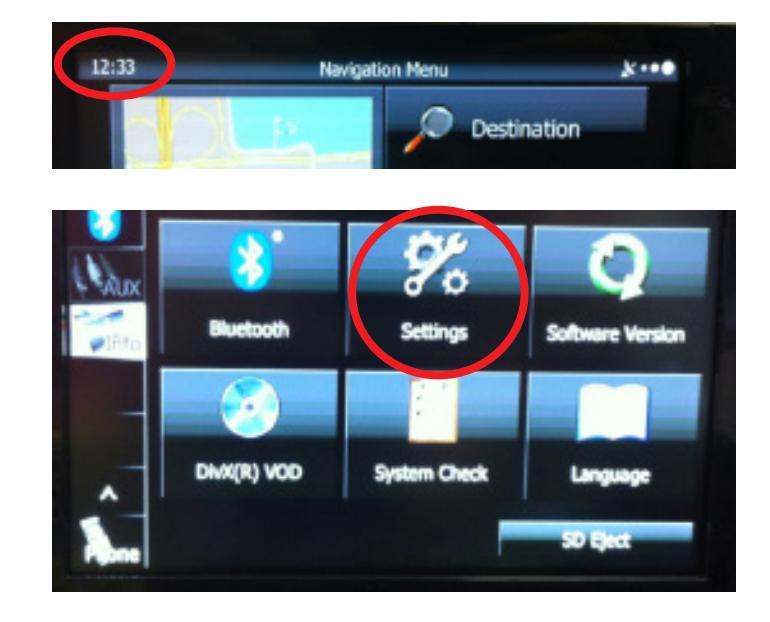
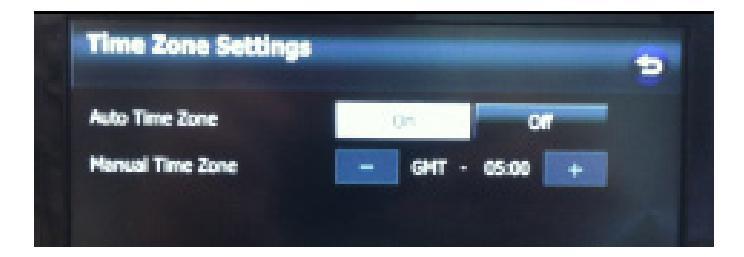
CONDITION: The clock shows the incorrect time.

The "Auto Time Zone" feature may be turned off.

If the clock's time is incorrect, check the Time Zone setting and make sure "Auto Time Zone" feature is set to "On".

- 1. Press the "Info" button
- 2. Press the "Settings" button
- 3. Press Time Zone "Set" button
- 4. Select Auto Time Zone "On"

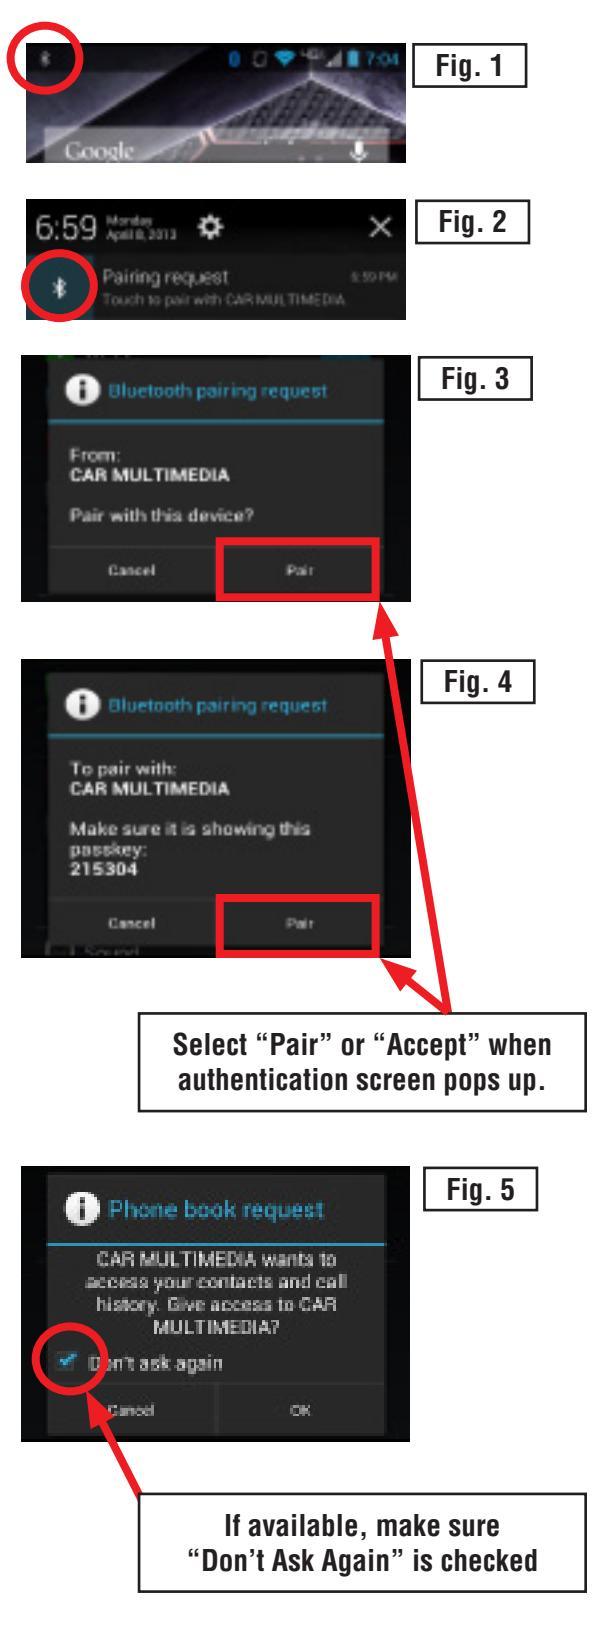
CONDITION: 1. Bluetooth will not auto connect to specific phone models.

2. Bluetooth Handsfree and Bluetooth Audio do not operate after connecting to the system.

Bluetooth connection between the navigation unit and the phone will not connect without accepting the pairing request on the phone or in the phone's notification area.

- 1. Check the notification area on the phone for a pairing request (Figs 1 & 2).
- Check the authentication screen for a pairing request, then select "Pair" (Figs. 3 & 4).
- If the option for "Don't ask again" is available, make sure this box is checked. (Fig. 5)
- 4. After this process, the Bluetooth will connect. The user may need to perform this process again for future connections.
