Service Bulletin Mazda North American Operations

ubject:	MIL ON WITH DTC P0139	Bulletin No:	01-025/13
		Last Issued:	08/22/2013

2010 Mazda5

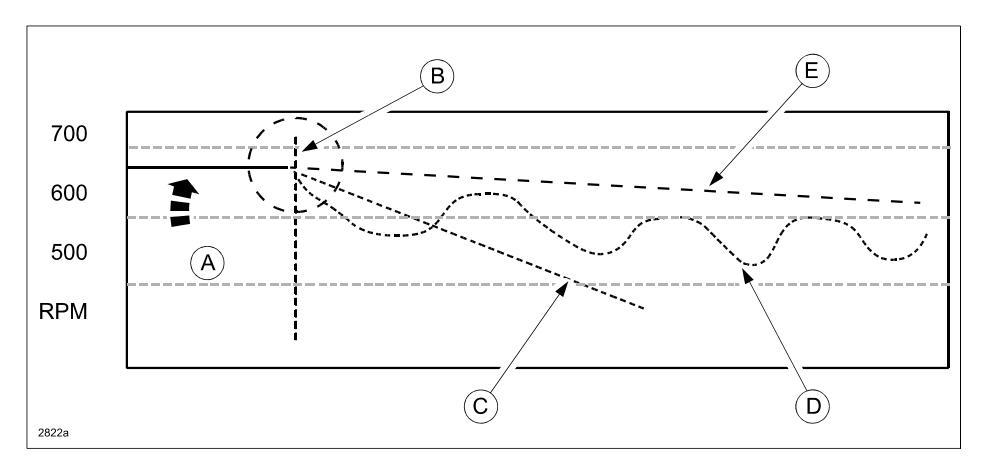
- The engine speed is stable within the specification -> The concern is not caused by carbon accumulation in the throttle body. Diagnosis for other concerns according to the Workshop Manual. Chart for making decision of carbon accumulation in the throttle body.

A	Engine at idle (warmed-up with no loads)
В	Start of test mode
С	Sample 1: No Good - RPM decreases
D	Sample 2: No Good - RPM is unstable
E	Sample 3: Good - RPM is within spec

- 6. Check the engine idle condition when the "test mode" is ON. Idle speed: 650-750 rpm
 - The engine speed drops for more than 100 rpm, or the engine speed is unstable and flunctuates between 500-700 rpm -> The concern is caused by carbon accumulation in the throttle body. Clean the throttle body according to the following procedure.
