VW Elsa Newsletter

Edition 84: May 5, 2014

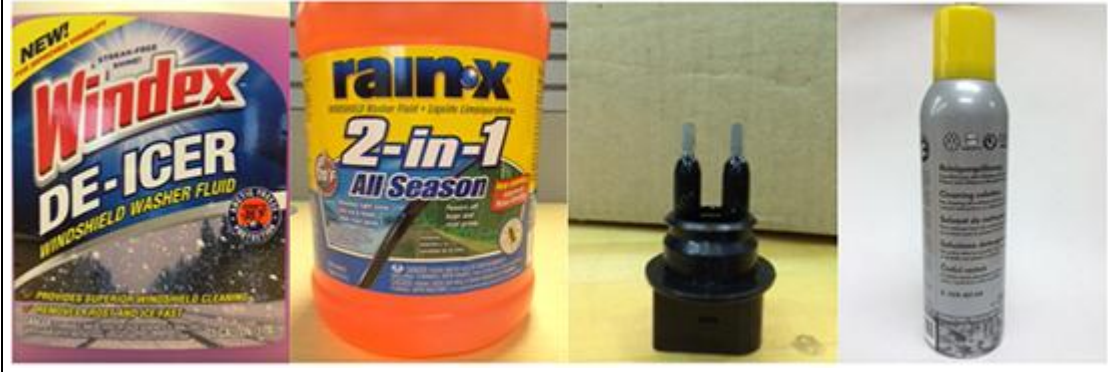
97-14-01 Washer Level Sensor

The indicator lamp in the I.P. for washer fluid remains illuminated and the washer reservoir is full. Validate the washer reservoir is full with the proper washer solvent (G-052-164). Refer to Elsa for proper fluid type and fluid quantities under repair manual, maintenance, fluid capacity table. If the fluid is not blue in color, drain the fluid, remove the sensor and clean with cleaner (D-009 - 401 - 04) or equivalent. Reinstall the sensor, top off washer reservoir with proper fluid and validate that the indicator lamp in the I.P. is no longer illuminated.

Non-approved fluids can cause residues to form on the sensor which causes the

washer fluid lamp to remain on when reservoir is full . Below are examples of non - approved fluids, a picture of the sensor in question (G33) and a picture of the approved cleaner (D-009-401-04).
