VW Elsa Newsletter

Edition 95: July 21, 2014

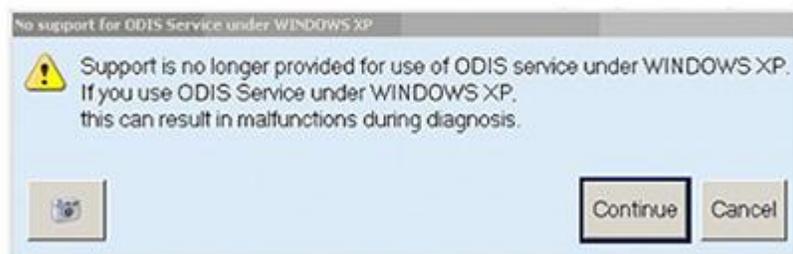
- Beginning with application **version V2.2.0 – feature number 6.0.5**, ODIS Service functions are no longer supported on devices with Windows XP.
- ODIS Service application **version 2.2.0 – feature number 6.0.5** is scheduled for online update release **on July 14th**. The successful installation and function of this update is only possible on VAS diagnostic devices with Windows 7.
- **DO NOT** attempt to install an online update identified by **feature number 6.0.5** (or higher) on devices with Windows XP! The feature number is always indicated in the download prompt.
- If the update specified above is inadvertently installed and ODIS Service is started, the following message will appear:

- To ensure that the latest versions of ODIS Service are always installed, we urge you to update all eligible diagnostic devices from Windows XP to Windows 7 immediately.
