TECH TIMES

The Professional Publication for Kia Dealership Technicians & Service Staff

Volume 17, Issue 4

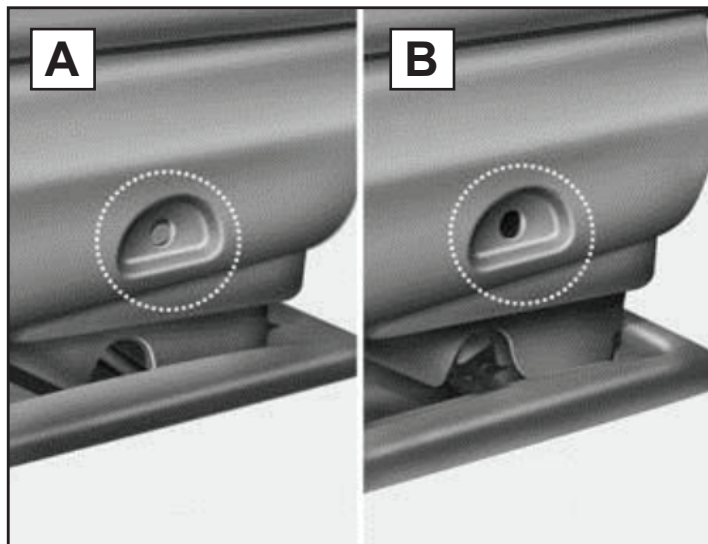
- Latch lock indicator shows a green circle on both sides of the seat base (A). If the green circle is not visible (B), make sure the seat is properly attached.

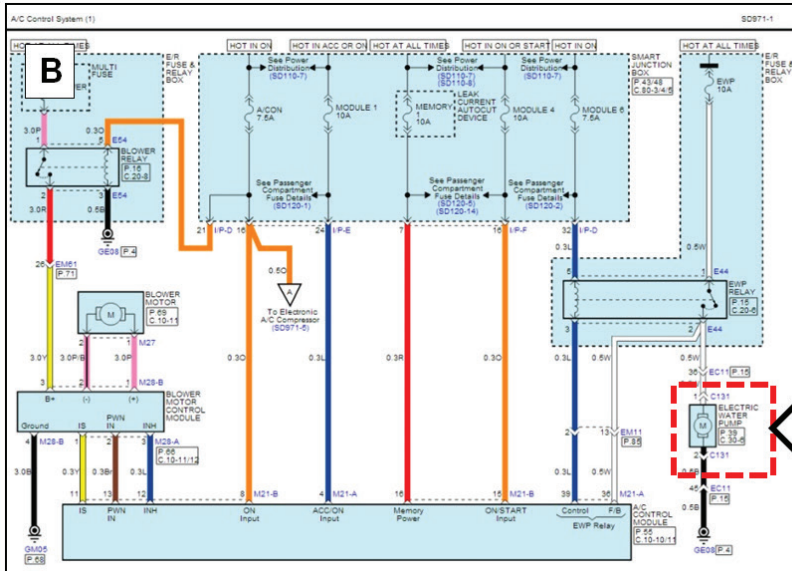
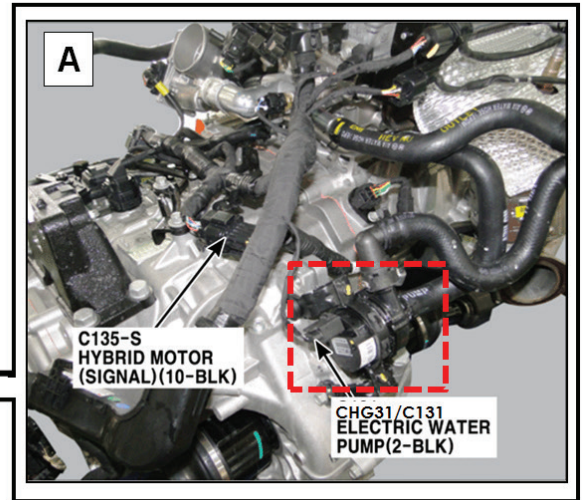
When diagnosing a concern on Optima Hybrid related to the heater intermittently blowing cold air while in EV mode, check the Electric Water Pump (EWP) for the A/C system (NOT the main cooling system EWP), located on the rear of the transmission (A), for proper operation. To test EWP operation, disconnect connector CHG31/C131 (B) and apply power and ground to the EWP. If the EWP operates after applying power and ground, continue diagnosing per the ETM. If the EWP does not operate, replace the EWP to resolve the concern.

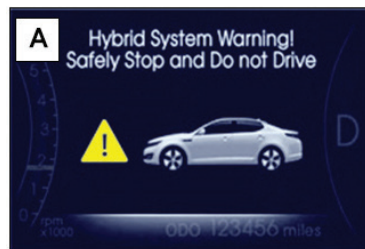
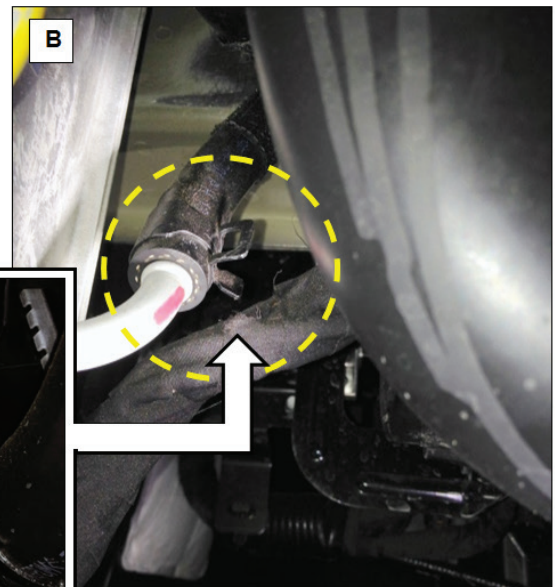
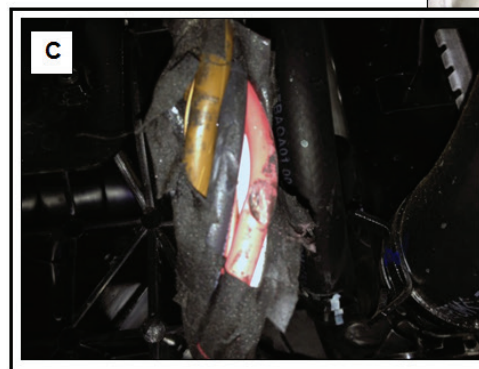
When diagnosing an Optima Hybrid with a “Hybrid System Warning!” message (A) in the cluster, the malfunction indicator lamp (MIL) on and DTC P1784 (EOP 3-Phase Wiring Line Open), in either active or in history, check for contact between the Electric Oil Pump (EOP) harness and the oil cooler hose clamp (B). If the harness is visibly damaged from contact (C), repair or replace as needed.

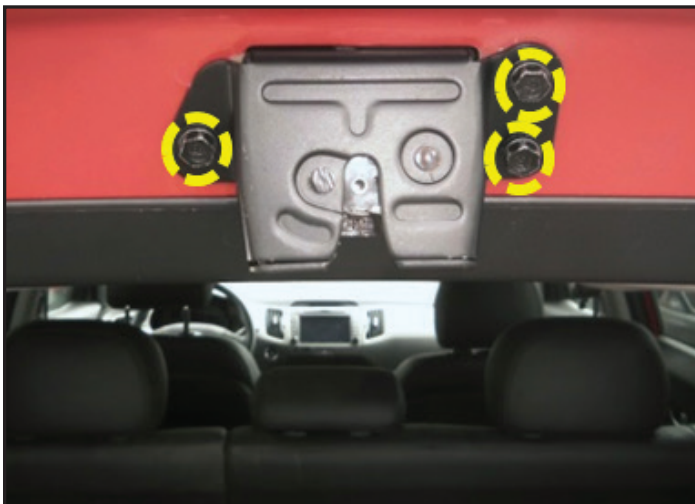
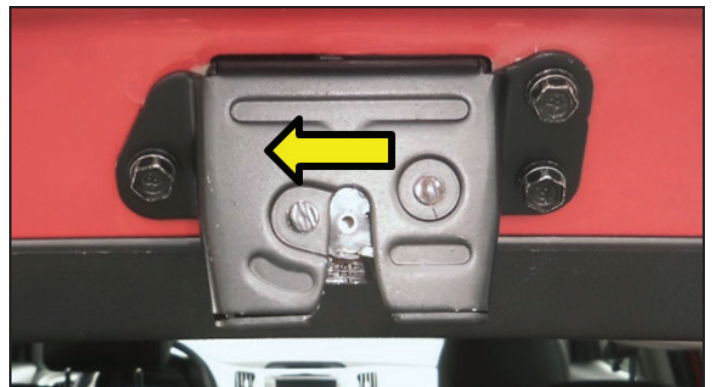
When encountering a customer concern related to excessive rear hatch closing effort on some 2011MY to 2014MY Sportage (SL) vehicles, first, verify the customer concern by comparing the closing effort on the affected vehicle to other like vehicles. Make sure all windows are rolled up and use minimal effort to try and close the hatch. If more effort is required to close the hatch than on like vehicles, perform the following procedure:

1. Loosen three bolts securing the latch to the tailgate.
2. Shift the latch as far to the left as possible and re-torque the bolts to proper specifications.

Tightening torque: 5.1~8.0 lb-ft (6.9~10.8 Nm).
