Service Bulletin

PRELIMINARY INFORMATION

- Subject: Oil Leak At Front Of Engine
- Models: 2010-2011 Buick Lucerne 2010-2011 Chevrolet Impala Equipped with a 3.9L engine (RPO LGD)

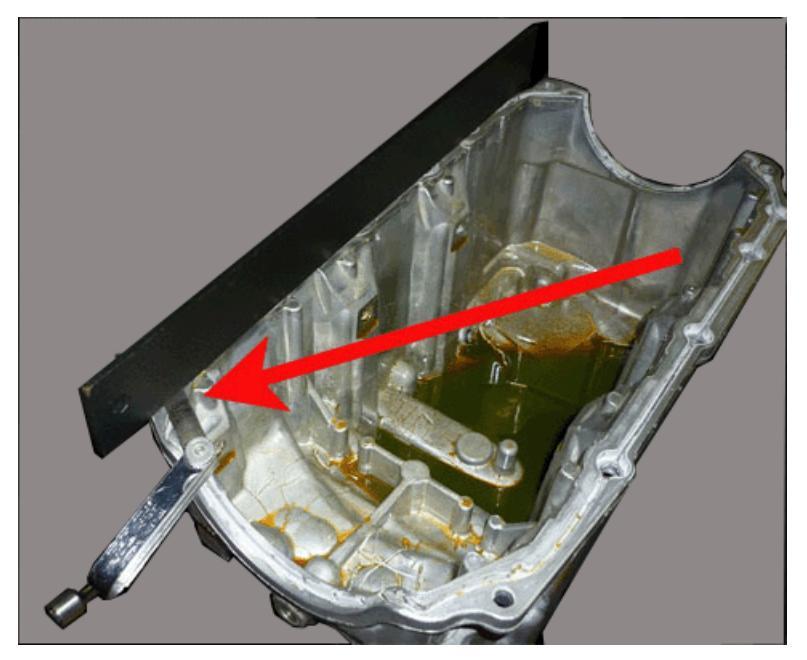
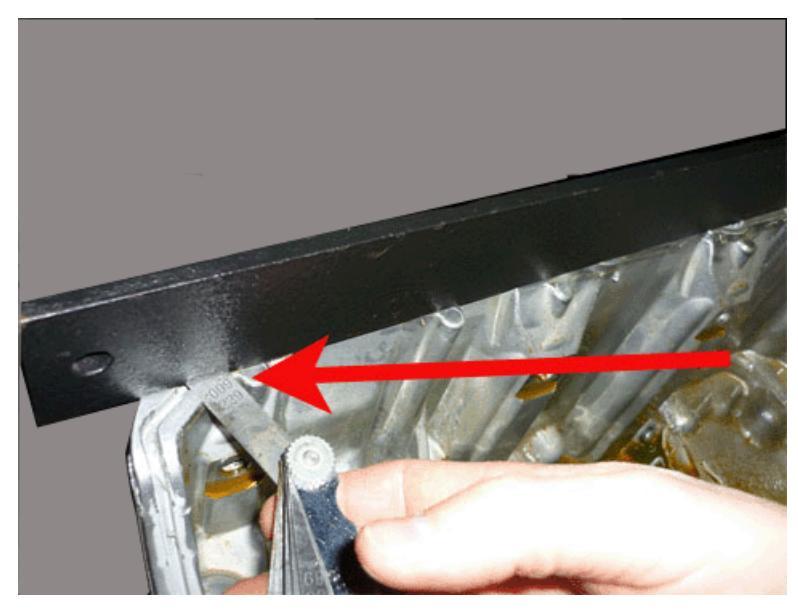
Some customers may comment on an oil leak from the front of the vehicle. Upon further inspection the leak can be isolated to the engine oil pan to front cover mating surface. This condition may be caused by warpage/taper of the oil pan sealing surface.

Using a straight edge and a feeler gauge measure taper on each side rail of the oil pan as shown below.

If the taper is greater than .005"(0.127mm) the oil pan sealing surfaces will require resurfacing/milling by a capable machine shop.

If taper is .005"(0.127mm) or less no machining will be required. Note: If taper is .005"(0.127mm) or less, apply a thin layer of sealer GM P/N 12346004 (Canadian P/N 10953480), or equivalent to the oil pan rail(s) the length of the tapered area to ensure that the gasket seals to the pan.

After the oil pan has been resurfaced or measurement was .005"(0.127mm) or less, reinstall using appropriate SI installation procedure.
