Countries: CANADA, COLOMBIA, UNITED STATES, PUERTO RICO
Availability: ISIS, FleetSIS
Major System: ELECTRICAL SYSTEM
Current Language: English
Other Languages: NONE
Viewed: 1846

Document ID: IK0800426
Revision: 2
Created: 5/17/2013
Last Modified: 6/2/2014
Author: Will (Mark) Wiley

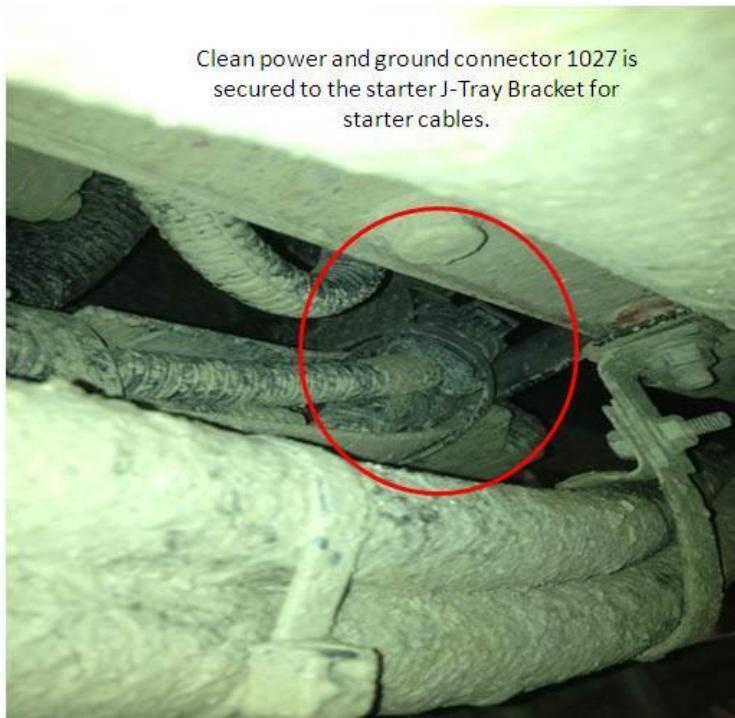
Figure 1: Connector 1027 - ECM Battery Feed on Vehicle

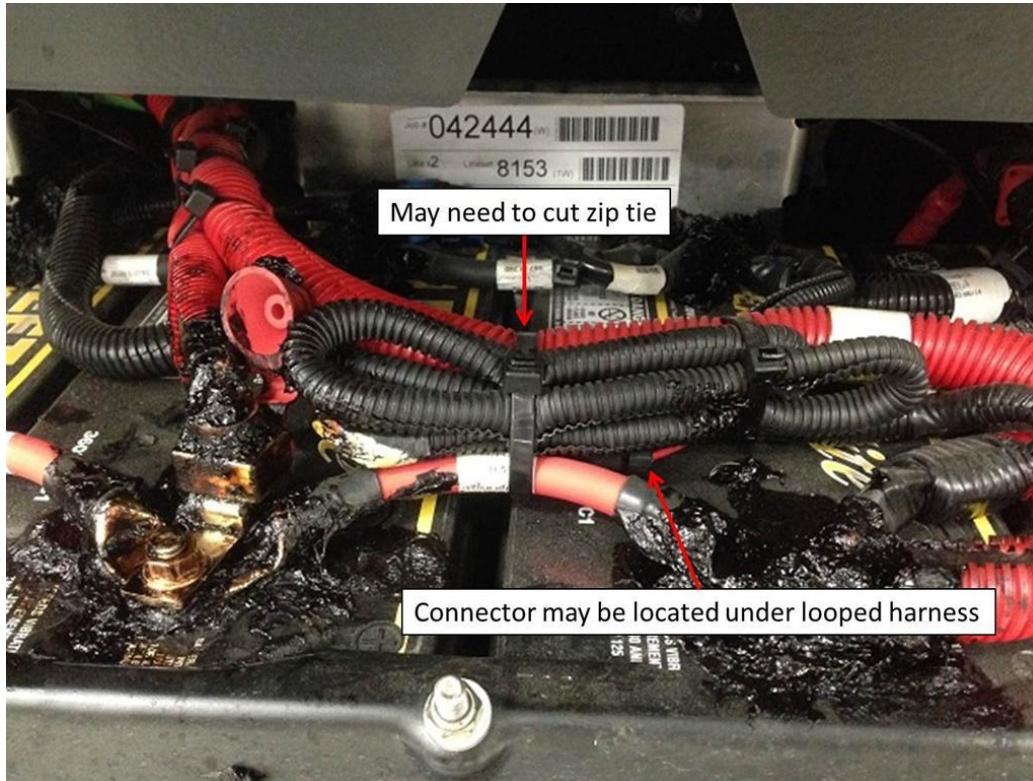
Figure 3: Battery Box
