SUBJECT: 2009-2011 Tribute PCM Software Update - Special Service Program (SSP) 94

2009-2011 TRIBUTE - PCM SOFTWARE UPDATE

ATTACHMENT II SPECIAL SERVICE PROGRAM SSP94

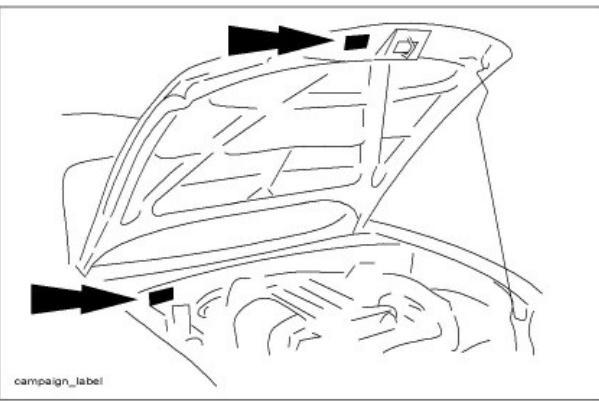
2. Affix the Campaign Label to the hood or bulkhead as shown:

Fill out a blue "Campaign Label" (9999-95-065A-06) with Campaign No: "SSP94", your dealer code, today's date.
