TECHNICAL BULLETIN Q404NAS2 16 SEP 2014

SECTION: 501-00

Service Action: Fixed Side Step 'Rattle' Noise / Trim Loose

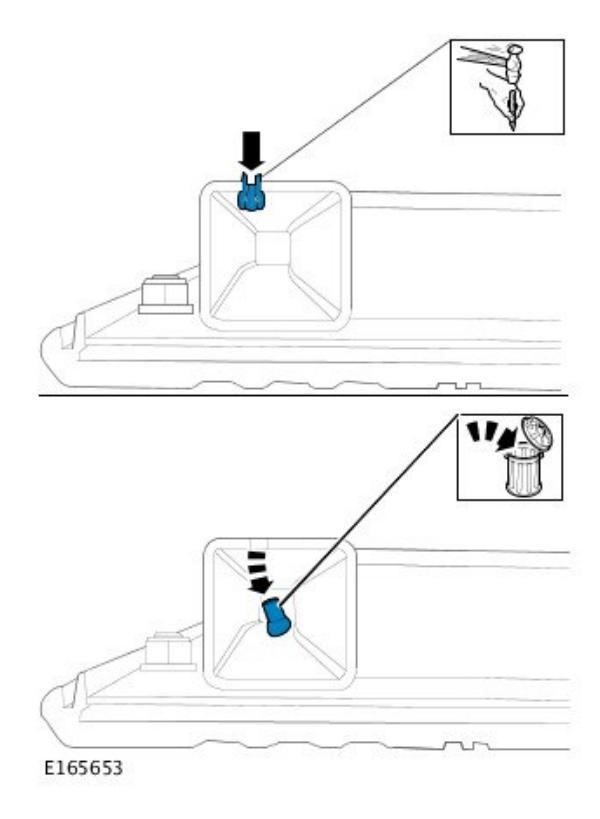
9. ONOTE: Make sure all the rivets are removed from the side step; failure to perform this may cause a rattle.

Remove and discard the rest of the 10 rivet inserts.

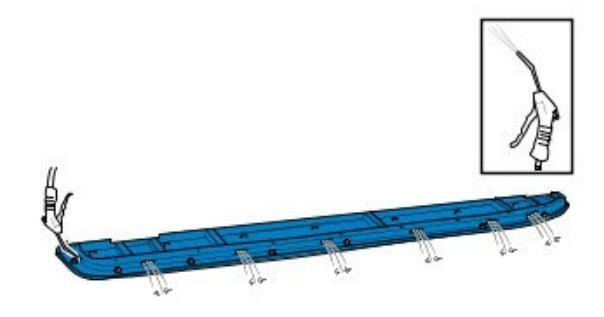
E165654

NOTE: Make sure all the rivets are removed from the side step; failure to perform this may cause a rattle. 10. 🕻

Using a suitable tool, remove all the excess material from the rivet removal. $% \left({{{\mathbf{r}}_{\mathrm{s}}}_{\mathrm{s}}} \right)$

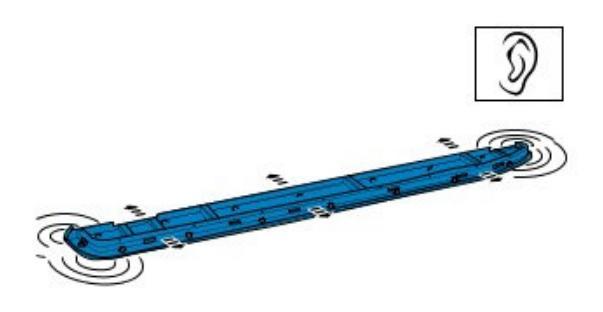
E165655

11. ONOTE: Make sure all the rivets are removed from the side step; failure to perform this may cause a rattle.

Shake the side step to make sure there is no material inside the step after drilling.
