# VW Elsa Newsletter

Edition 101: September 1, 2014

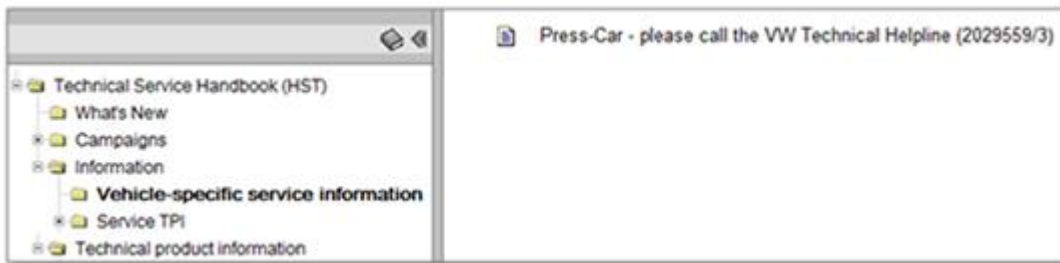
**Issue:** In the "Notes" pop-up, some links may lead to a screen displaying the message "No Data Available".

**Cause:** The "Notes" pop-up is using a filter that is allowing additional line items to be displayed that are not related to the VIN/submitted vehicle.

1. No information is missing. If a link directs you to “No Data Available”, then this link is not valid for the vehicle.
2. The “Vehicle-specific service information” folder in the Technical Service Handbook (

) section of ElsaPro will have the concise list of applicable PSS’s for the selected vehicle:

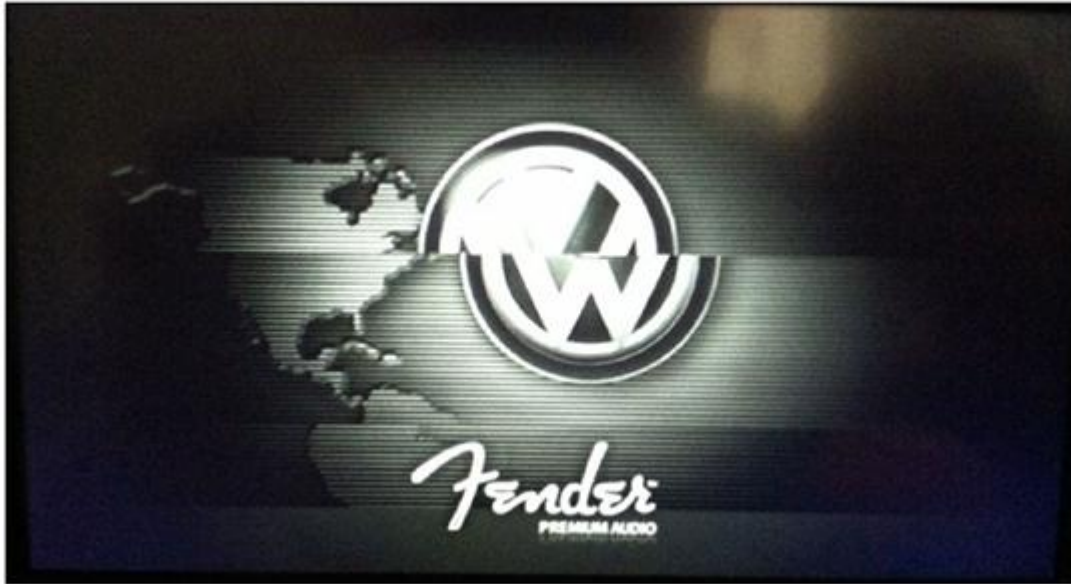
**91 14 07 - 2037873**  
**RNS 510 Welcome Screen Image Distorted**

The customer may complain that the image of the RNS 510 welcome screen is distorted or shifted as seen below.

**Note: This technical bulletin must be read in its entirety before attempting the software update.**
