Service Bulletin

Subject: **Hood Shakes While Driving**

Models: 2015 Chevrolet Colorado 2015 GMC Canvon

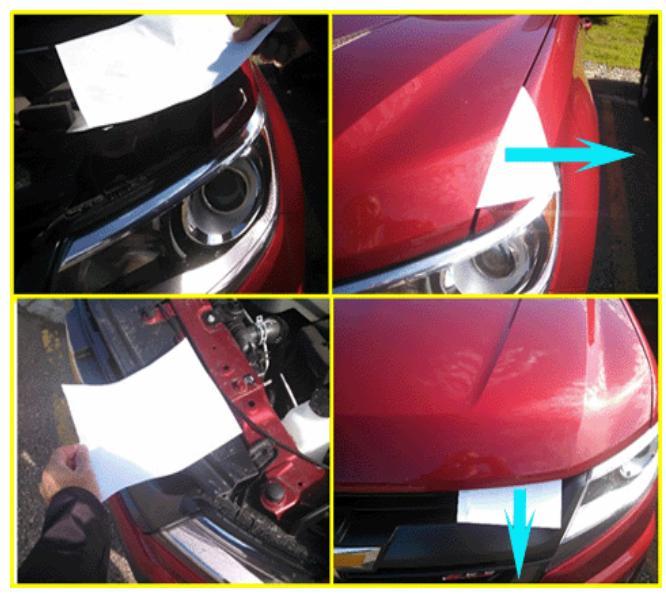
4001655

The hood may shake or flutter while driving. This could be caused by hood bumpers or the hood latch being out of adjustment

2. With a piece of paper, check at the outer and middle bumpers to ensure good contact of bumpers to hood. Paper must not pull free when the hood is closed
