**SB-10041404-9666**

**Document ID:** IK0800298  
**Revision:** 2  
**Created:** 8/17/2011  
**Last Modified:** 7/3/2014  
**Author:** Chris Moody

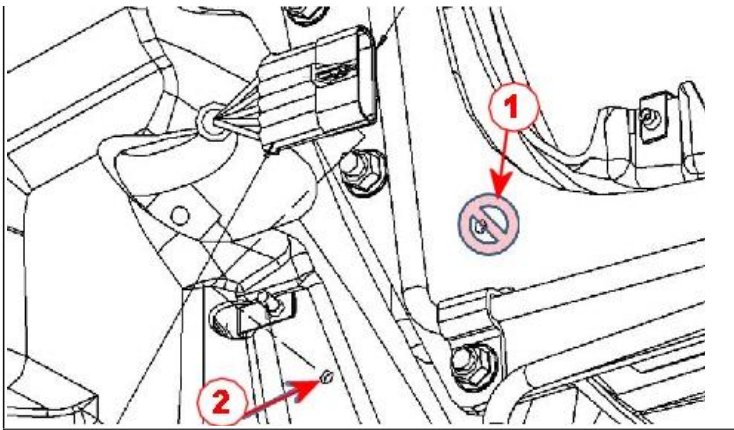
**Figure 3: Move connector**
