Tech Note: HVIL Diagnostic Guide

What the Technician Sees

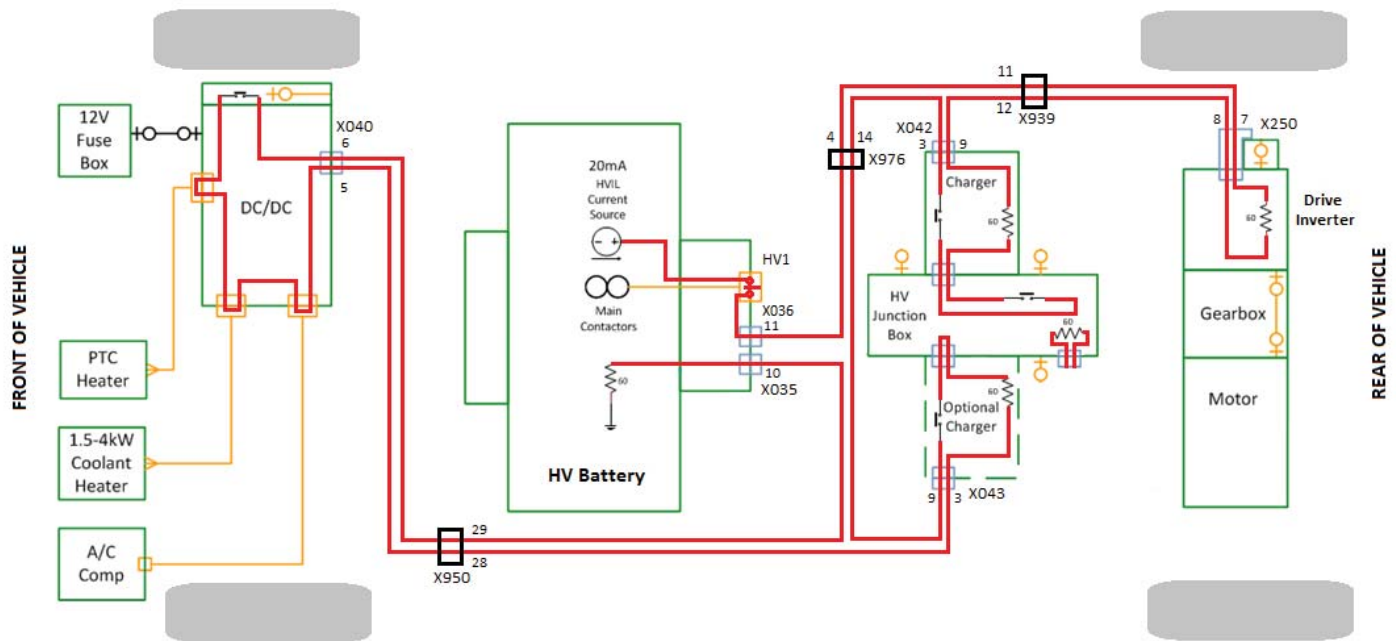
The High Voltage Interlock Loop (HVIL) routes through every high voltage (HV) component and HV connector in the vehicle. Figure 1 shows the HVIL circuit (in red), the HV components (in green), and some of the HV harness connectors.

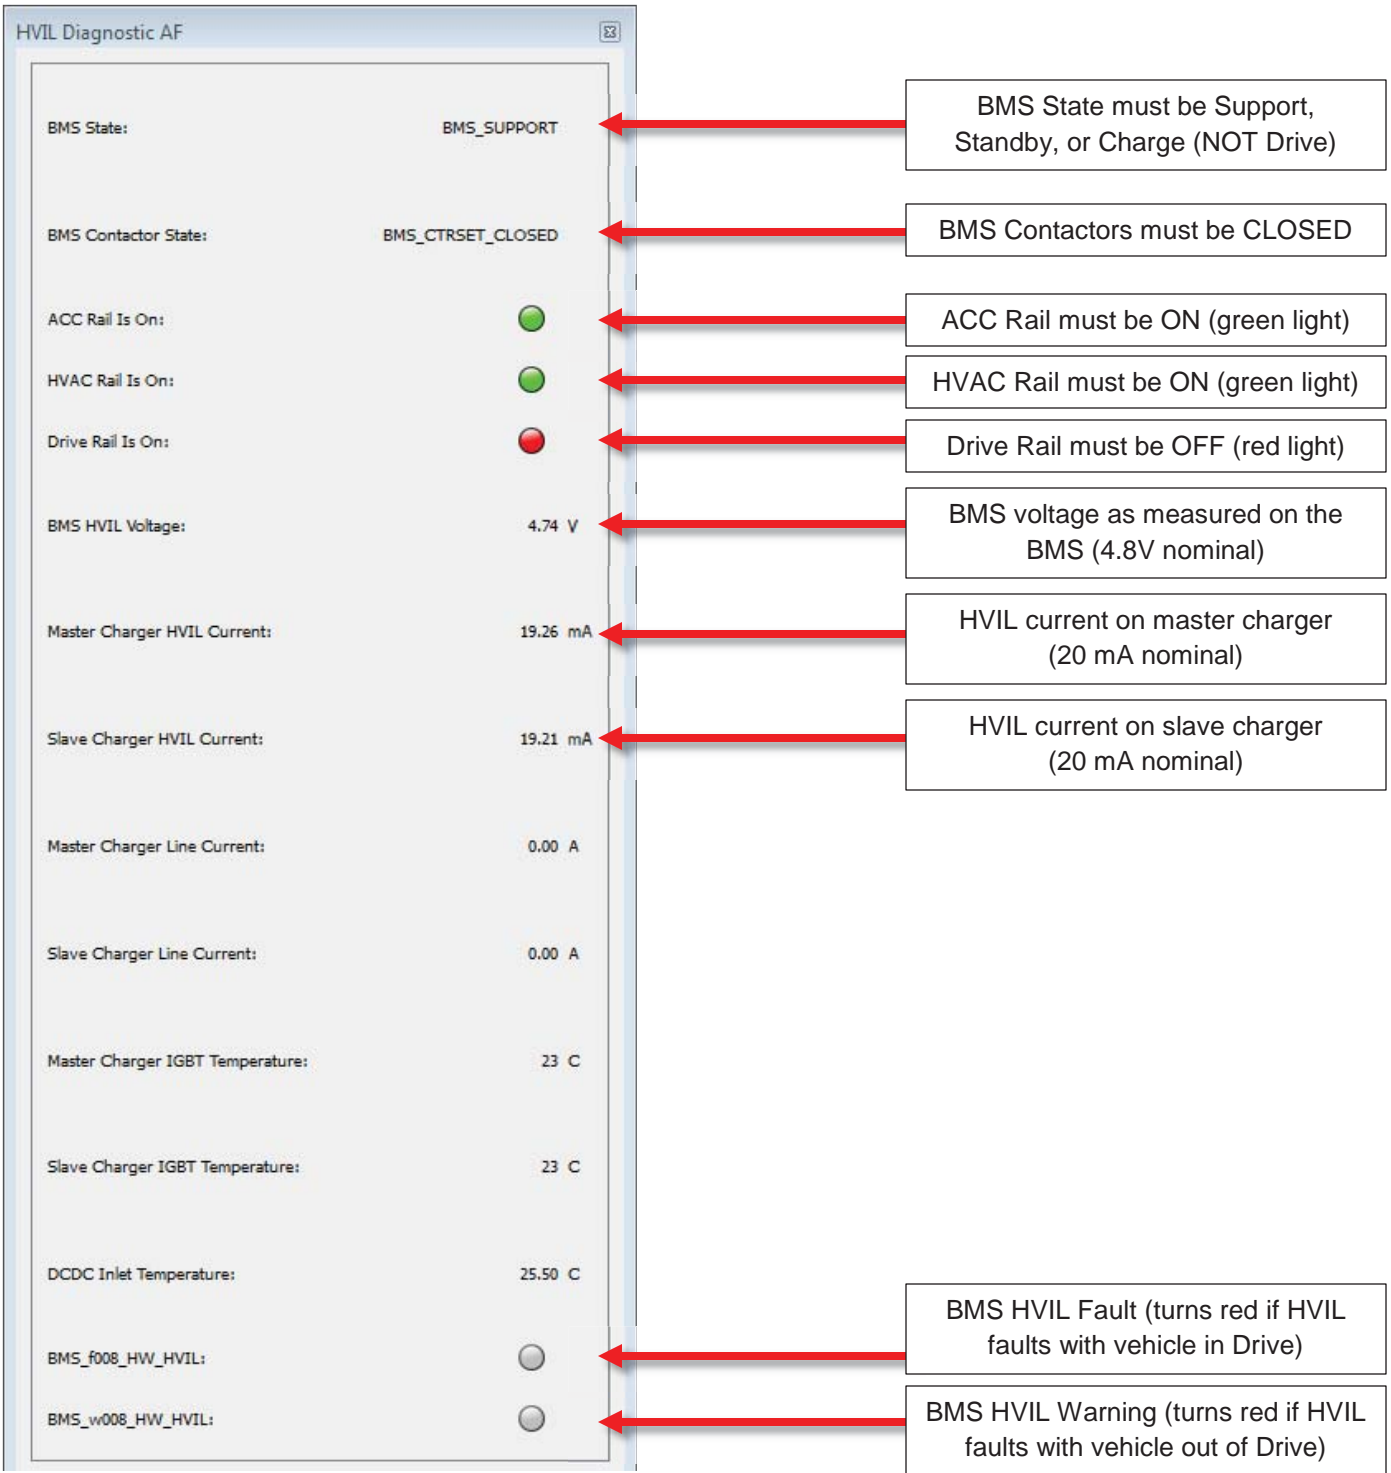
Figure 2 (TDS HVIL panel view)

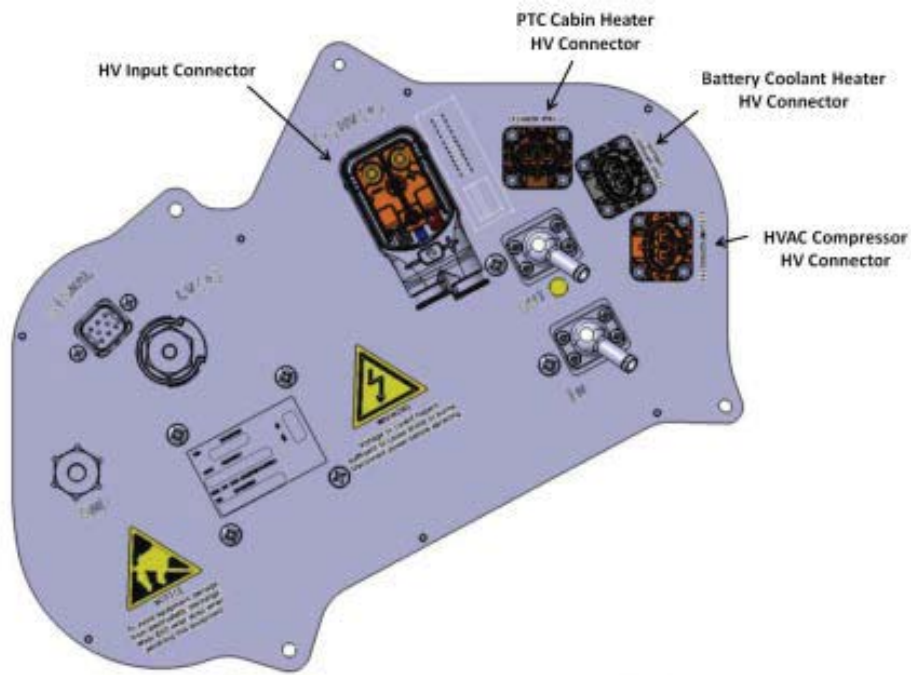
Figure 4 (DCDC connector face)

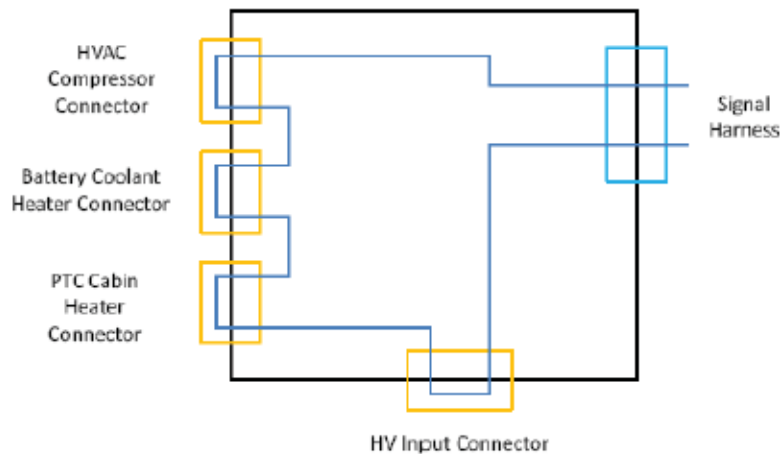
5. Listen to the alert tones and the sound of contactors opening to identify a loose connection during the previous step. Ideally, have a second person in the driver seat checking for alerts on the touchscreen. Figure 5 shows the DCDC HV connector circuit overview.

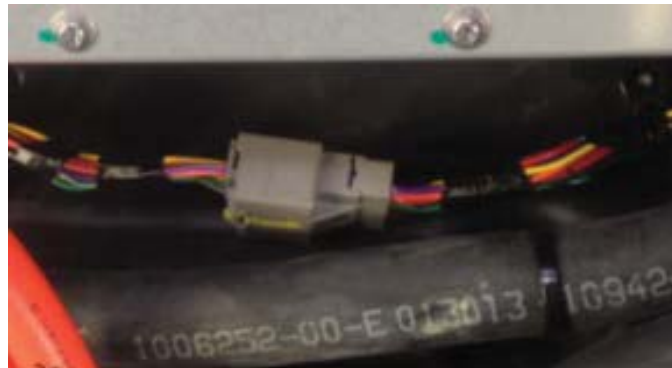
Figure 9 (X976, behind master charger)

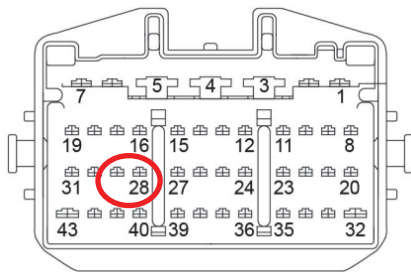
Table 3: Crimp and pin drag check locations

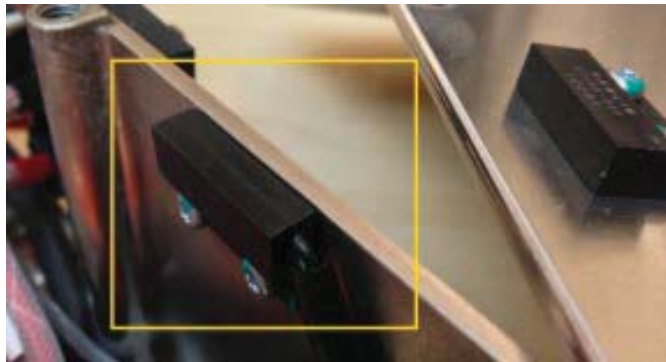
- **Failure Type:** A damaged reed switch causes increased resistance and increased HVIL voltage.
- **Subsystem:** High voltage junction box (Figure 13).
- **Issue:** The glass bulb protecting the reed switch is shattered inside the black plastic housing. The cause seems to be significant mechanical stress. Root cause is TBD.
- **Diagnostic for Service:** Check the resistance of the assembled HVJB. Check the switch function with a magnet. A closed switch should read < 1.0 Ohm. Also carefully check that the female pins of the reed switch are not splayed open.
- **Corrective Actions:** Replace the complete HVJB. An ATTAC case confirmation is needed to only replace the magnetic reed switch.

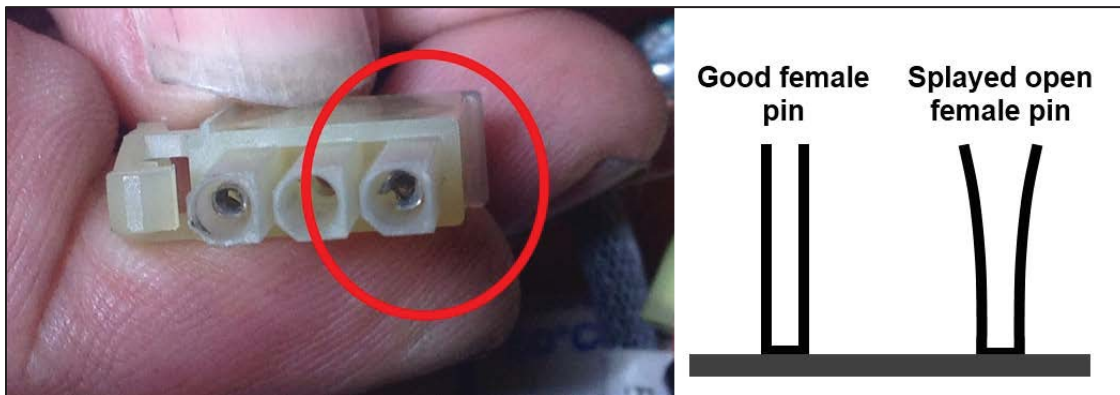
- **Failure Type:** A splayed-open female pin on the HVJB reed switch connector causes increased resistance and increased HVIL voltage.
- **Subsystem:** High voltage junction box reed switch connector into charger (Figure 14).
- **Issue:** One of the two female pins on this connector is splayed open, which causes poor connection with the male side. This is most likely a manufacturing defect, but root cause investigation is still ongoing.
- **Diagnostic for Service:** Unplug the connector from the charger and closely examine the female pins. If a pin is not completely round, it is bad (Figure 14). Affected connectors have currently been found on vehicles ranging from VIN P09968 to P11256.
- **Corrective Actions:** Replace the complete HVJB. An ATTAC case confirmation is needed to only replace the magnetic reed switch.

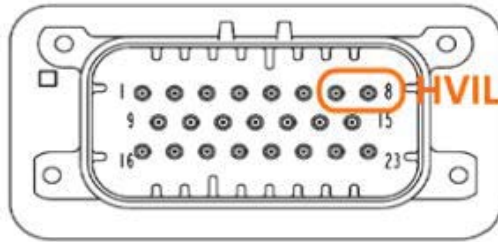
- **Failure Type:** An intermittent or loose connection causes increased resistance and increased HVIL voltage.
- **Subsystem:** Drive Inverter logic connector X250 (Figure 15).
- **Issue:** Four pins in the X250 connector are very loose (including 7 and 8 for HVIL).
- **Diagnostic for Service:** Check whether the connector is fully locked and assembled properly.
- **Corrective Actions:** Log the results in an ATTAC case.

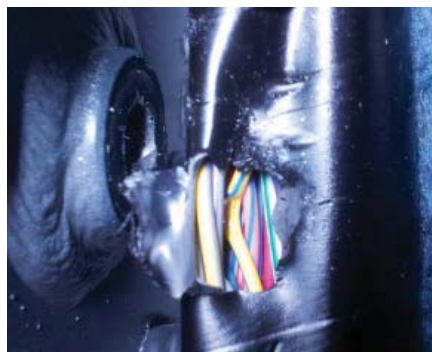
- **Failure Type:** Wire damage is causing an HVIL short to ground.
- **Subsystem:** The wire harness between connectors X950 and X043, near the driver side seatbelt pre-tensioner.
- **Issue:** The HVIL wire is squeezed and shorted to ground (Figure 16).
- **Diagnostic for Service:** Check wire for damage.
- **Corrective Actions:** Log the results in an ATTAC case.

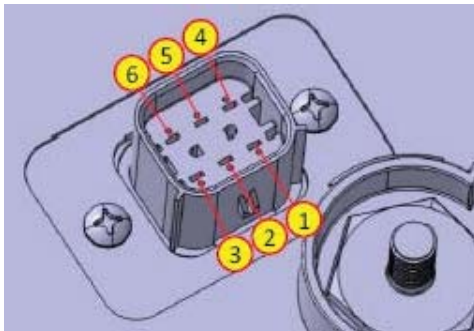
- **Failure Type:** An intermittent or loose connection causes increased resistance and increased HVIL voltage.
- **Subsystem:** DCDC connector X040 (Figure 17).
- **Issue:** The connector is not properly holding its terminals.
- **Diagnostic for Service:** Check that the connector is fully locked and assembled properly.
- **Corrective Actions:** Log the results in an ATTAC case.
