**December 17, 2014**

ATB 50873-01155 REV2(1411)

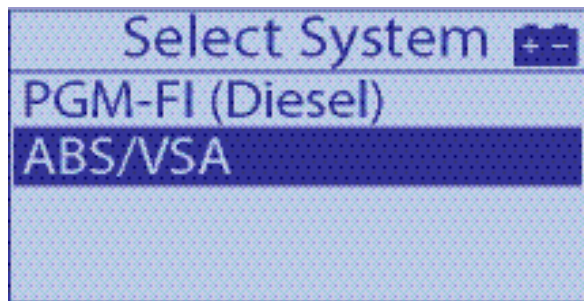
1. Connect a fully charged jumper battery to the vehicle and leave it connected during the entire update procedure to maintain a steady voltage.
2. Apply the parking brake and make sure the headlights are turned off.
3. Turn the ignition to ON and turn off all accessories.
4. Connect the MVCI to the vehicle.
5. Press the ENTER button on the MVCI to see the **User Config** menu. Select **CM Update Mode**, then press ENTER.
6. Select **Reprogramming**, then press ENTER.
7. When the **CM Update Mode** software screen appears, press ENTER to continue.
NOTE: The FW VER must be 3.01.40 or later and Database Update must be 12 Nov 2014 or later.
8. When the **Select System** screen appears, select **ABS/VSA**, then press ENTER.
