Service Bulletin

Subject:	Bulletin No:	09-032/14	
CD PLATER DISPLAT CONCERNS	Last Issued:	07/14/2014

2014 Mazda3 vehicles (with MAZDA CONNECT and CD player) with VINS lower than JM1BM**** ** 154022 (produced before December 01, 2013)

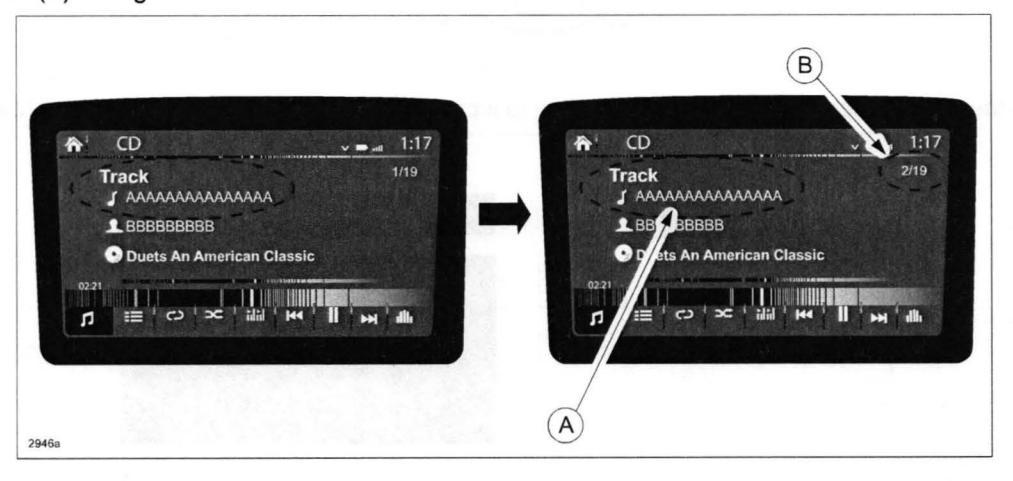
Symptom 1: The song title on the CD display (A) does not change when it goes to the next song. However, the track number (B) changes

This is caused by improper software of the CD player. The software of CD player has now been changed to correct this issue.

Customers having this concern should have their vehicle repaired using the following repair procedure.

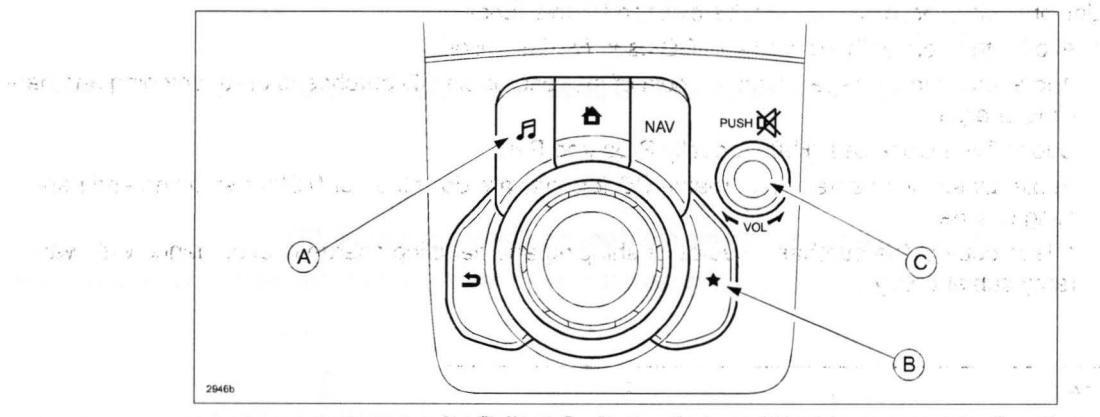
- 1. Verify customer concern.
- 2. Check the software version.
 - a. Press the three buttons (Music (A) + Favorites (B) + Volume Mute(C)) on the commander switch at the same time for 2-5 seconds and the Diagnostic Test Screen will appear.

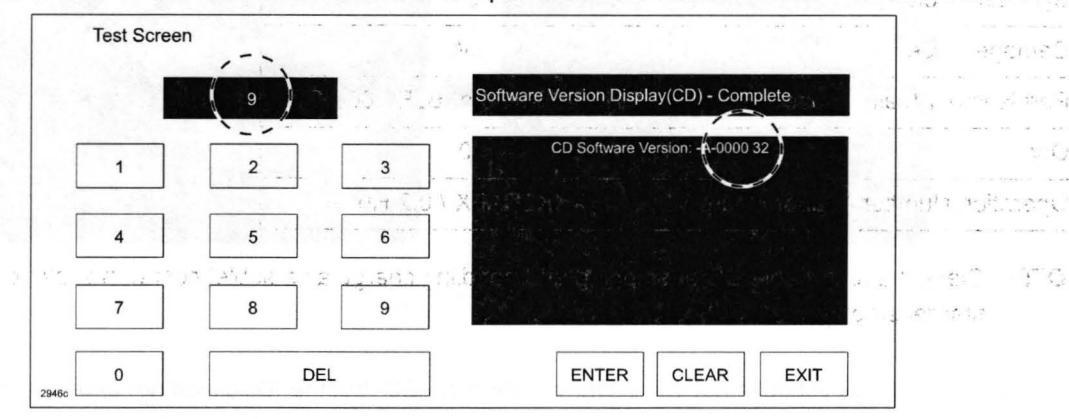
b. Use the touchscreen or the commander switch to input '9' and then select "ENTER" on the Test screen.

- c. Check the last two digits of the CD player software version.
 - If two digits are "32", this Service Bulletin is not applicable.
 - If software version is below "32", go to the next step.
- Order a CD with update software from MStore (CD Player Update P/N 9999-95-CD32-14) or burn the update software (A-000032) to a CD (Music Type). DO NOT use a DVD. The update software is available on MS3 under "IDS/Infotainment -> Mazda Connect Updates.
