NUMBER: 11-001-14

GROUP: Exhaust System

Weld Length on Exhaust Hanger Bracket Too Short

2013	DD	Ram 3500 Cab Chassis
2013	DP	Ram 4500/550 Cab Chassis

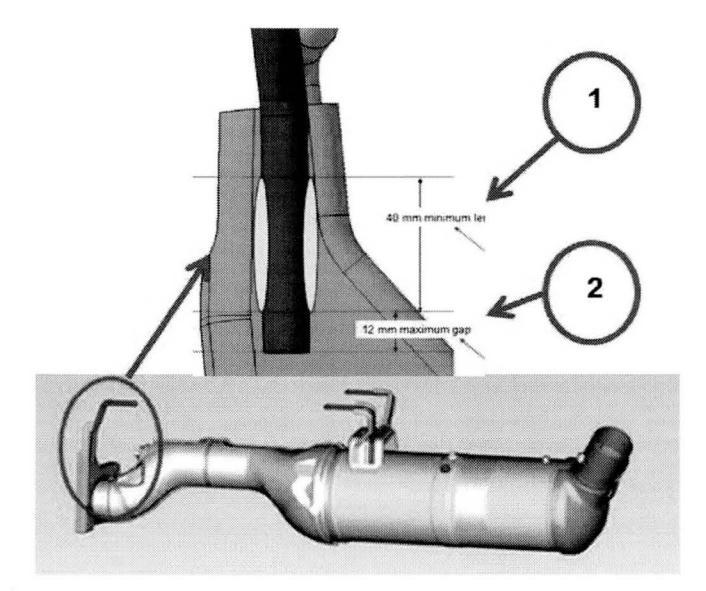
Fig. 1 SCR Hanger Bracket

- 1. Raise the vehicle on a lift.
- 2. Locate the SCR inlet hanger bracket (Fig. 1).

- 1 Minimum Weld Length is 40mm (1.57 in.)
- 2 Minimum Weld Distance From Rod End is 12mm (0.47 in.)
- 3. Measure the distance from the end of the hanger rod to where the weld starts to secure the rod to the bracket (Fig. 2).

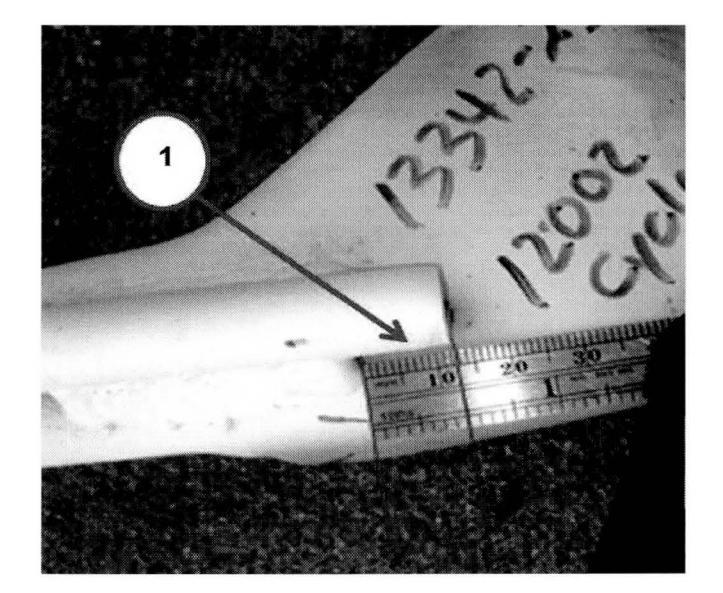
Fig. 2 Weld End Gap

1 - Minimum Weld Distance From Rod End is 12mm (0.47 in.)

- 4. Is the distance 12mm (0.47 in.) or less?
 a. YES>>>Continue to the next step.
 b. NO>>>Proceed to Step #7 (dealer repair) or Step #19 (sublet repair).
- 5. Measure the length of the rod to bracket weld on each side of the rod (Fig. 3).

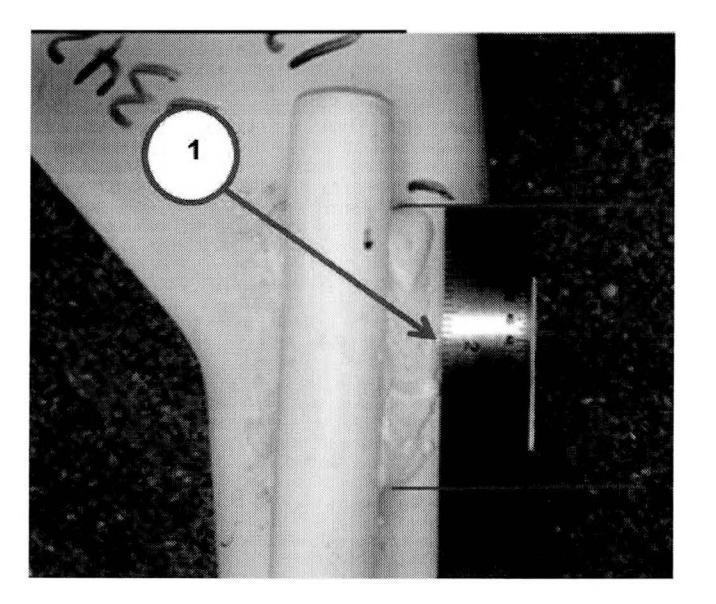
Fig. 3 Weld Length

1 - Minimum Weld Length is 40mm (1.57 in.)

- Is the length of the rod to bracket weld 40mm (1.57 in.) or longer on each side?
 a. YES>>>Inspection complete. No additional work is necessary.
 - b. NO>>>Proceed to the next step.
