Technical Service Bulletin

64 Creaking noises from the A-pillar, dash panel, or windshield - caused by centering pin assembly

64 14 34 2037934/1 July 25, 2014.

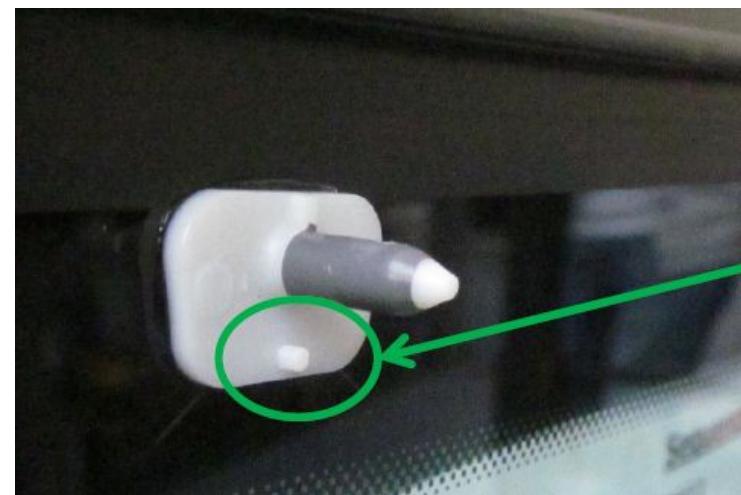
The small lug on the centering pins of the windshield can cause the creaking noises.

Figure 1. Small lug to be removed from centering pin.

- 1. Remove the windshield.
- 2. Use side-cutting pliers to remove the small lug from the centering pin (Figure 1 and Figure 2).

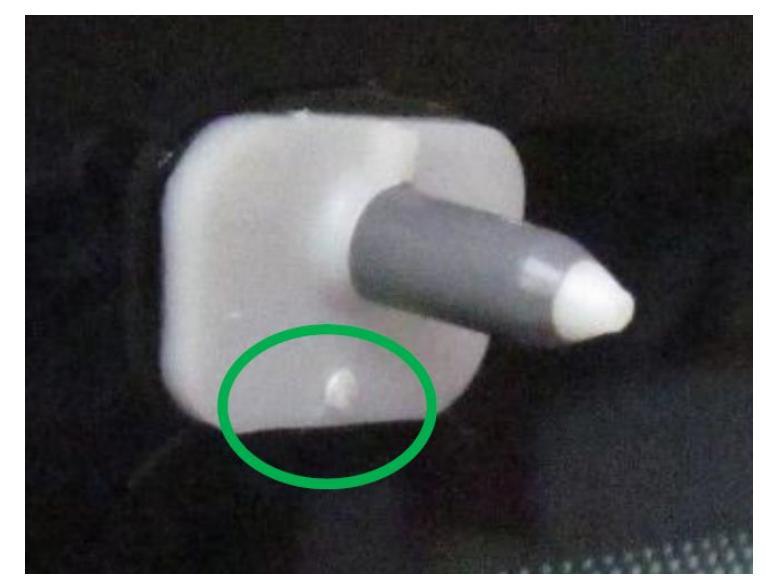
Figure 2. Centering pin with lug removed.

3. Re-install the windshield.
