Technical Service Bulletin

68 Creak or squeak noise from center console

68 14 13 2036335/1 January 30, 2014.

Model(s)	Year	VIN Range	Vehicle-Specific Equipment
A4	2014	095738 - 096694	Not Applicable

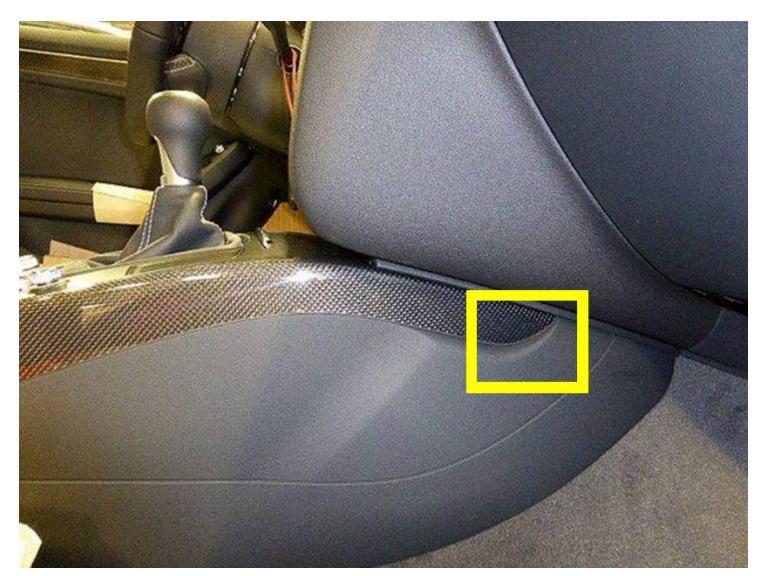
Creaking noise is heard from the right side of the dashboard or center console area, beneath the HVAC controls.

The installed insulation material is extended into the wrong area. The dashboard cross member mount is resting on the insulation, which causes the creaking noise.

Figure 1. Affected area.

1. Remove the insulation from the affected area (Figure 1 and Figure 2).

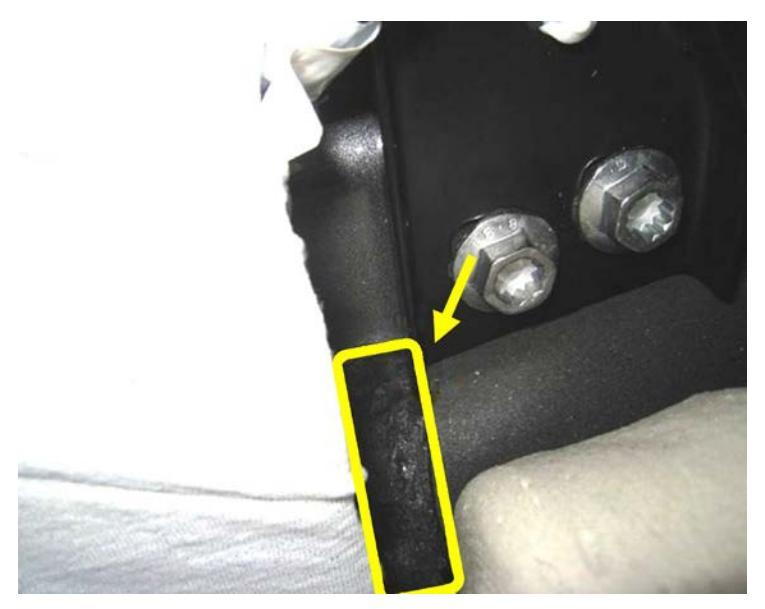
Figure 2. The arrow shows where the dashboard cross member mount is resting on the insulation. The outlined area shows the insulation to be removed.

2. If the insulation cannot be removed completely, apply a piece of felt tape to dampen the noise.
