Technical Service Bulletin

94 Xenon headlights are aimed too low

94 14 45 2037810/1 July 22, 2014.

Model(s) Year	VIN Range	Vehicle-Specific Equipment
A3	2015 - 2016	All	xenon headlights

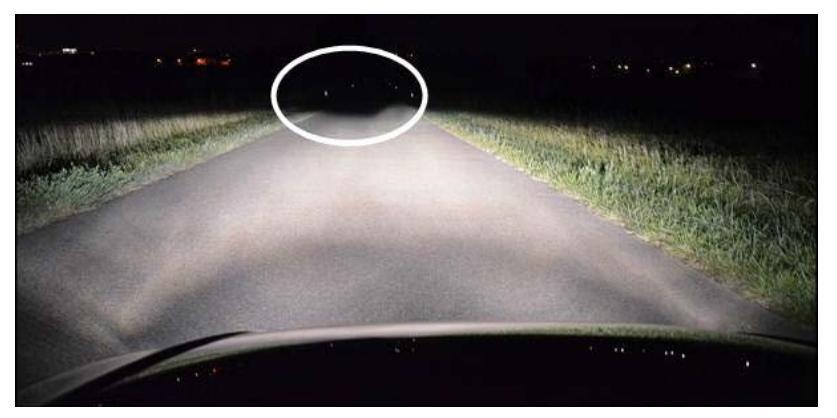
The "dark spot" in the headlight illumination pattern is normal. It is a result of the geometry and structure of the xenon headlight (Figure 1 and Figure 2).

Figure 1. Illumination of xenon headlight.

The xenon headlight meets all legal regulations. This condition is normal. Adjusting or replacing the headlight will not remove the dark spot.

If no adjustment is made, explain to the customer the design of the headlights and the pattern that is required to match legal regulations.

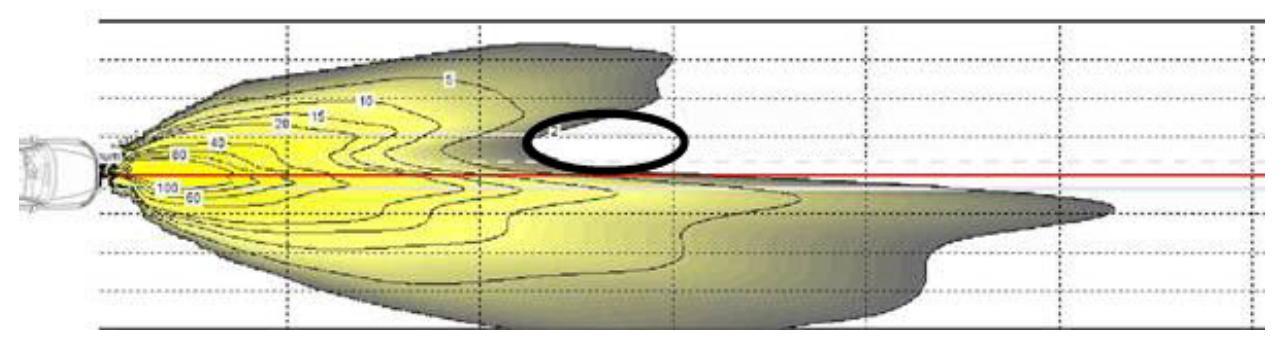
Figure 2. Light distribution of A3 xenon headlights.
