ATTENTION: GENERAL MANAGER I PARTS MANAGER I	IMPORTANT - All Service Personnel Should Read and Initial in the boxes		😸 SUB	
CLAIMS PERSONNEL	provided, right © 2014 Subaru of America, Inc. All right	s reserved. $\overline{\mathbf{Q}}$	UALITY DRIVEN	[®] SERVICE
	SERVIC	E BULLETIN		
APPLICABILITY:	•		NUMBER:	12-174-14
	2014MY Forester Mode	S	DATE.	10/00/14

SUBJECT: Instrument Panel Side Vents Coming Loose

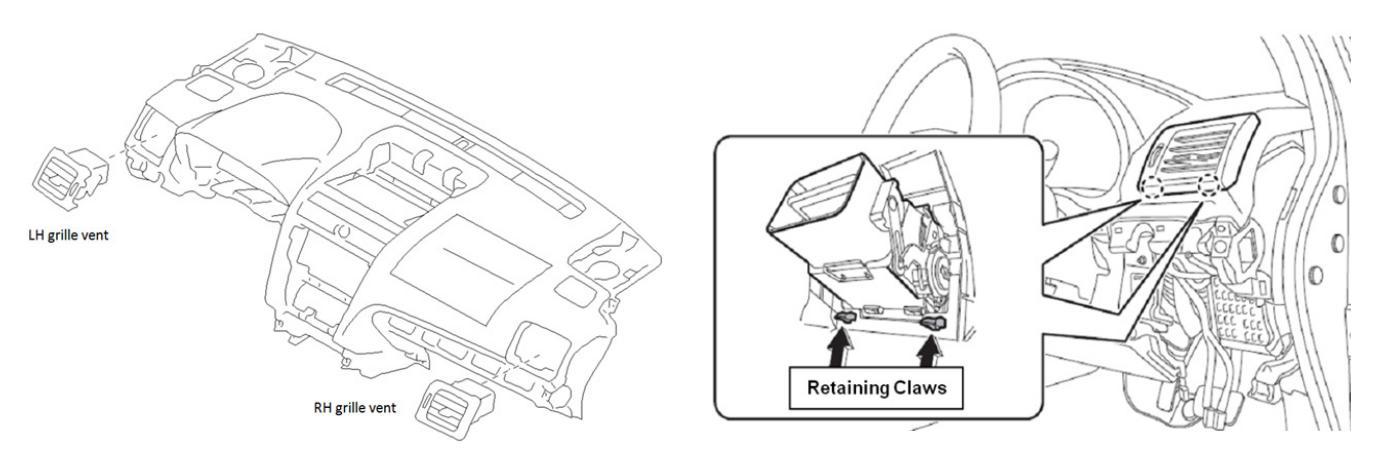
To address customer concerns of the instrument panel side dash grille vent assembly coming loose, the retaining claw portion has been redesigned to provide better retention.

Should you encounter a complaint of the side grille vent(s) being loose, replace the loose vent with one which has the new design retaining claws. There has been no change to the current Service Manual procedure for grille vent replacement.
