TECH TIMES

The Professional Publication for Kia Dealership Technicians & Service Staff

Volume 17, Issue 3

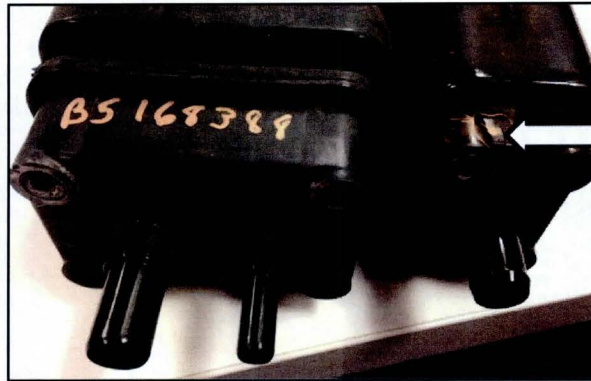
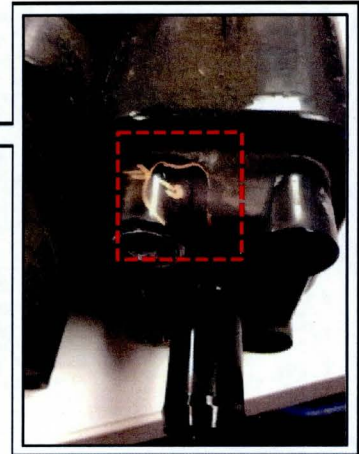
When addressing a concern related to a DTC P0456 (Evaporative Emissions System – Small Leak Detected) on 2011-2014 Optimas, and inspection of the vapor lines, connections and fuel cap reveal no abnormalities, closely inspect the mounting holes of the charcoal canister for visible cracks (refer to the images to the right). If cracking is found, replace the charcoal canister per the applicable procedure on KGIS. If no cracking is found, please proceed with normal evaporative system diagnostics.

Please refer to Pitstop PS 322

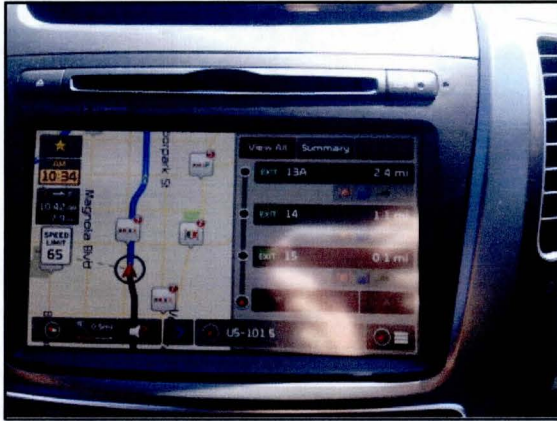
Sirius® traffic is not being displayed

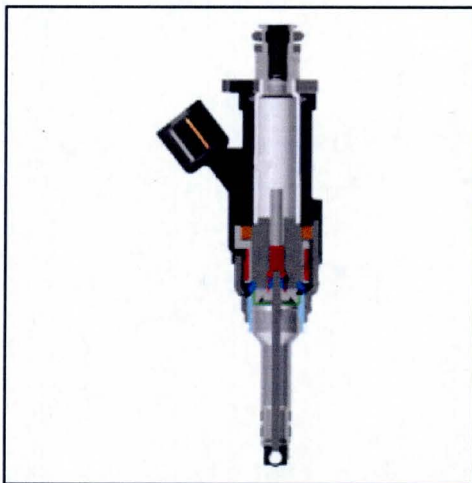
A design feature of vehicles equipped with a Gasoline Direct Injection (GDI) system is the placement of each fuel injector directly into the engine cylinder head assembly. Therefore, it is completely normal for the combustion process to create deposits on the injector spray tip surfaces. Although spray tip deposits may appear to be heavy enough to affect injector performance, there is actually no change in the fuel delivery or spray pattern. GDI injectors operate at high pressure and deliver fuel through small spray orifices near the center of the injector tip, at a high velocity. As a result, combustion deposits that form near the injector spray orifices are washed away as fuel is delivered. In addition, the injector ball and seat are engineered to reduce any potential effects of carbon coking.

The internals of the Injector are designed to minimize the formation of deposits

NOTE: Ultra-sonic or mechanical cleaning of GDI fuel injectors should never be done in an attempt to improve vehicle drivability or injector performance. Attempting to remove spray tip deposits through mechanical means, such as wire brush cleaning or scraping, will damage the spray orifices and degrade injector performance.

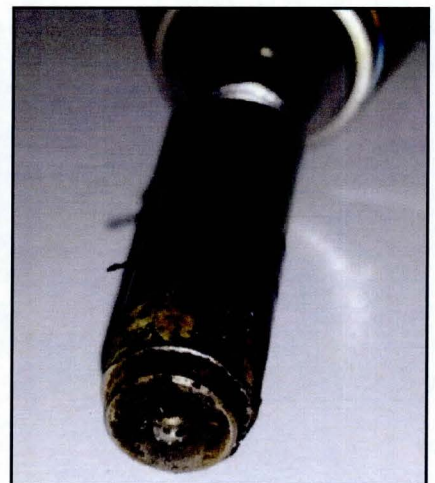
Normal injector appearance while in service

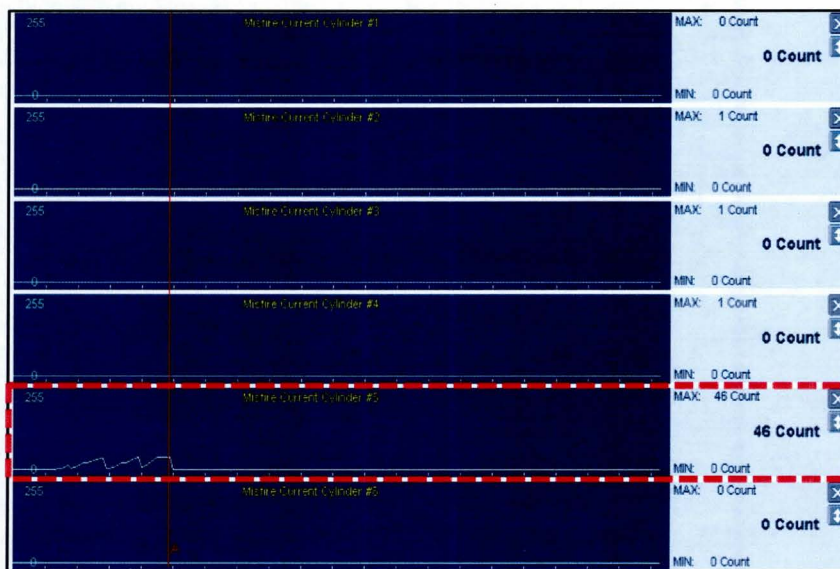
When addressing a customer complaint of rough idle on a Sorento or Cadenza, which occurs only on the first start of the day and lasts for, approximately, 30-45 seconds, check for the possibility of poor injector performance on a particular cylinder. This concern may feel like a misfire, however, it is not an emissions or catalyst damaging misfire and it does not typically trigger any DTC(s). To correct this condition, use GDS to monitor for Current Misfire Counts on all 6 cylinders during the first cold start in the morning, to help determine which cylinder is responsible for the rough idle condition. Replace only the injector for the indicated cylinder. To verify the repair, recheck again after an overnight cold soak to make sure the rough idle condition is no longer present.

The example below shows a rough idle condition on cold start due to the Injector in Cylinder #5.

Please refer to Pitstop PS 320

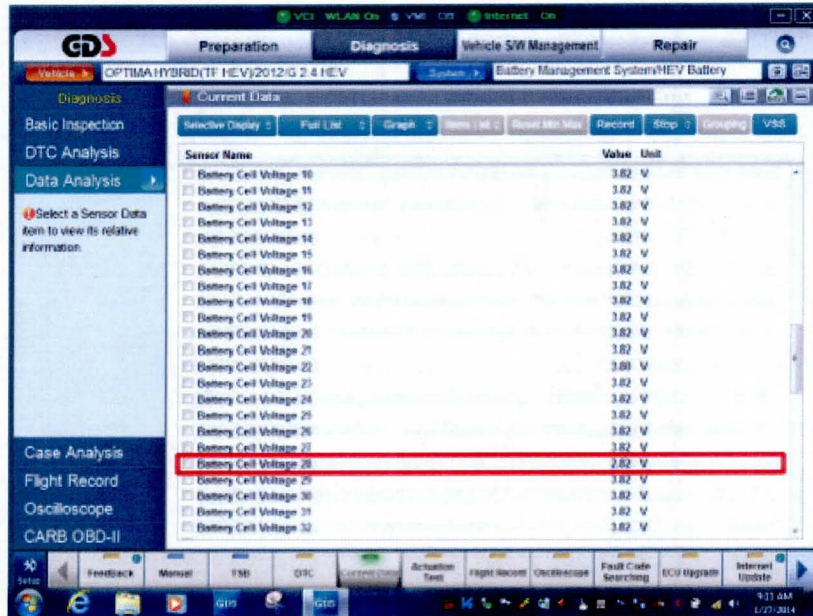
When addressing a customer complaint related to a battery warning lamp illuminated in the dash and drivability issues on Optima Hybrid, access GDS to check for any active DTC(s). Also, review the **BMS > Current Data** to inspect for one or more HEV battery cells showing one (1) volt, or more, lower than the than rest of the cells (see below). Duplicating this condition may not be possible when viewing in Ready Mode. If so, test drive the vehicle with a flight recorder to capture the event in city driving conditions. Send all supporting information to Techline for documentation of condition and further diagnosis.

Please refer to Pitstop PS 292
