TECHNICAL BULLETIN Q418 UPS6614-3bNAS1 19 NOV 2014

SECTION: 501-17

Update Prior to Sale: Panoramic Roof Opening Panel / Blind Switch Function

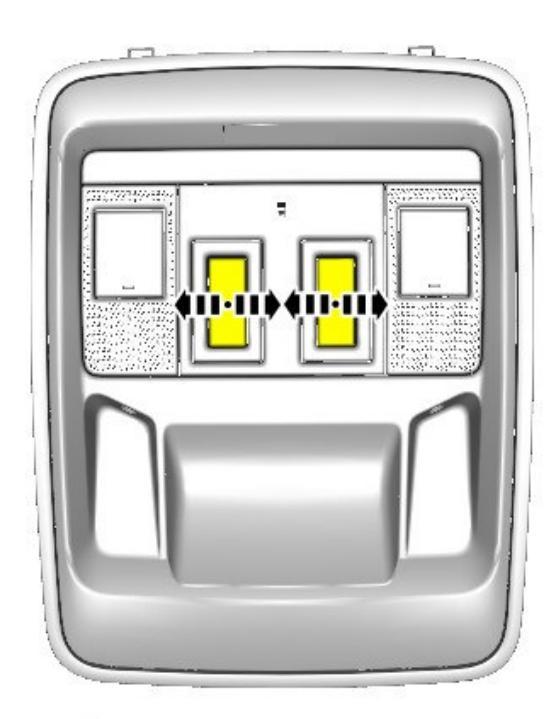
E171780

- 1. Inspect the front overhead console roof opening panel and roof opening blind switches for side-to-side movement.
 - If faulty, the switches will feel loose and move side to side in the console.

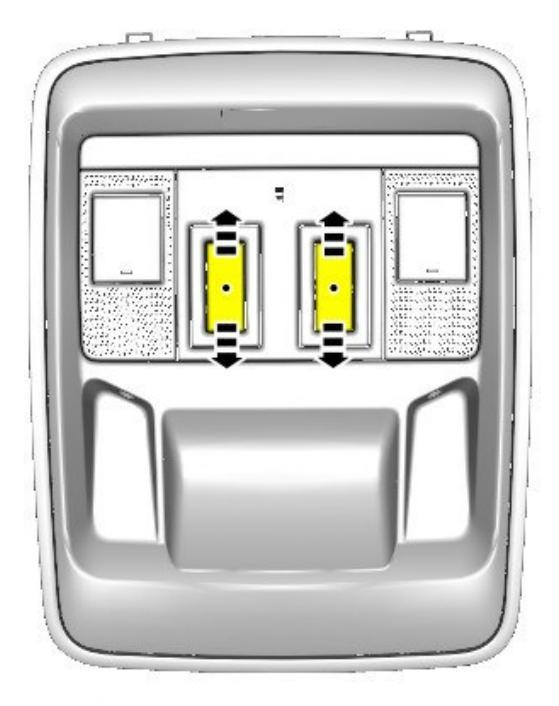
E171778

- Inspect the front overhead console roof opening panel and roof opening blind switches for positive operation and any abnormal noises when operated.
 - If faulty, a switch will lack a positive 'click' and may also 'squeak' when operated.

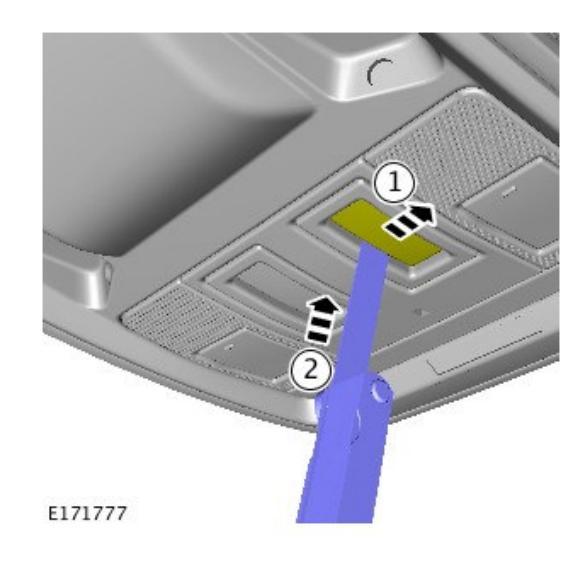
If any side-to-side movement is found in step 1 and either switch is not secure in the front overhead console, use a plastic feeler gauge to measure the movement of the switch(es) in the front overhead console.

- Side-to-side movement < / = 0.5mm: no further action required.
- Side-to-side movement > 0.5mm: continue to step 4.

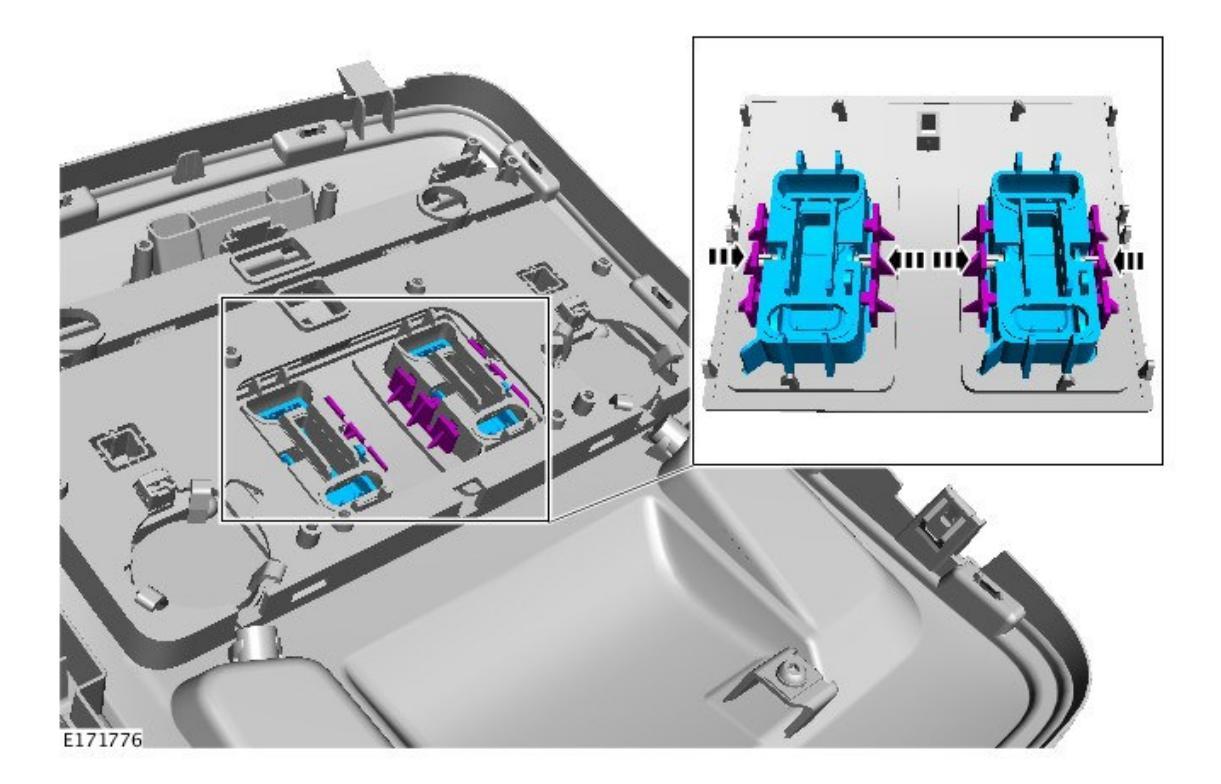
7. Inspect the switch retaining clips, making sure all the clips are fully engaged.
