**Document ID:** IK1100025

**Title: Prostar and Lonestar Clutch Service Information**

**Applies To: International Prostars and Lonestars Built with Hydraulic Clutch Systems**

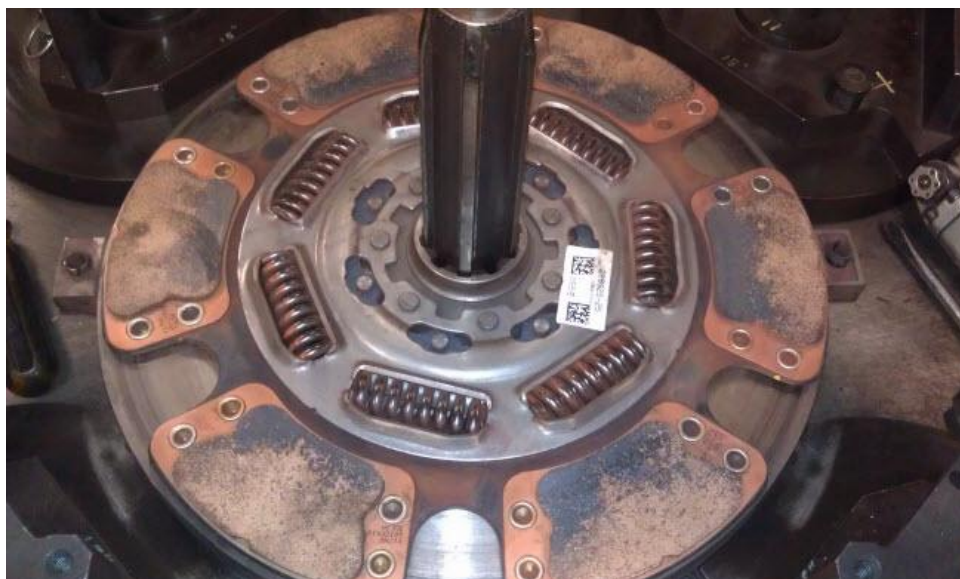
The photo below shows NORMAL wear on an Eaton clutch disk. Eaton clutch disks are beveled. The high side of the bevel is on the opposite side of the notch in the friction material. The bevels are opposite on each side of the clutch disk.
