Title: ACM/DCU and DSI Faults Troubleshooting

Applies To: 2010 and 2013 (OBD) Emission DT, 9 & 10

This document is for troubleshooting the Aftertreatment Control Module(ACM)/Doser Control Unit (DCU) and Down Stream Injection(DSI) assembly on the 2010 and 2013 emissions DT/9/10 engines.

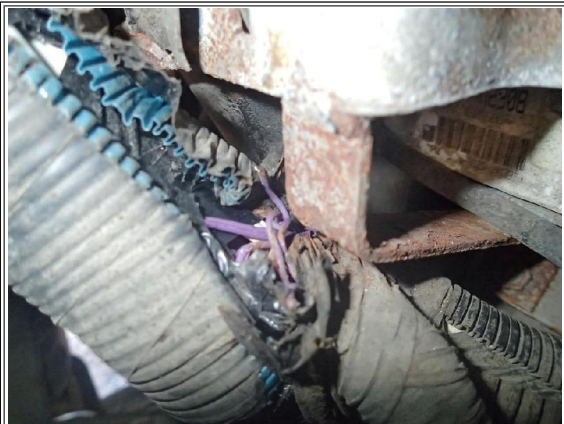
Wiring from the ACM/DCU to DSI should be inspected for any chafing and proper routing. Also inspect the powers and grounds for any issues. If the issue is centralized on a particular wire or circuit, then it should be load tested and wiggled to pinpoint the issue.

Figure #2: Harness chafing(incorrectly routed)

No: Correct any wiring issues and make sure it is properly routed. Retest and verify aftertreatment fault does not return.

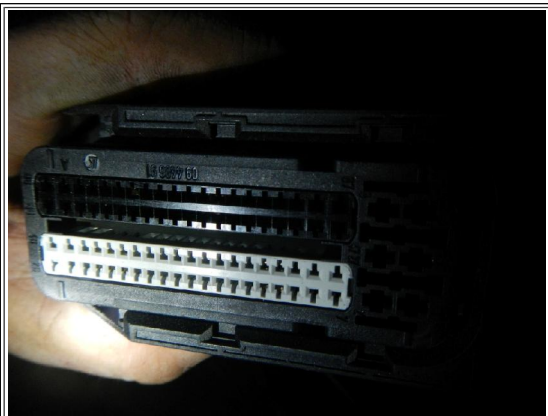
The ACM/DCU 86-Pin, 53-pin and the 24-Pin Engine/IP connector should be inspected for connection issues at the pins. A weak pin or one that is not fully snapped into the connector can create intermittent codes from vehicle vibration. By removing the connector comb you can easily inspect pins and check their wire crimp connection.

Figure #3: Connector Inspection(ACM/DCU 86-Pin)

No: Replace any connector pins that do not make a good connection or properly snap into the connector. Retest and verify aftertreatment fault does not return.
