Compression and Leak-Down Testing

HID Modified Headlights

Engine Cranks But Will Not Start

MSN 15402 (1504)

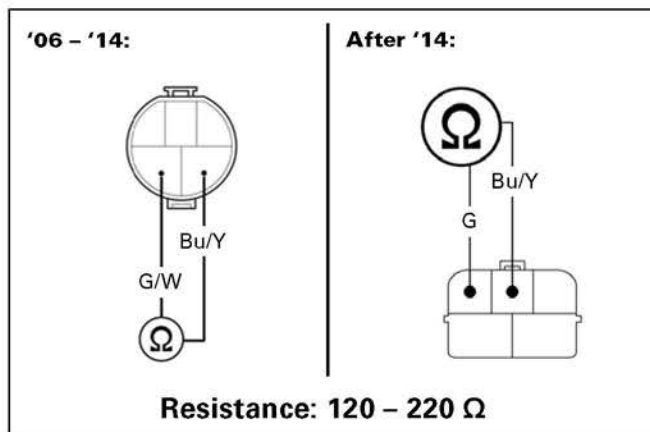
1. Refer to the Service Manual and test the ignition coil primary peak voltage. If the results are OK according to the Troubleshooting table on page 21-5, go to step 2.
2. Refer to the Service Manual and test the CKP sensor peak voltage. If the results are OK according to the Troubleshooting table on page 21-5, go to step 3.
3. If both the ignition coil primary peak voltage and CKP sensor peak voltage are within spec and there is no spark at the plug, measure the resistance through the CKP sensor at the alternator connector with a multi-meter as shown. If the resistance is outside the value shown, replace the stator.
