Service Bulletin

Subject: Driver Outside Wide Load Mirror Turn Signal Too Bright

Models: 2015 Chevrolet Silverado 1500 2015 Chevrolet Silverado 2500/3500 with RPO AVF 2015 GMC Sierra 1500 2015 GMC Sierra 2500/3500 with RPO AVF With Mirror RPO DPN or DQS

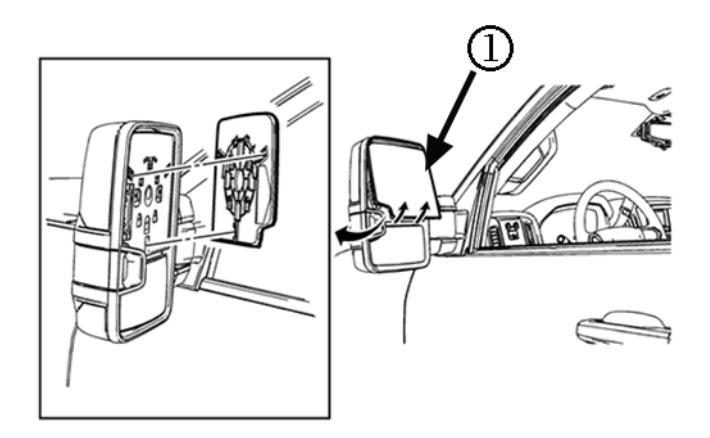
Some customers may comment that the driver's outside wide load mirror turn signal is too bright. This concern is more noticeable when driving at night.

The cause of this condition may be the brightness of LED's in the turn signal on the mirror.

Replace the original upper left hand outside rearview mirror glass only with a new part designed to reduce the intensity of the LED indicator.

- 1. Remove the upper outside rearview mirror glass (1). Refer to the appropriate Outside Rearview Mirror Glass Replacement Upper procedure in SI.
- 2. Install the new upper outside rearview mirror glass. Refer to the appropriate Outside Rearview Mirror Glass Replacement- Upper procedure in SI.
