Service Bulletin

PRELIMINARY INFORMATION

Subject:	Malfunction Indicator Lamp (MIL) ON, Poor Transmission Shift Performance/Quality
Models:	2015-2016 Chevrolet Silverado
	2015-2016 GMC Sierra
	Equipped with Allison Model 1000 Automatic Transmission (RPO MW7)

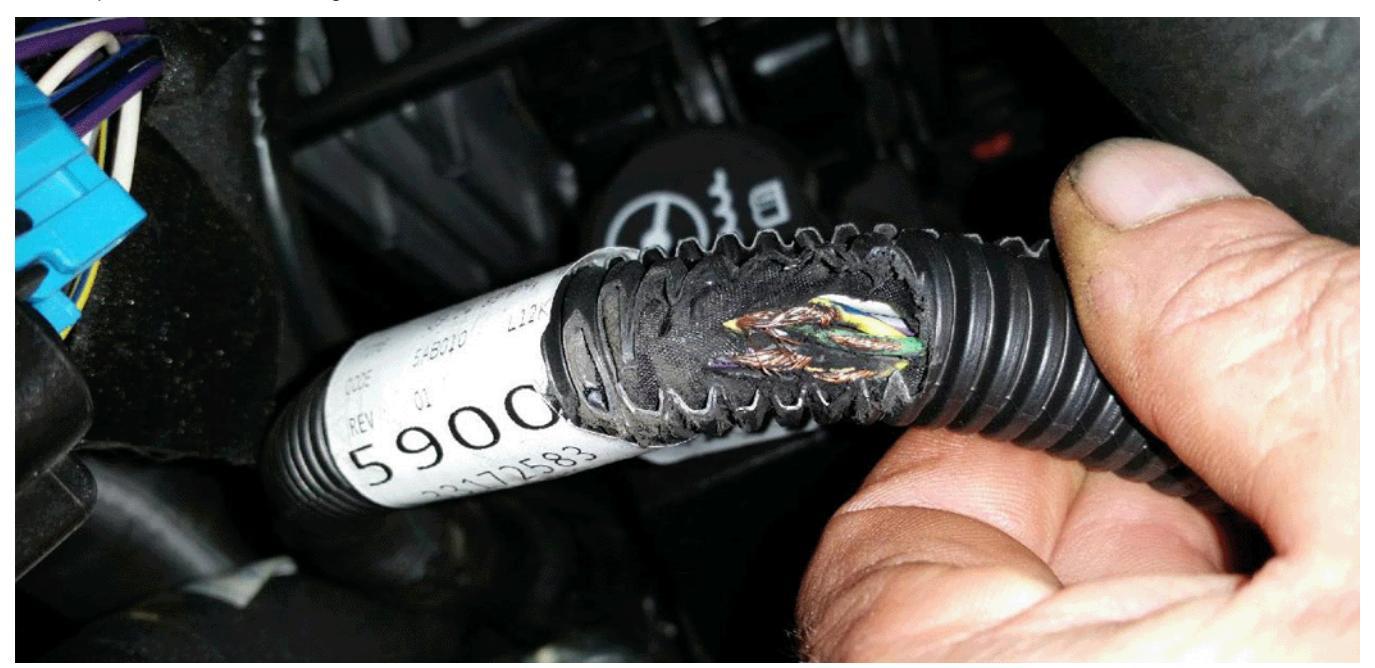
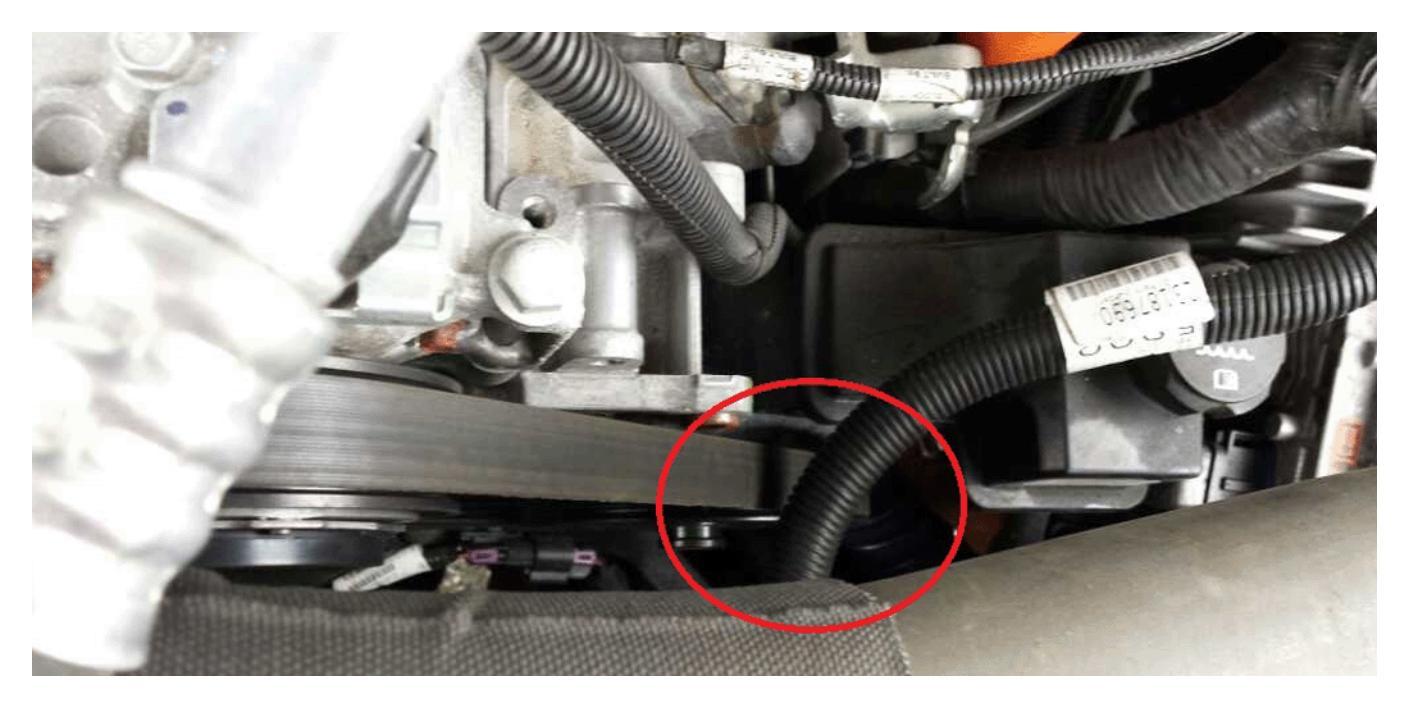
The TCM wire harness routing allows interference with the engine accessory drive belt, which can cause damage to the wire harness. See the picture below of a damaged harness.

Repair the TCM harness as required.
