Service Bulletin

Subject: Rough Idle In Drive

Models:	2015 Cadillac Escalade Models	
	2014 Chevrolet Silverado 1500	
	2015 Chevrolet Silverado 1500, Suburban, Tahoe	
	2014 GMC Sierra 1500	
	2015 GMC Sierra 1500, Yukon Models	
	With engines 4.3L, 5.3L, 6.2L RPO L83, L86, LV1, LV3

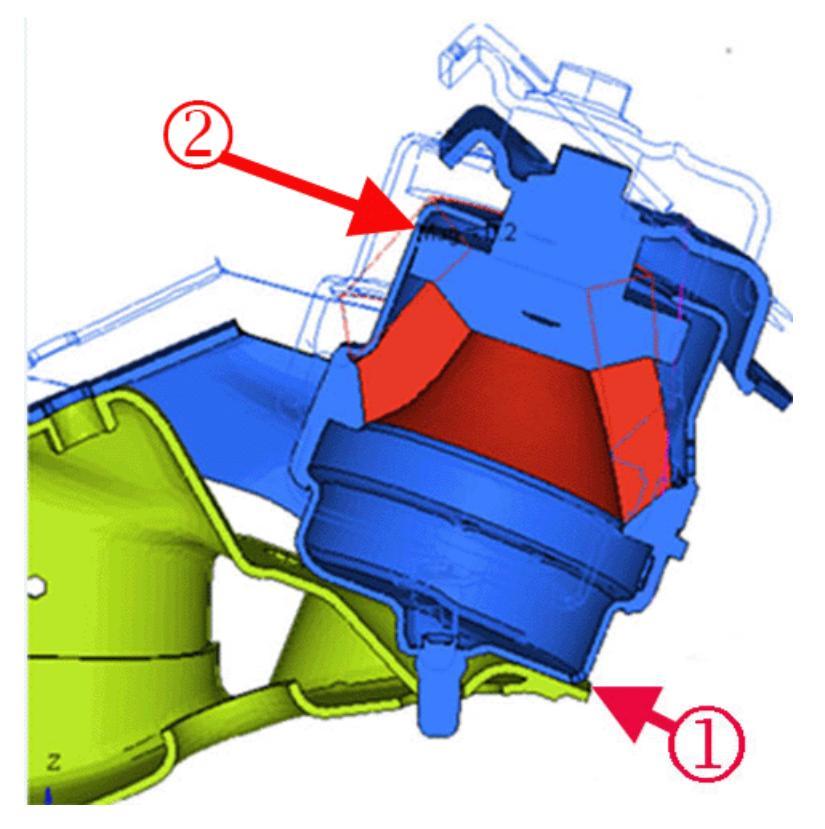
Installing shims between the mount and frame bracket at the lower inboard location (1), alleviates the ground-out in the mount (2) at the upper outboard area.

Install 3mm-thick "shims" (spacers, not tapered shims) between bottom surface of mount and frame bracket, on the inboard side of mount (1).
