**Document ID:** IK1201245  
**Revision:** 5  
**Created:** 11/25/2014  
**Last Modified:** 5/7/2015  
**Author:** Michael Sokolowski

**Title:** 2010+ DT/9/10 EGR Valve Diagnostics

**Applies To:** 2010+ MaxxForce DT/9/10

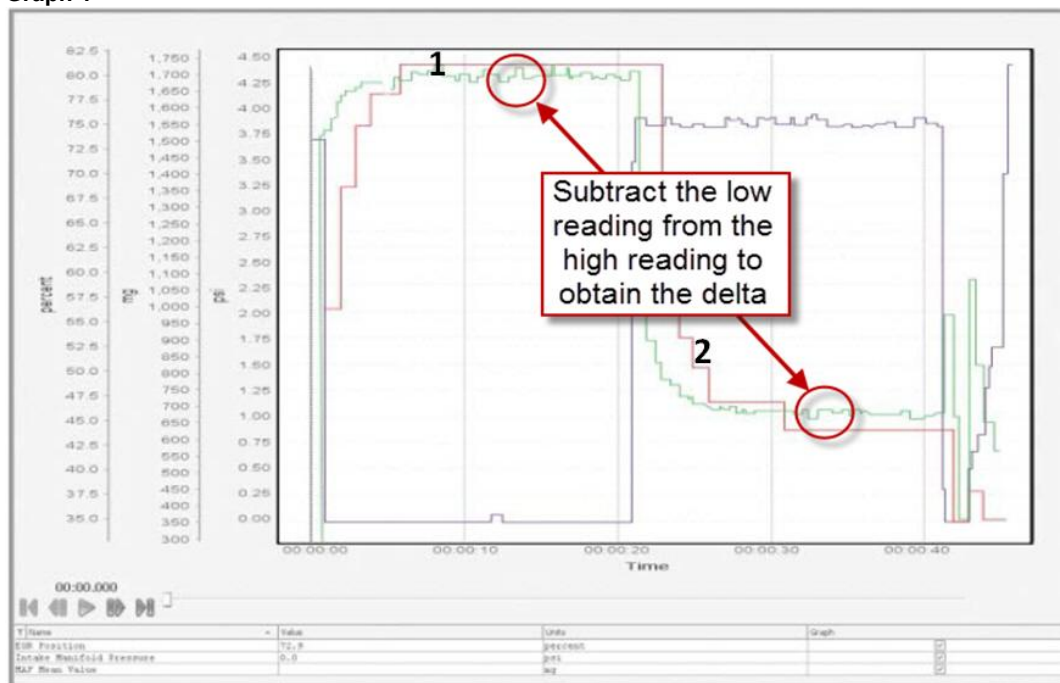
Graph 1

| Step | Action | Decision |
|---|---|---|
| 6 | Perform & Record Air Management Test.<br>MAF Mean Value Delta obtain the reading by subtracting the high reading in the beginning of the test to the low reading near the end as shown below in Graph 1: | <b>Yes:</b> No further action required |
| | 1. 466 ST $\geq$ 690 mg<br>2. 466 HT $\geq$ 740 mg<br>3. 570 $\geq$ 850 mg | <b>No IMP:</b> Go to step 7 |

1. MAF Mean Value High Point  
2. MAF Mean Value Low Point
