**Title:** Interpreting AMS Snapshot

**Applies To:** 2010 + MaxxForce DT, 9, 10, N9 & N10 (ESN 3,300,000 and later) operating below 4,000' altitude

This article describes how to read and interpret the AMS (Air Management System) Test on 2010 and newer I-6 Engines.

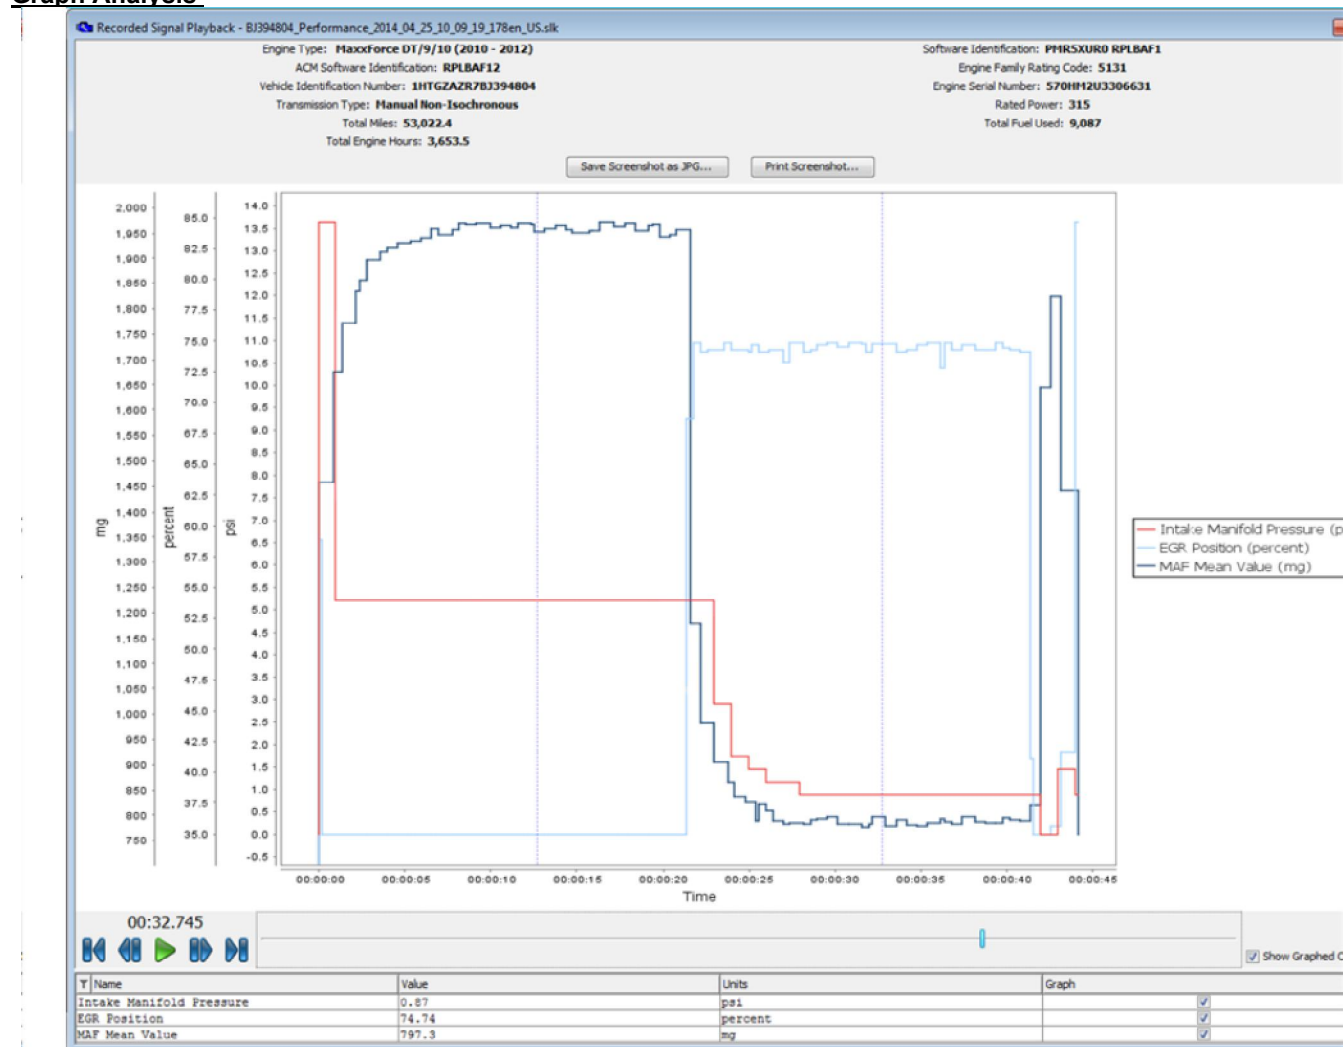
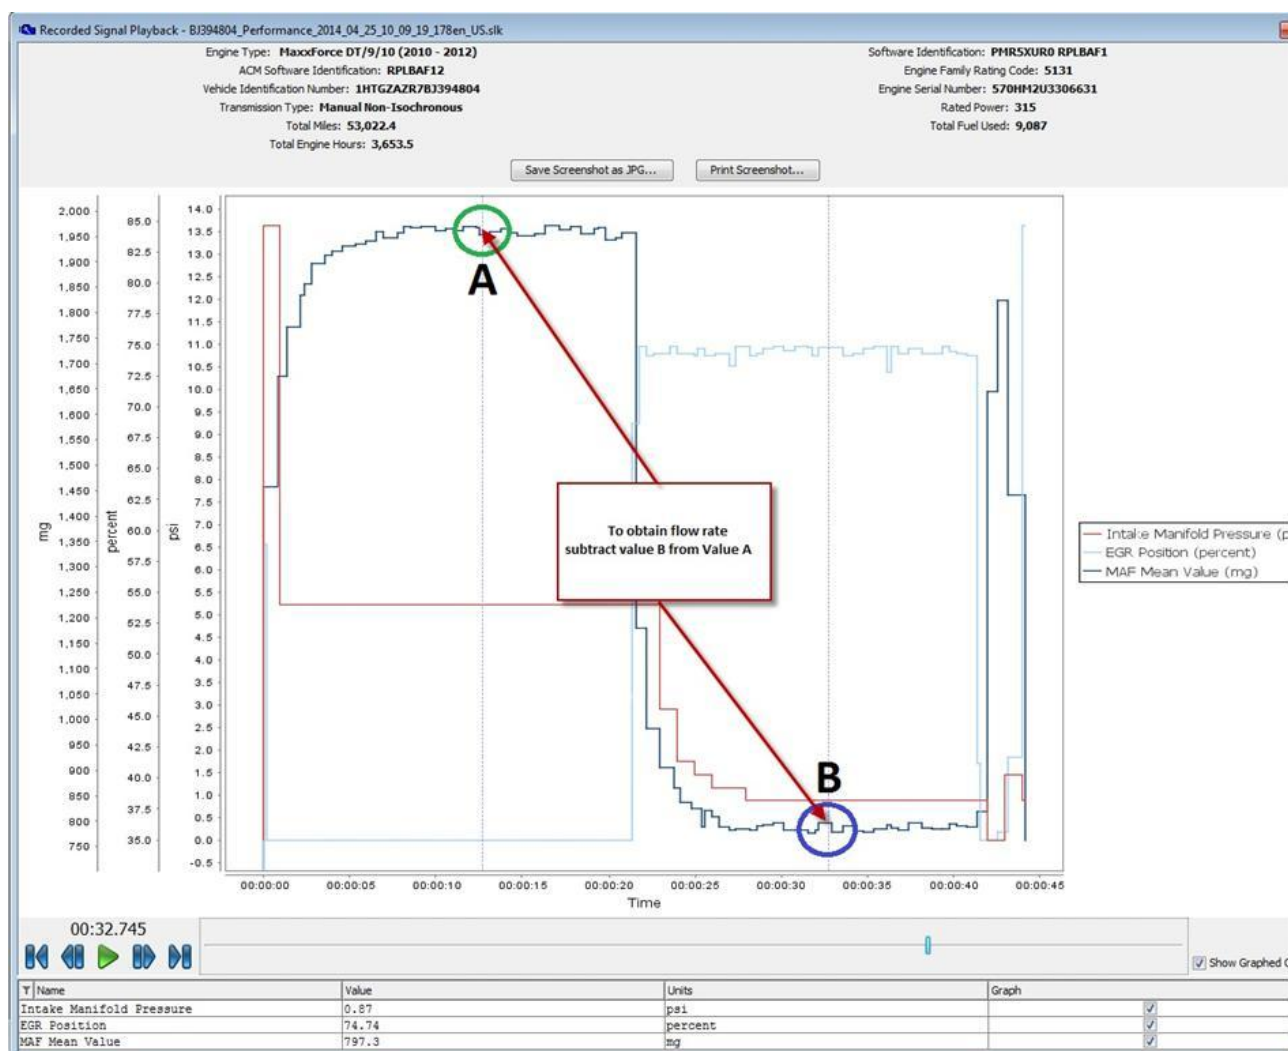
**Graph Analysis**

5. Calculate the EGR flow in mg by subtracting reading B from reading A then compare to specs:

- A. 466 ST  $\geq$  690 mg
- B. 466 HT  $\geq$  740 mg
- C. 570  $\geq$  850 mg

If the calculated EGR Flow Rate does not meet spec proceed with the following

A. Remove the ETV (Engine Throttle Valve) from the EGR mixer housing, using a flashlight and mirror inspect the inlet air heater for severe plugging.

(80% or more plugging is required to cause an EGR flow issue)

B. If severe plugging is not present in the EGR mixer housing, cycle EGR valve 5 times with the output state test low / high and watch plunger operation using a mirror and flashlight.

**(Do not remove the EGR valve unless a SPN 27 and or SPN 2791 fault is set or valve fails to move)**

C. If the EGR valve actuation does not log any DTCs, and unit still logs SPN 2659 FMI 14 remove rear EGR crossover pipe and inspect for plugging (Replace if plugged and retest).

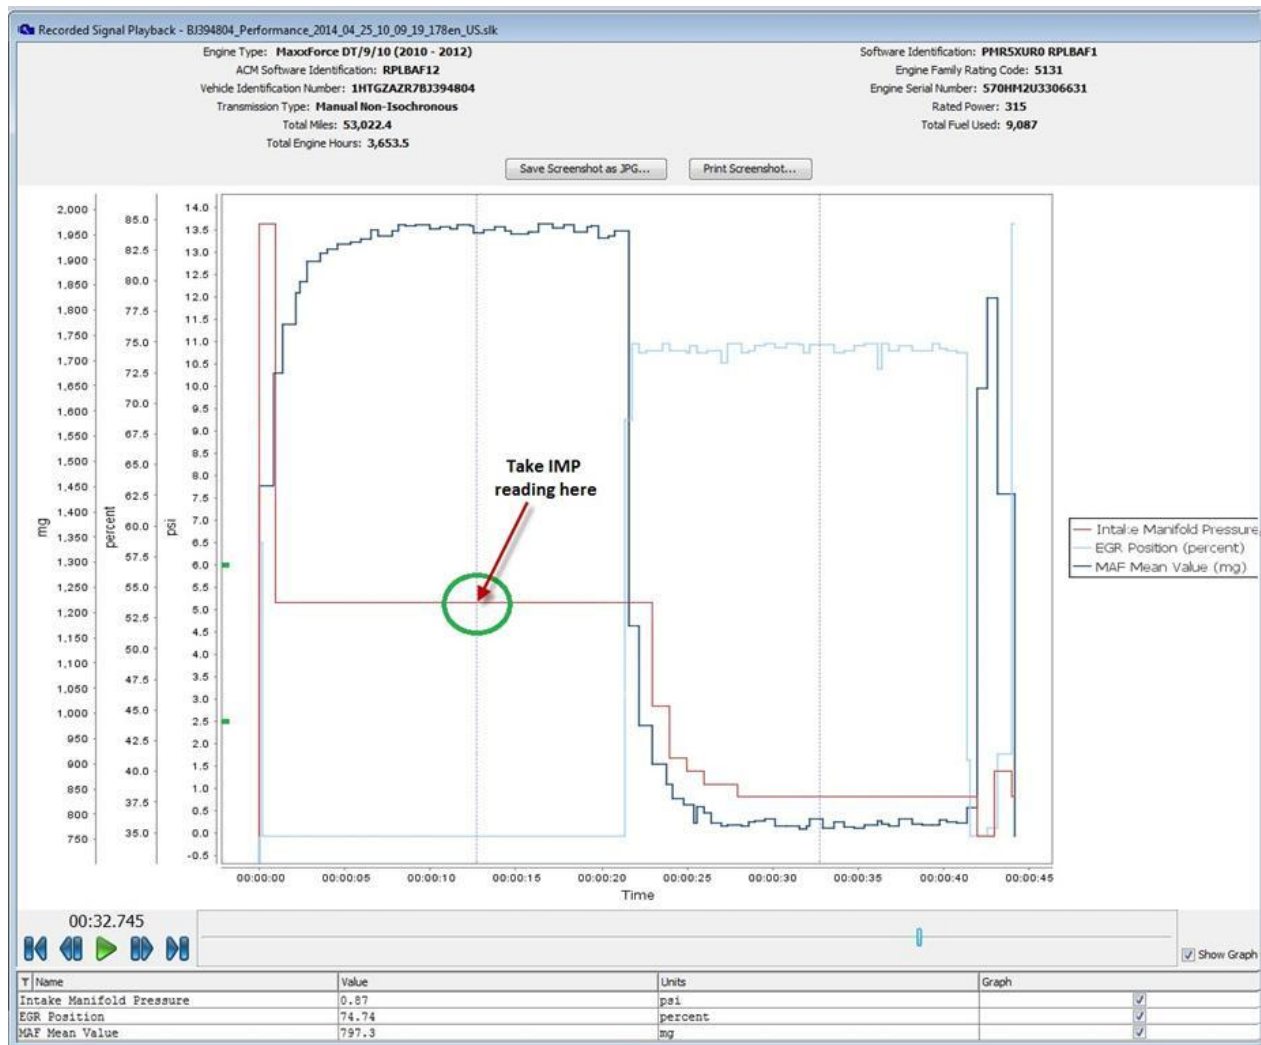
6. Verify IMP meets spec during the first half of the test:

A. Spec is 2 PSI or greater

If IMP does not meet spec proceed with the following:

A. Below range: Follow [IK1200648 Low Power Complaint due to Low Boost or ETV Boot Tear](#)

B. Above range: [Check turbocharger wastegate adjustment per IK1201103](#)
