**Document ID:** IK1201245  
**Revision:** 3  
**Created:** 11/25/2014  
**Last Modified:** 3/30/2015  
**Author:** Michael Sokolowski

**Title:** 2010+ DT/9/10 EGR Valve Diagnostics

**Applies To:** 2010+ MaxxForce DT/9/10

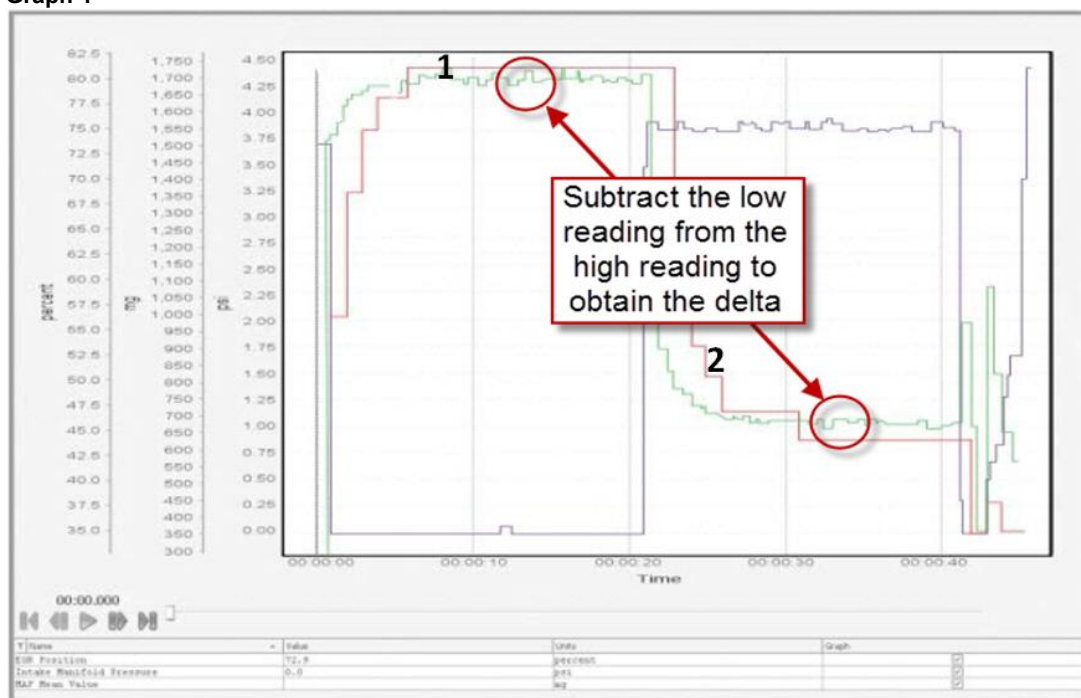
Graph 1

| <b>5</b> | Perform & Record Air Management Test.<br>MAF Mean Value Delta obtain the reading by subtracting the high reading in the beginning of the test to the low reading near the end as shown below in Graph 1:<br><br>1. 466 ST $\geq$ 690 mg<br>2. 466 HT $\geq$ 740 mg<br>3. 570 $\geq$ 850 mg<br><br>Intake Manifold Pressure (IMP) Graph 2:<br><br>1. 2 - 6 PSI<br><br>Does Air Management test meet specifications listed above? | <b>Yes:</b> No further action required<br><br><b>No IMP:</b> Go to step 6<br><br><b>No MAF Delta:</b> Go to step 7 |

1. MAF Mean Value High Point (mg)
2. MAF Mean Value Low Point (mg)
