<b>Countries:</b>	AUSTRALIA, BRAZIL, CANADA, TAIWAN, UNITED STATES, MEXICO, GUAM, KOREA, SOUTH KOREA, SOUTH AFRICA	<b>Document ID:</b>	IK0300008
<b>Availability:</b>	ISIS, Bus ISIS, FleetISIS	<b>Revision:</b>	9
<b>Major System:</b>	SPRINGS AND SUSPENSION	<b>Created:</b>	4/25/2007
<b>Current Language:</b>	English	<b>Last Modified:</b>	11/18/2015
<b>Other Languages:</b>	NONE	<b>Author:</b>	David Horner
<b>Viewed:</b>	6009

**Title:** Vibration Troubleshooting

**Applies To:** All International Trucks

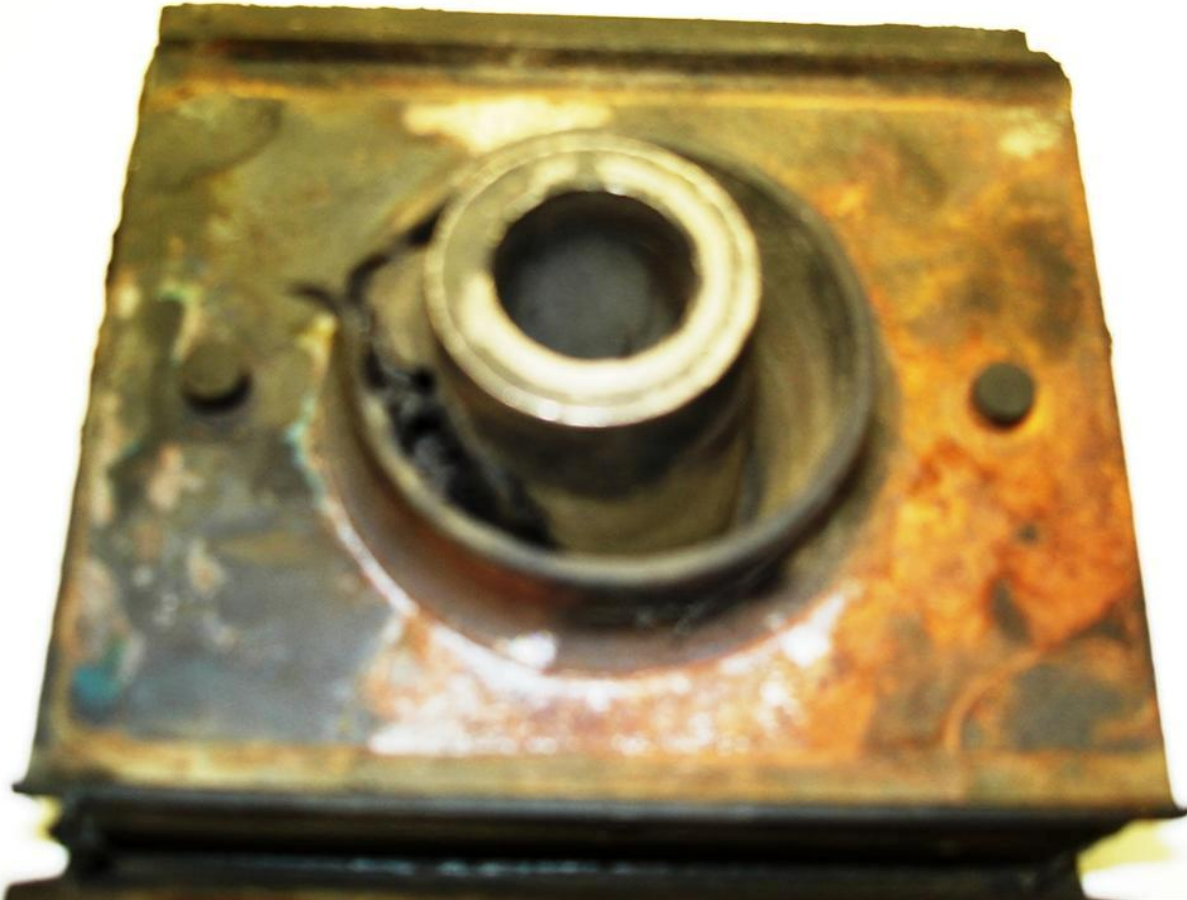
**Figure 2 - Rear Engine Mount Damage**

1. Remove the lower snubber washers on the rear engine mounts and look to see if the "spool" is centered in the mount bracket.
2. Jack the rear of the engine up to remove pressure from mount to see if the "spool" or the outer portion of the rubber on the mount is torn loose or damaged.
3. Remove and inspect the front engine mounts to inspect the inner radius of the isolator for damage.

Isolator is damaged.

- Replace any compromised mount - there are no part number changes just get what parts catalog calls for.
- With new mounts installed, carefully let the weight of the engine down on the mounts-pay close attention to note whether the weight of the engine cocks the spool to an angle and then note whether the spool is perfectly centered.

- Loosen the bolts that assemble the rear of cab crossmember and push out the frame if it is too narrow or pull frame together if too wide to allow centering of the rear engine mount bolts and retorque the crossmember bolts.

- If the frame is still too wide at the rear engine mount area then you will need to add grade eight washers between the mount and the frame to space it inward until perfectly centered.

- If the frame is still too narrow at the rear engine mount area then you will need to measure the frame width at the front engine crossmember, again at the rear engine mount area, and lastly at the first crossmember (rear cab mount) behind the engine and document these numbers.

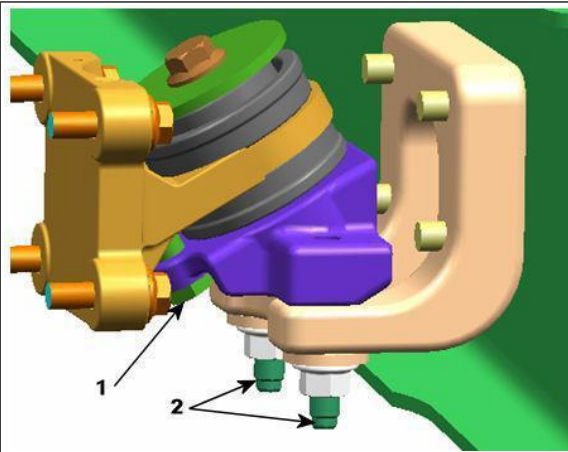
Figure 4

If the alignment bolts are left in, it will cause an engine vibration.

1. Temporary Alignment Bolt
2. Engine Mount Bolts

- When installing a MaxxForce 11/13 or N13 engine a shoulder bolt (PN 3822703C1 or 3596321C2) must be used to align both the left and right front engine mounts.
- This will ensure correct alignment of front engine mount bushings.
- Install the shoulder bolts (as shown in Figure 5) prior to lowering the engine into the chassis.
- After the engine has been positioned and the front and rear engine mount bolts have been tightened to the appropriate torque, remove the alignment bolt from each of the front engine mounts.

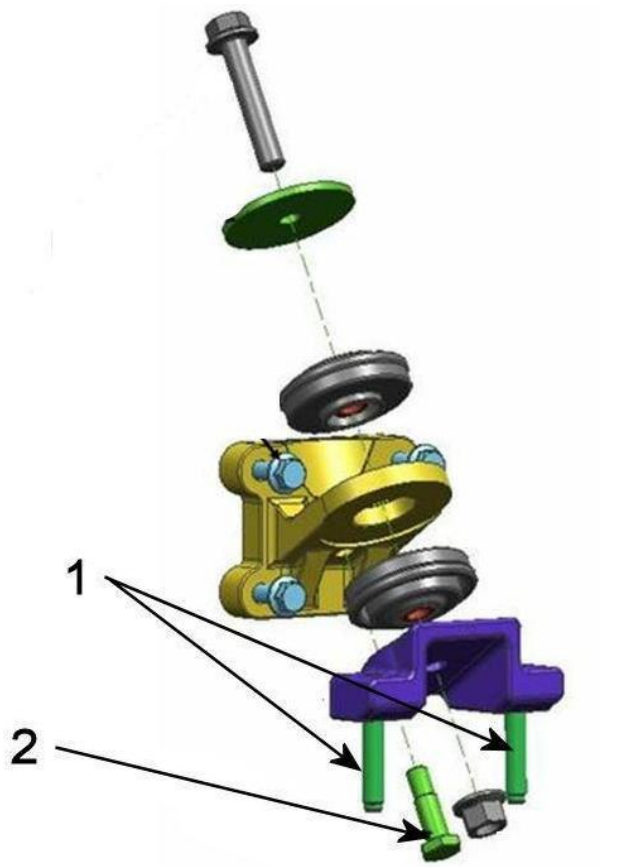
Figure 5

- 1. Front Engine Mount Bolts (Torque: 215-237 Nm) (160-175 Lbf-ft)
- 2. Temporary Alignment Bolt

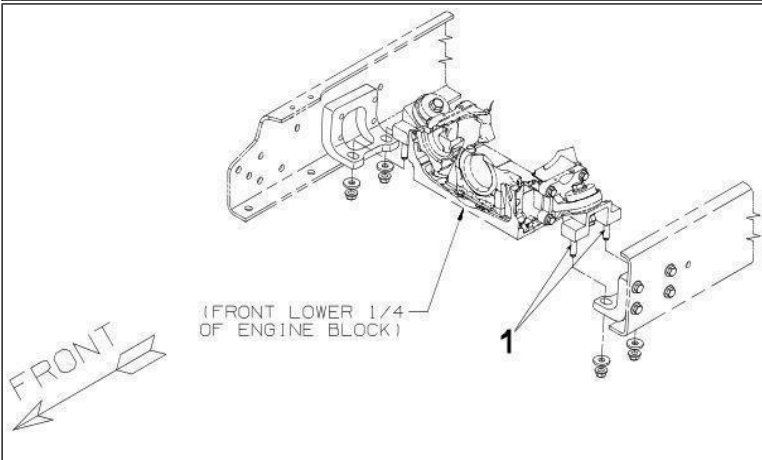
Figure 6

- 1. Front Engine Mount Bolts (Torque: 215-237 Nm) (160-175 Lbf-ft)
