Countries: AUSTRALIA, CANADA, TAIWAN, UNITED STATES, MEXICO, PUERTO RICO, GUAM, KOREA, SOUTH KOREA, NEW ZEALAND
Document ID: IK1201113
Availability: ISIS, FleetISIS
Revision: 13
Major System: ENGINES
Created: 4/3/2014
Current Language: English
Last Modified: 11/2/2015
Other Languages: [Español](#),
Author: Ben Krejcie
Viewed: 17323

Title: 2010 MaxxForce 11 & 13 and 2013 N13 HT EGR Core Removal/Installation

Applies To: 2010 MaxxForce11/13, 2013 N13, All Truck Models

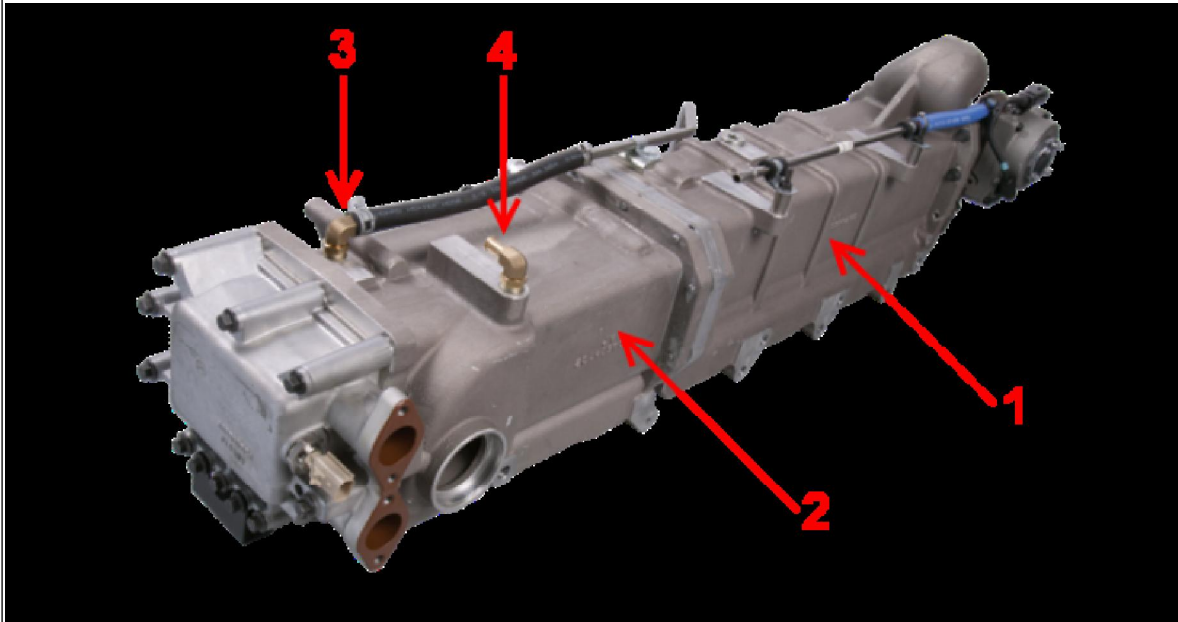
Figure 1: 2010 MaxxFace 11/13 EGR Cooler Assembly

- Item 1: High Temp (HT) Cooler
- Item 2: Low Temp (LT) Cooler
- Item 3: LT Cooler Pressure Test Port (dearation fitting)
- Item 4: HT Cooler Pressure Test Port (dearation fitting)

Visual inspection should never be used for diagnosing a bad cooler. The cooler (especially when constantly operated cold-- read, moving the truck around the lot) will cause condensation build-up, and when mixed with soot/exhaust constituents, can be easily confused with coolant. ALWAYS pressure test the cooler.

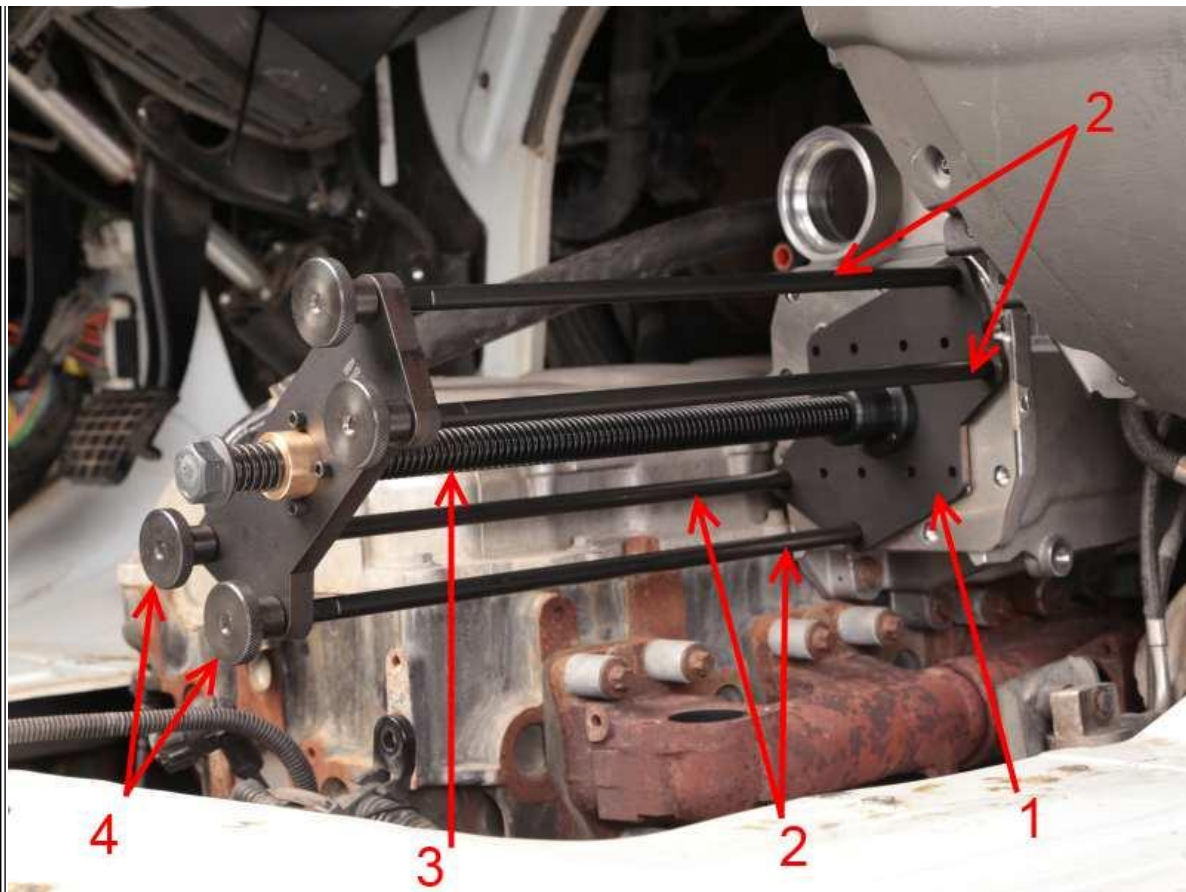
Figure 2: HT Core Removal Tool

- Item 1: Removal plate
- Item 2: Support rods
- Item 3: Forcing screw
- Item 4: Thumb screws

a. Screw in the support rods in the two upper right, and lower, bottom left corner, holes (**Figure 2**, Item 2). **Tighten using a 9mm open-end wrench.**

It is critical that the rods get torqued to the housing. There is a bevel between the threads and the shaft, designed specifically to drive the cooler header onto the shaft. **There is a distinct difference between bottoming out on the header plate, and bottoming out in the housing (hard stop).** Failure to do so will lead to the header being caught on the rod and breaking/bending the rod. There have been instances of the housing being damaged to the point of replacement, as well.

- b. Slide the puller over the rods
- c. Attach/tighten the thumb screws (**Figure 2**, Item 4).

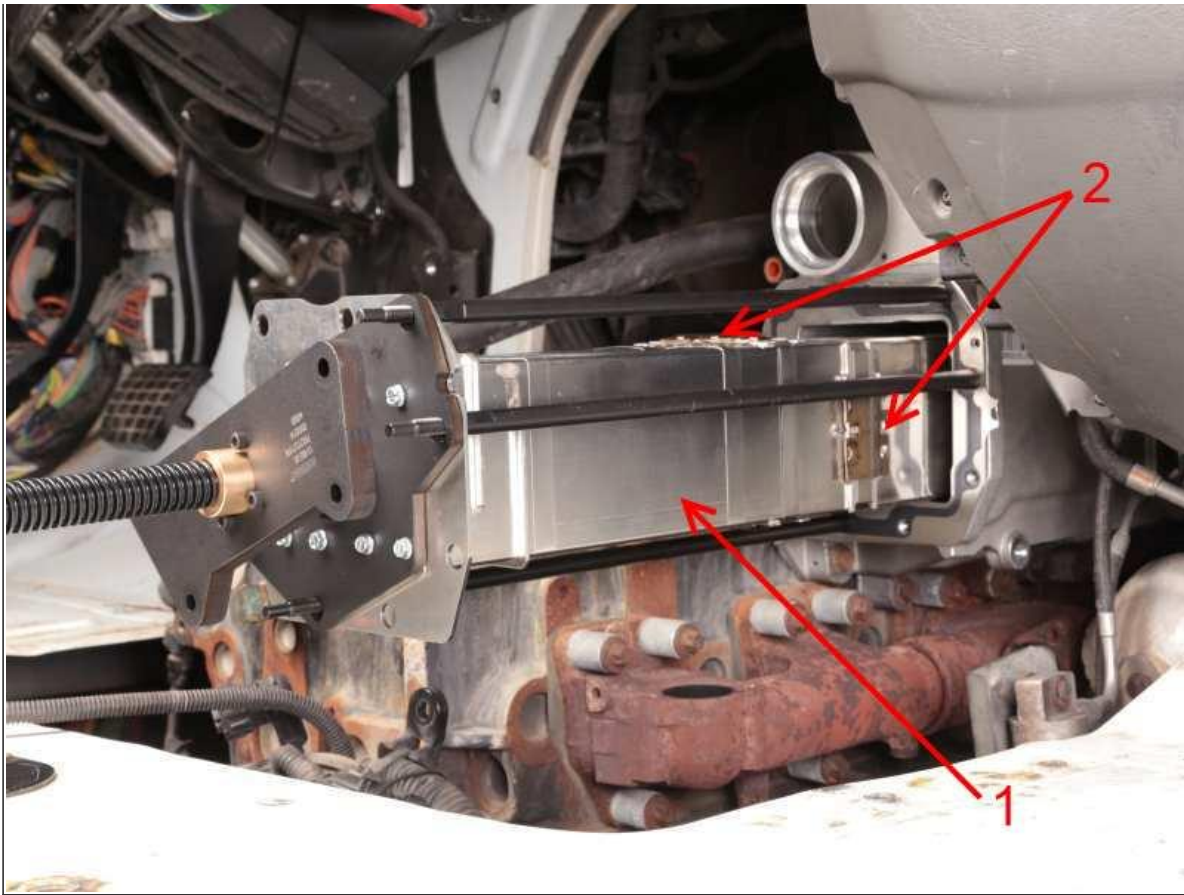
Figure 4: High Temp Core and Spring Clips

Item 1: HT Cooler Core
Item 2: Spring Clips

-There are two pairs of spring clips supporting the core in the housing. Therefore, the core will need to be pulled about 16 inches before it will be free to remove.

5. Back out the bolt to extract the core from the housing (**counter-clockwise**).

-NEVER use an impact on the tool. The tool was not designed to handle the stresses because core and/or housing damage will result from the uncontrolled force. Always use a ratchet.

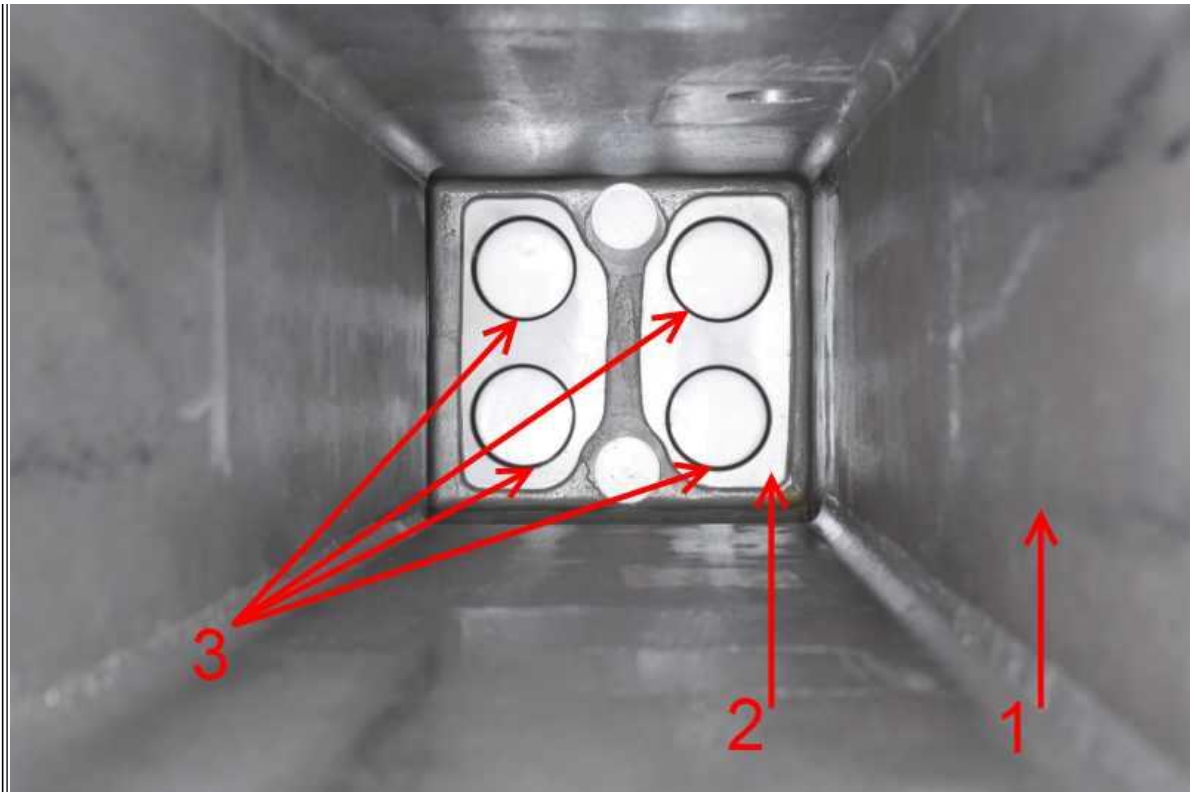
Figure 5: HT Diffuser O-Rings

- Item 1: HT Housing
- Item 2: Manifold (joint) Plate
- Item 3: O-Rings

10. Use a pick to remove the four o-rings in the center of the cooler and discard. *The o-rings must be replaced every time the core is replaced. Non-compliance will result in premature failure of the core.*

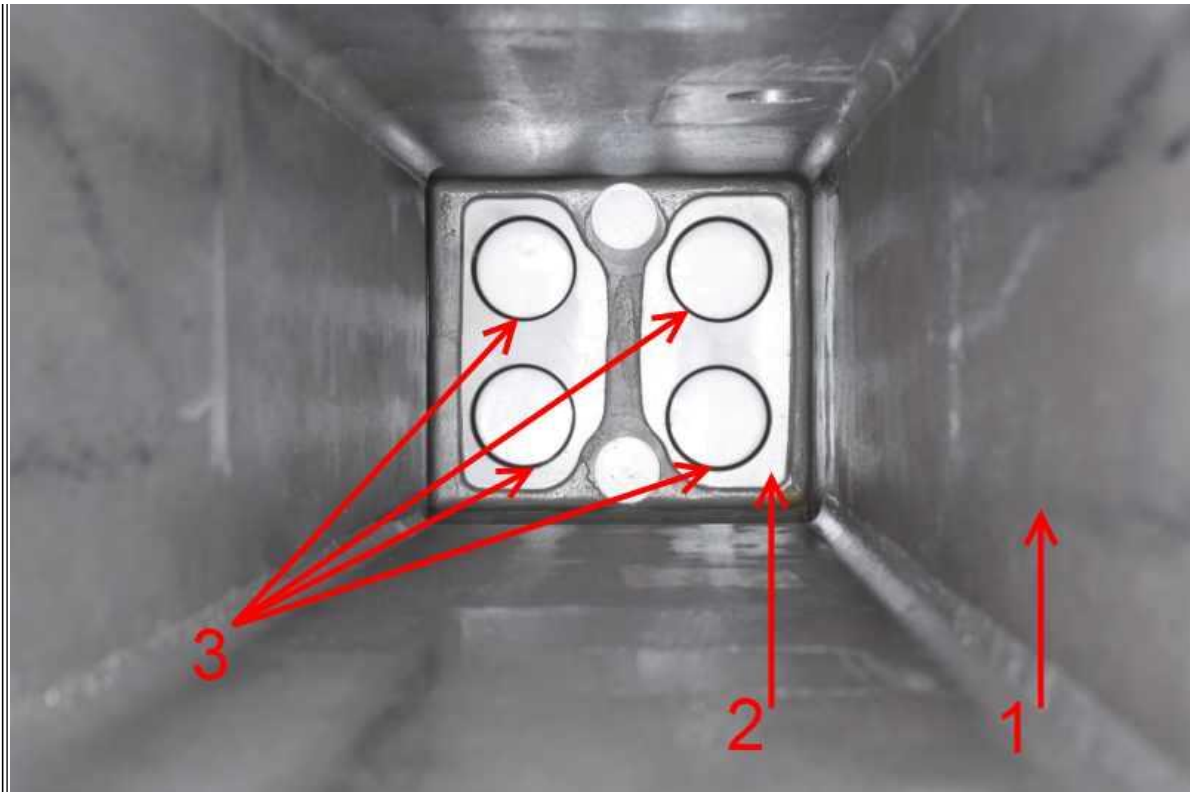
Figure 6: HT Diffuser O-Rings

Item 1: HT Housing
Item 2: Manifold (joint) Plate
Item 3: O-Rings

1. Install the four o-rings from the HT kit (**Figure 6**, Item 3) and ensure they are seated properly.

Make sure there is no debris in the o-ring grooves prior to installing the o-rings (they don't need to be spotless, just no soot chunks that will push the o-ring out of round). In development, this was the only instance of damaged o-rings (core outlet manifold cut off a section of the o-ring), outside of not actually seating them.

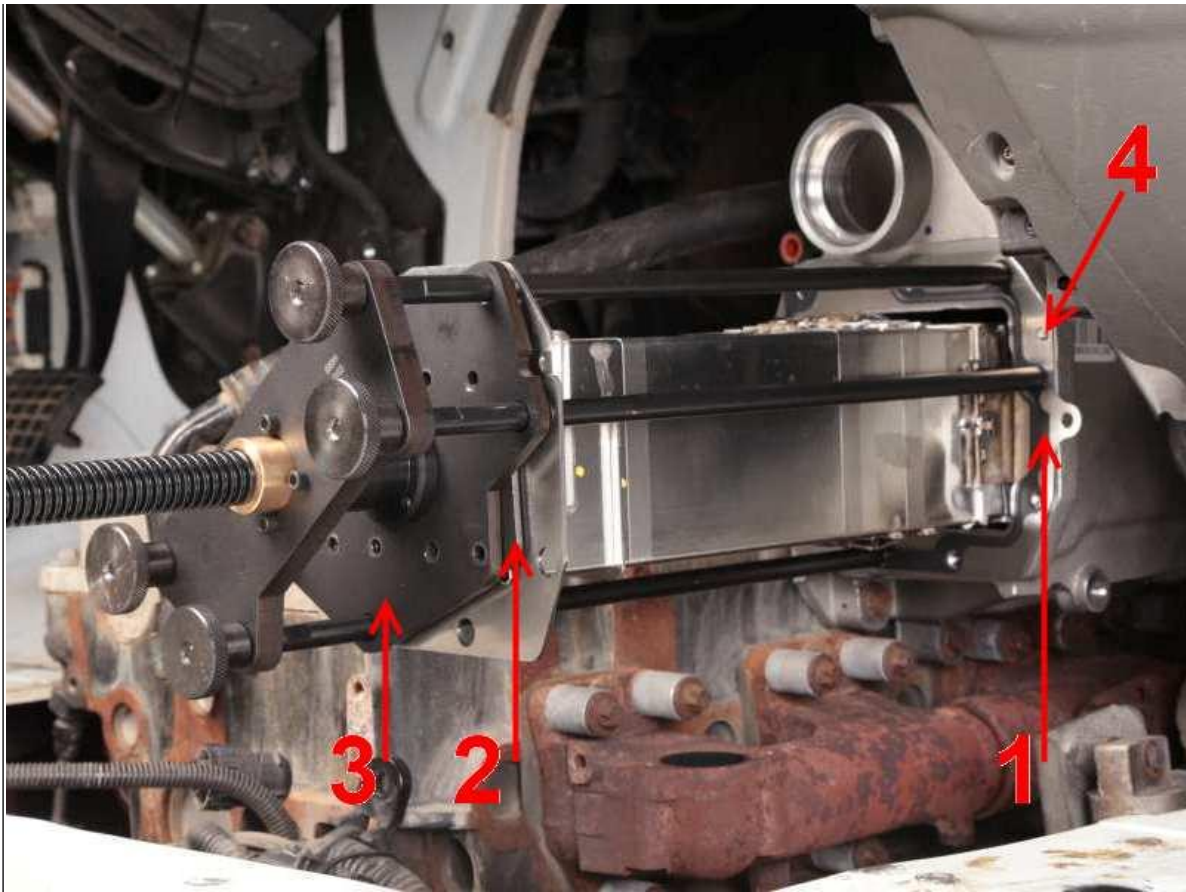
Figure 8: HT Core Installation

Item 1: Core to Housing Gasket
 Item 2: Installation Plate
 Item 3: Removal Plate
 Item 4: Dowel Pin

6. Apply liberal amounts of P-80 to the outlet manifold and spring clips of the HT core.
7. Slide the HT Core into the housing.
8. Attach the insertion plate to the tool and slide it over the rods.
9. Screw the thumbscrews onto the rods.
10. Use a torque wrench to tighten the bolt, which will drive the core into the housing. Stop when the core header touches the gasket.

DO NOT OVER TIGHTEN. Stop when the plate merely touches the gasket/housing. The core should take up to 10 lb-ft of bolt torque to slide in. **Damage to the tubes will occur if the torque exceeds 15 lb-ft (equates to 1000 lb force).**

NEVER USE AN IMPACT. Failure to do so will lead to damage to the tool, core and housing.

If the previous core and new core are on the opposite ends of the position spec, it's possible the plate will not line up and will cause the core to bottom out (on the plate, before sliding into the O-rings). The core/housing can be saved by loosening the HT/LT joint bolts (would require removing the cooler from the engine). This won't save time but will save a good core from being scrapped.
